Westgate Hall: Options Appraisal

Conception Architects

Condition Survey and Schedule of Required Conservation Works Westgate Hall

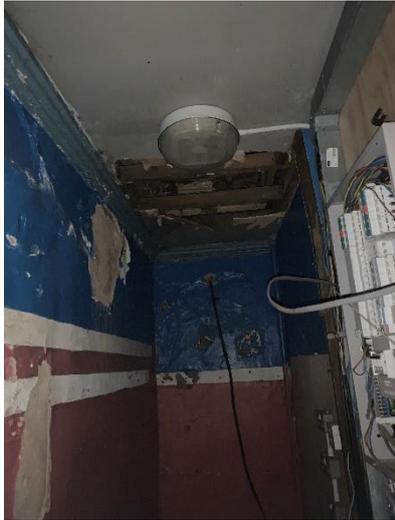
Wiring centre on right-hand side wall of RG06.

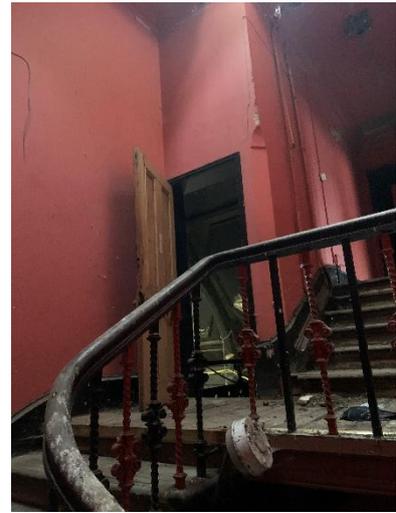
Intricate historic ceiling light with damaged/missing glazed sections.

The ornate ceiling window will also need to be repaired and the missing glazing reinstated as required.

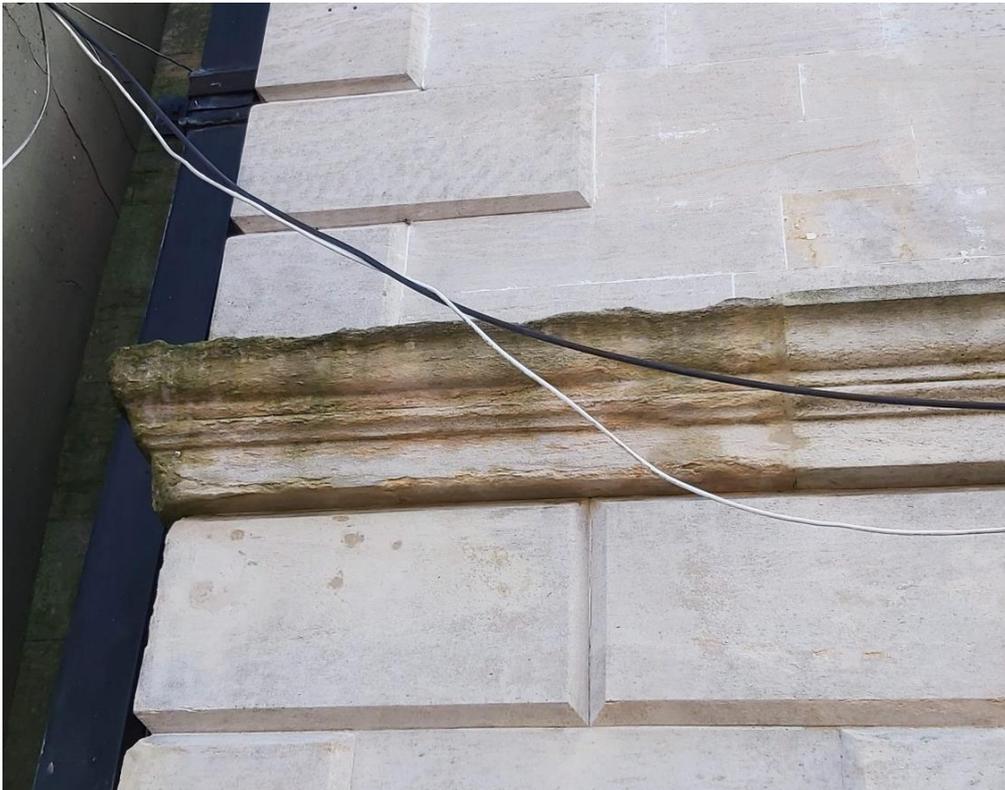
Photo 2 - Water Damage Stonework

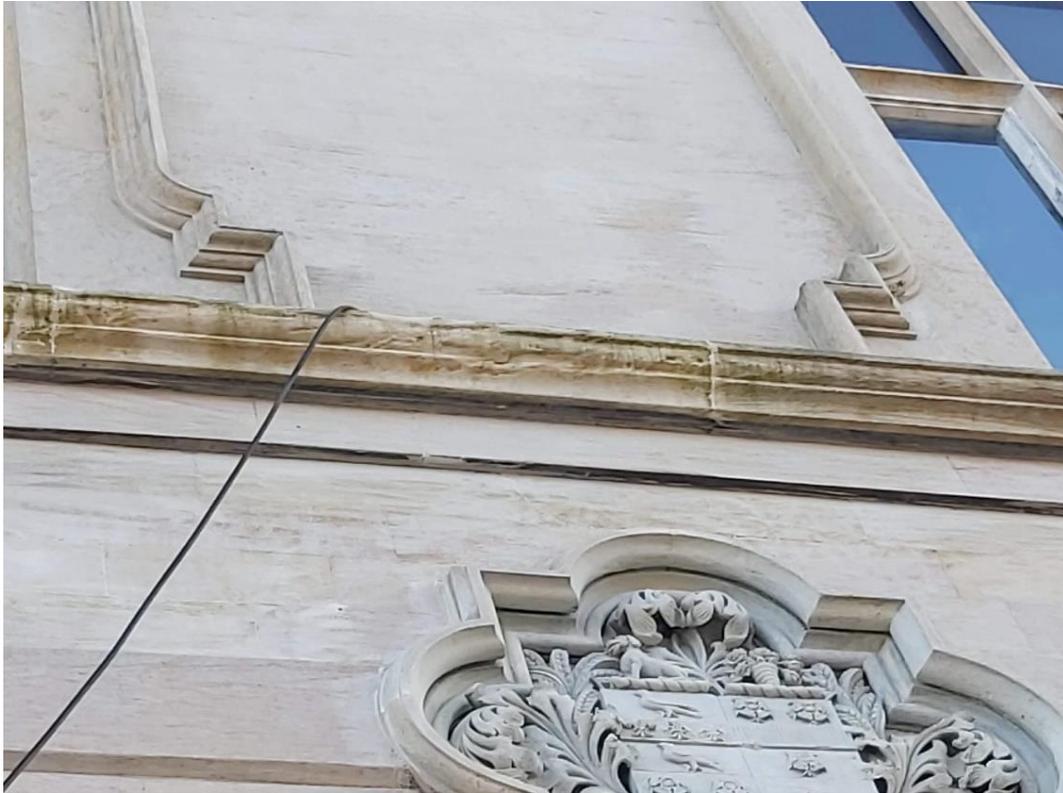
Photo 3 - Weathered Stonework

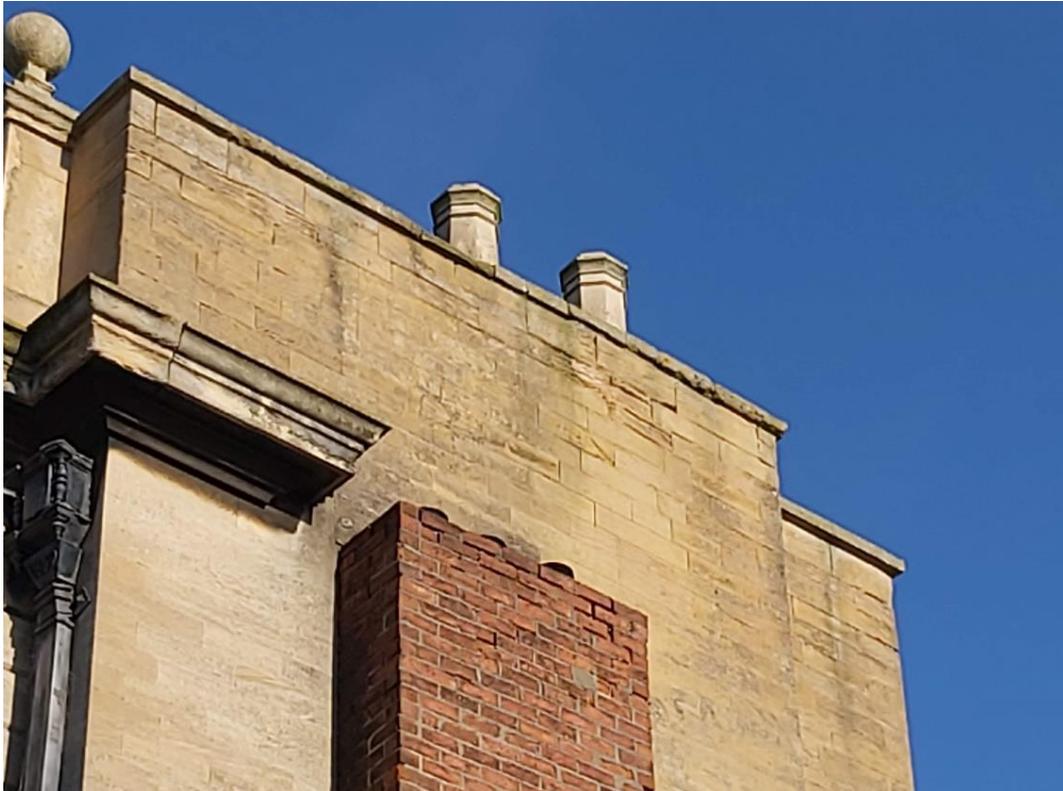
Photo 5 - Defective Mortar Joints, Coping Stones & Weathered Stonework

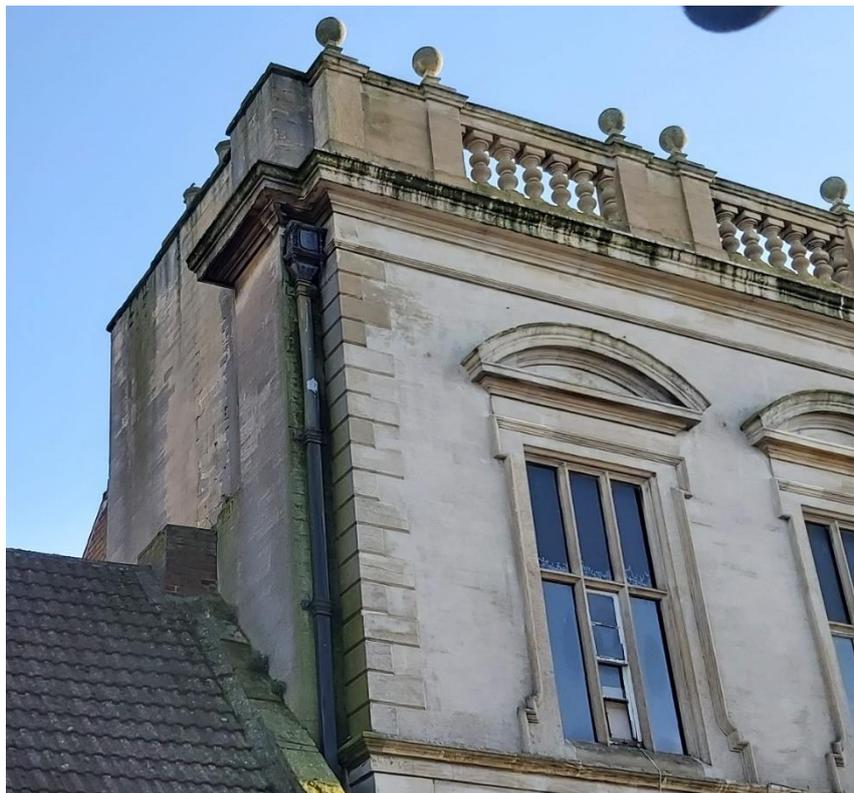
Photo 6 - Side Elevation Showing Water Damage & Ingress from Defective Drainage

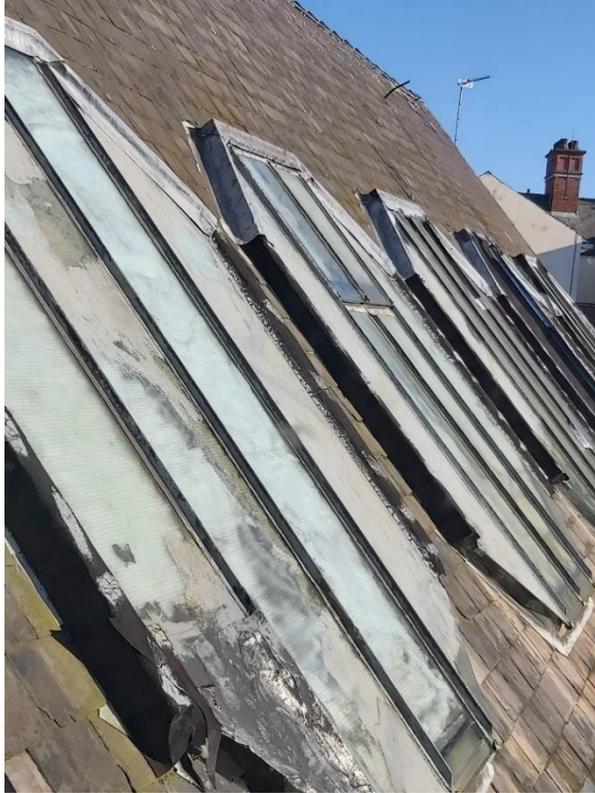
Photo 7 - Roof Damage

The report identified the roof to be in a worse condition than the rest of the Hall in general and should be inspected and repaired by a specialist roofing contractor. High level scaffolding and the removal of the existing internal finishes and slate covering will need to be removed to confirm the condition.

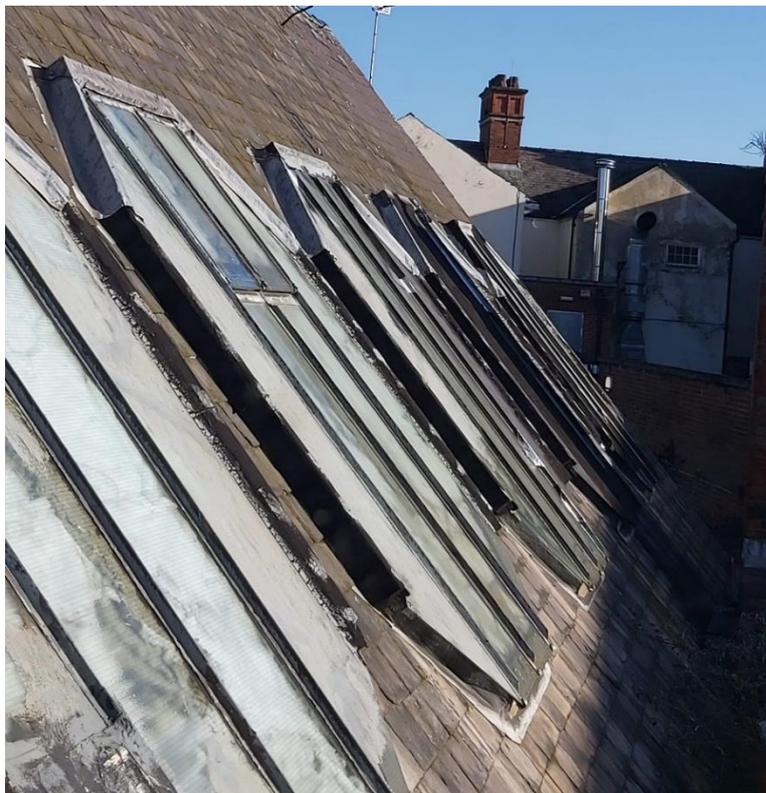
Photo 8 - Roof Damage

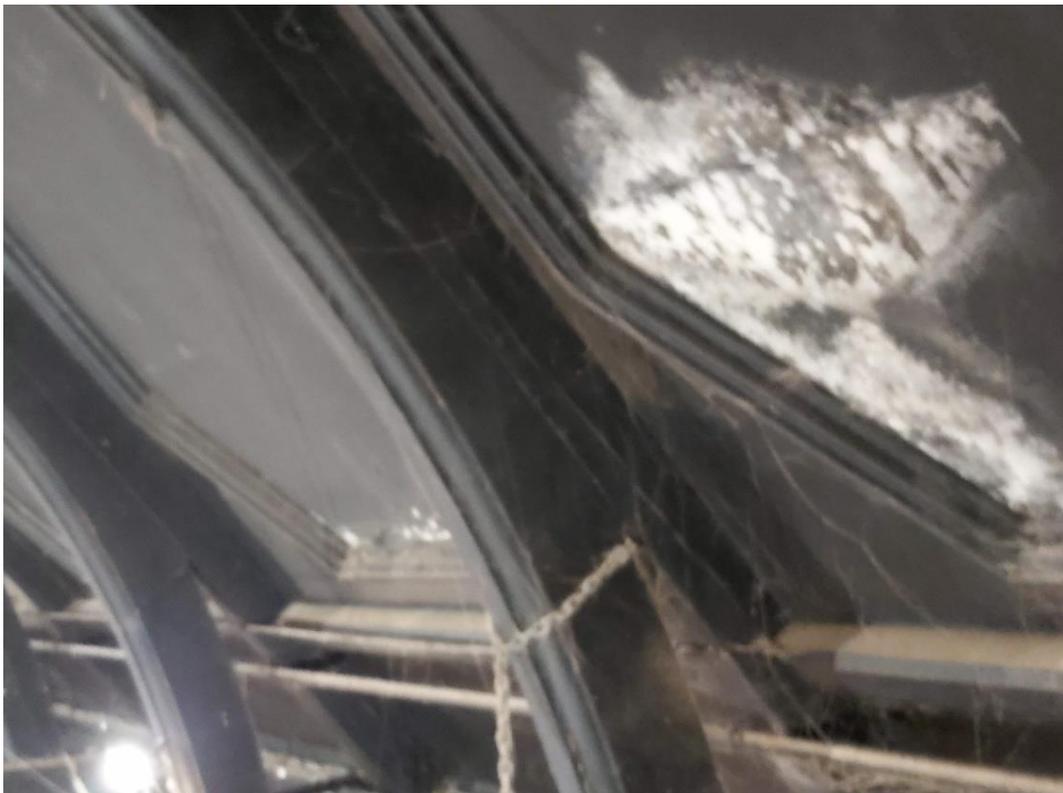
Photo 10 - Main Hall Ceiling Water Damage

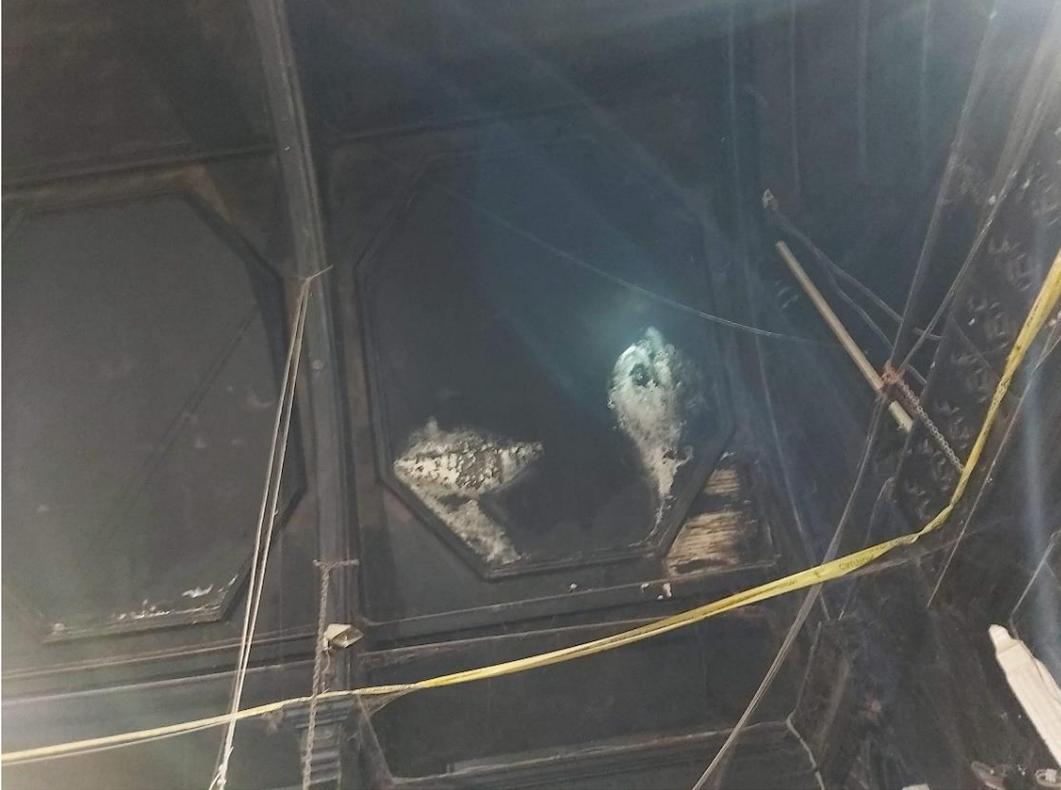
Photo 12 - Main Hall Ceiling Water Damage

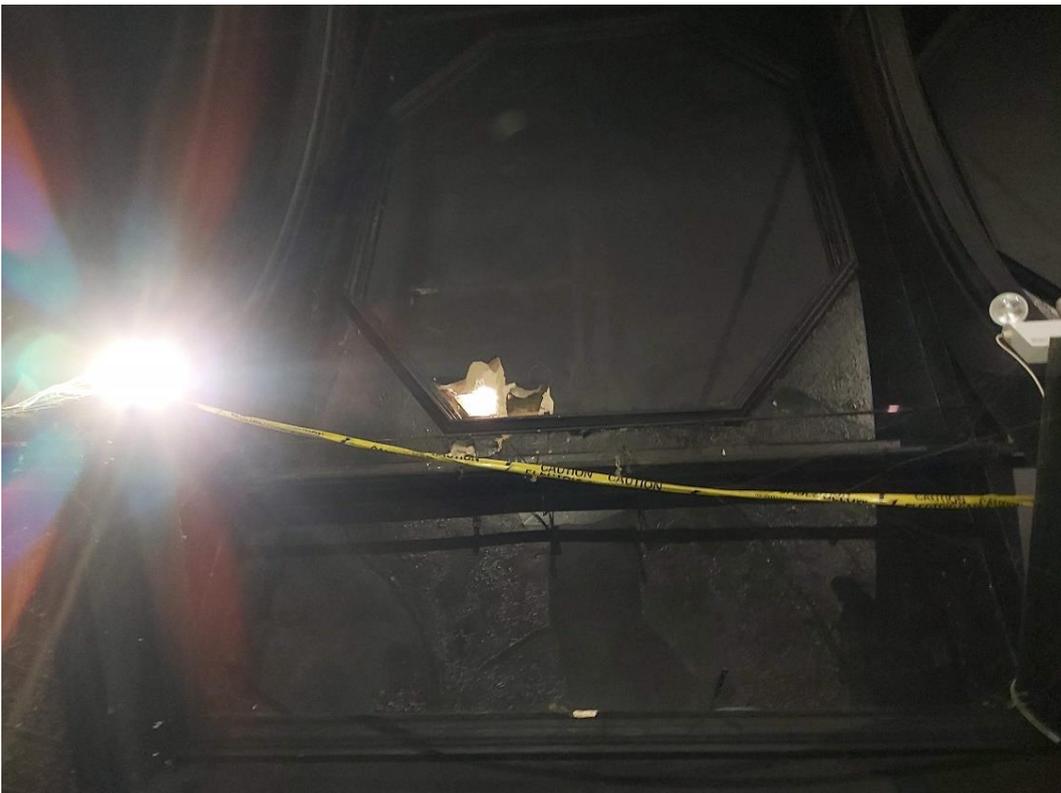
Photo 11 - Main Hall Ceiling Damage

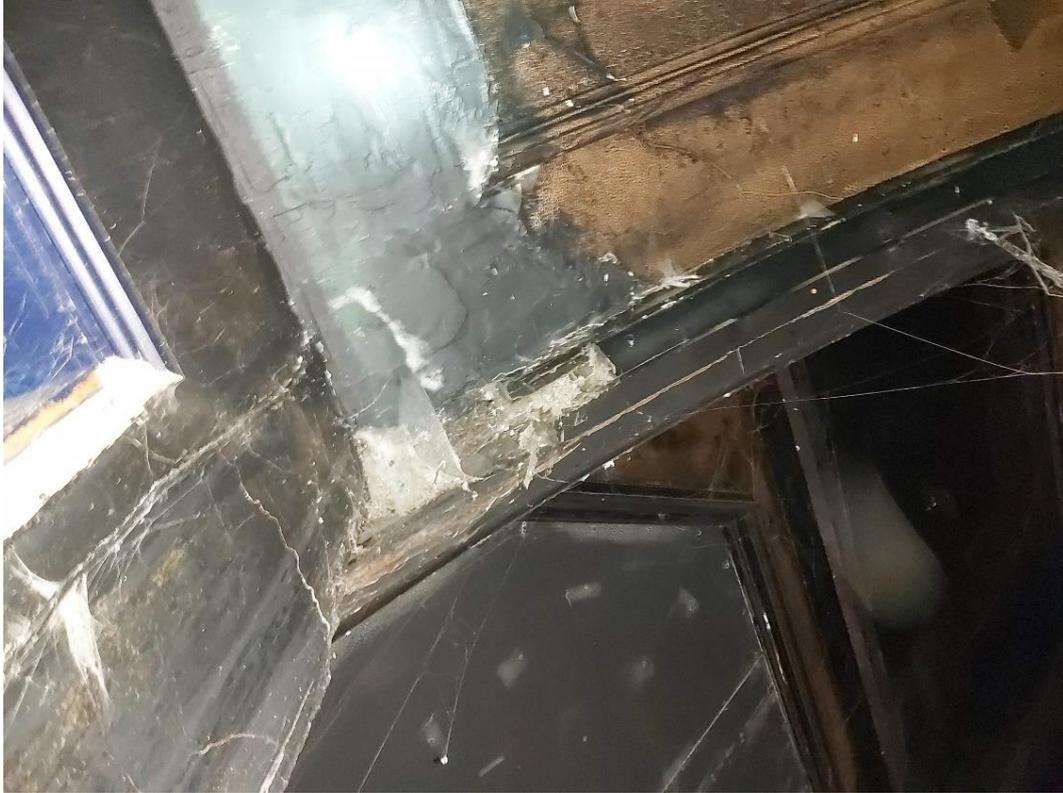
Photo 13 - Main Hall Timber Truss Damage

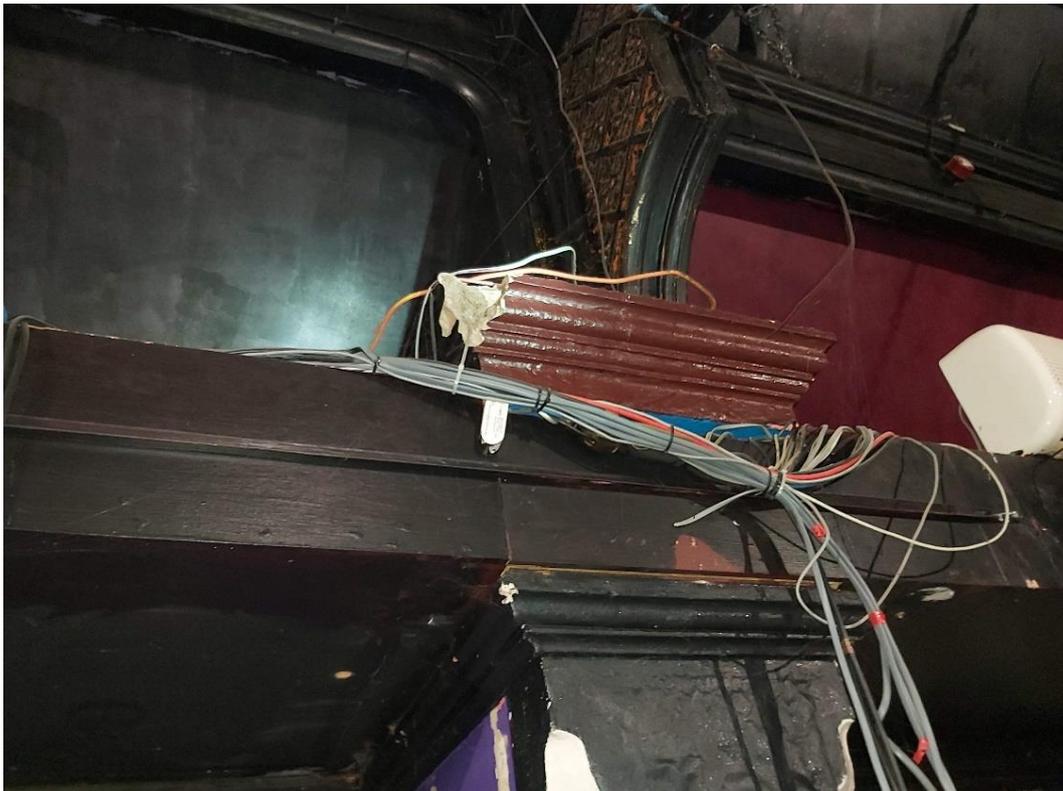
Photo 14 - Main Hall Masonry / Stone Pier Damage

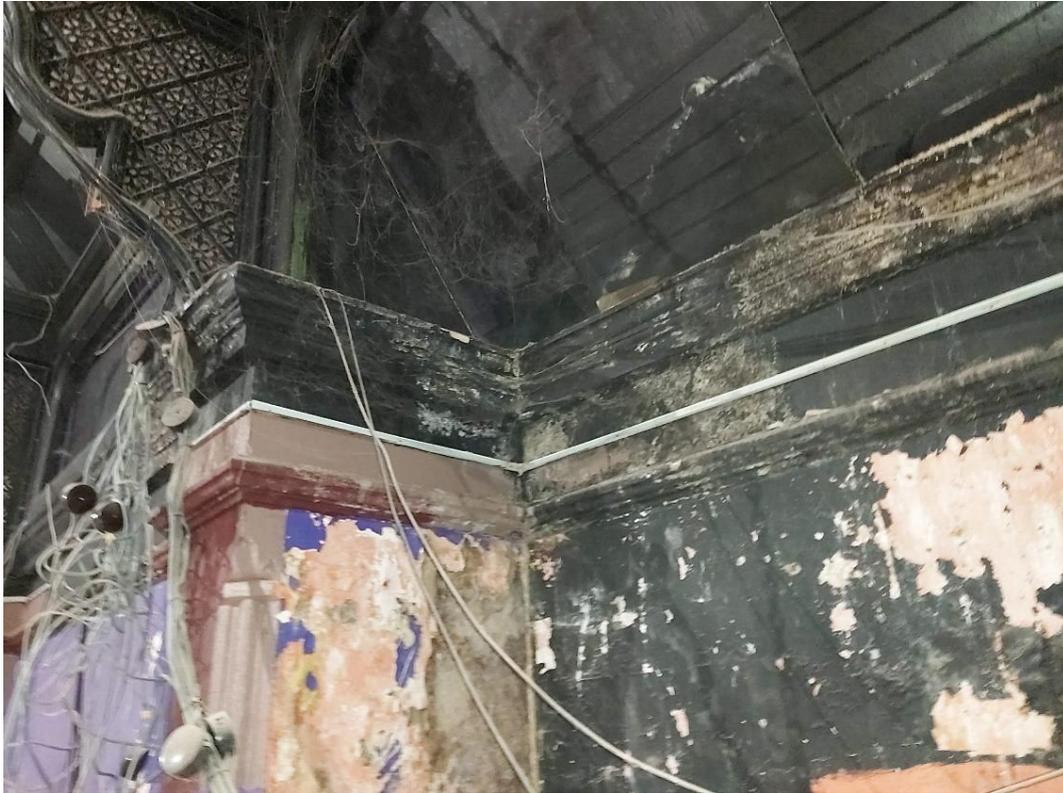
Photo 15 - Main Hall Masonry & Plaster Damage from Water Ingress

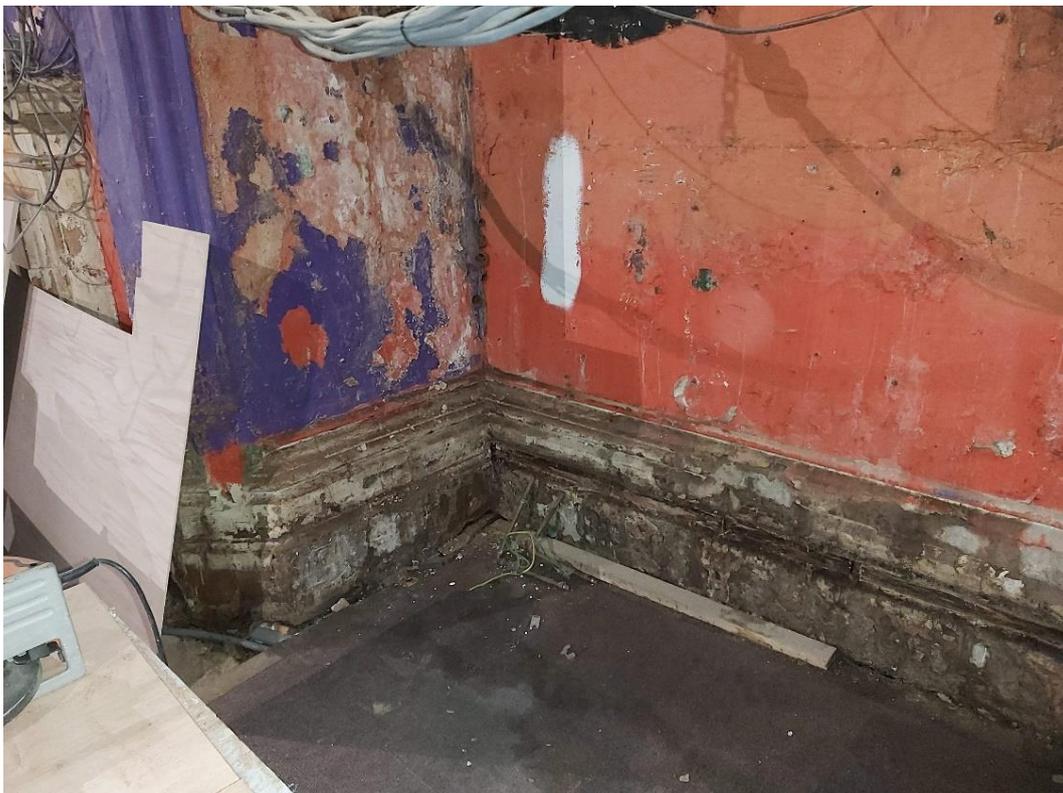
Photo 16 - Main Hall Masonry, Woodwork & Floor Damage From Water Ingress

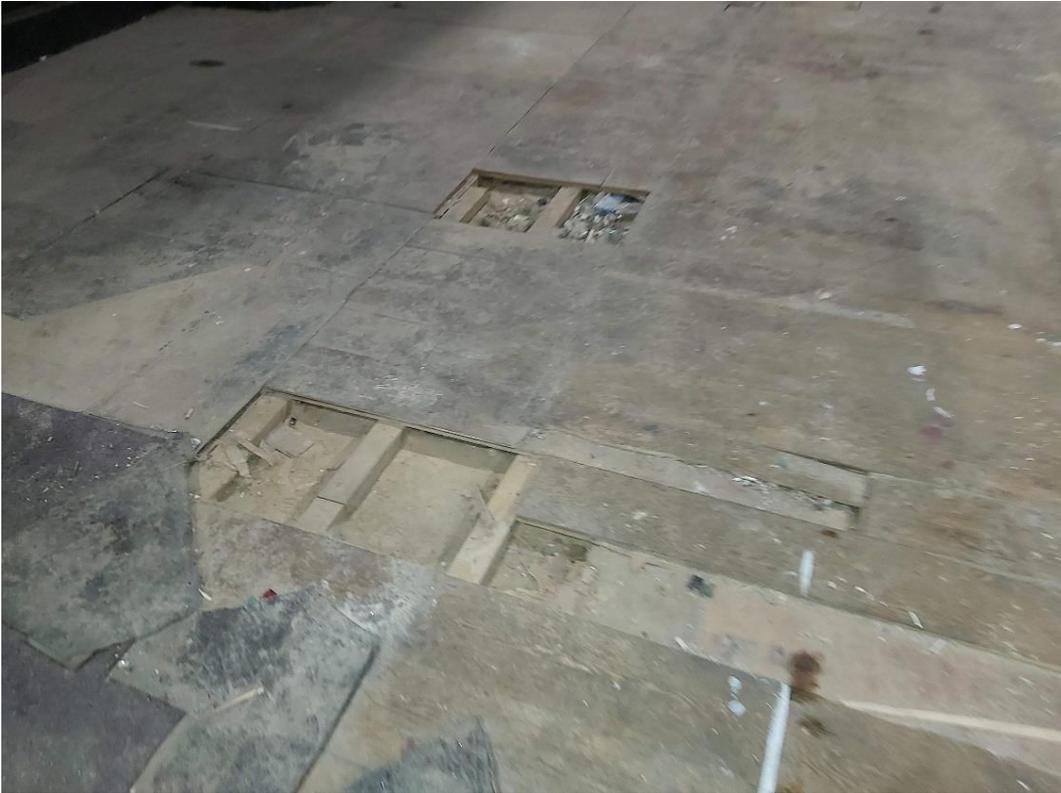
Photo 17 - Main Hall, Defective Subflooring

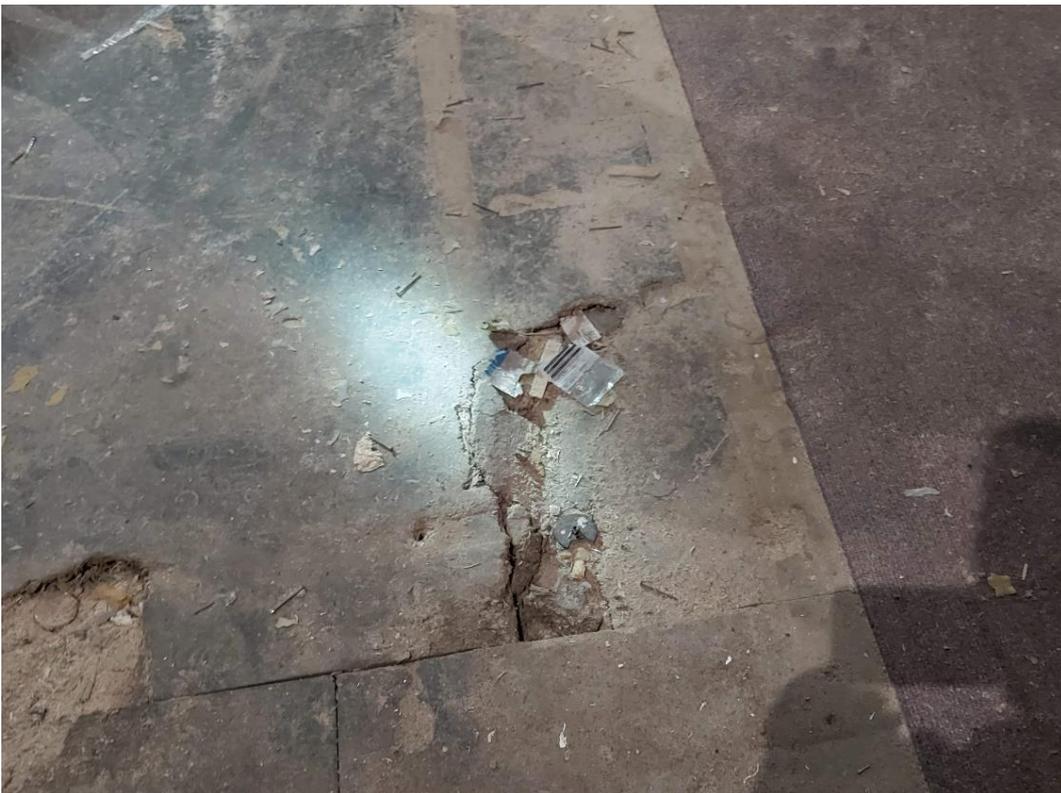
Photo 18 - Main Hall Existing Floor Construction / Damage

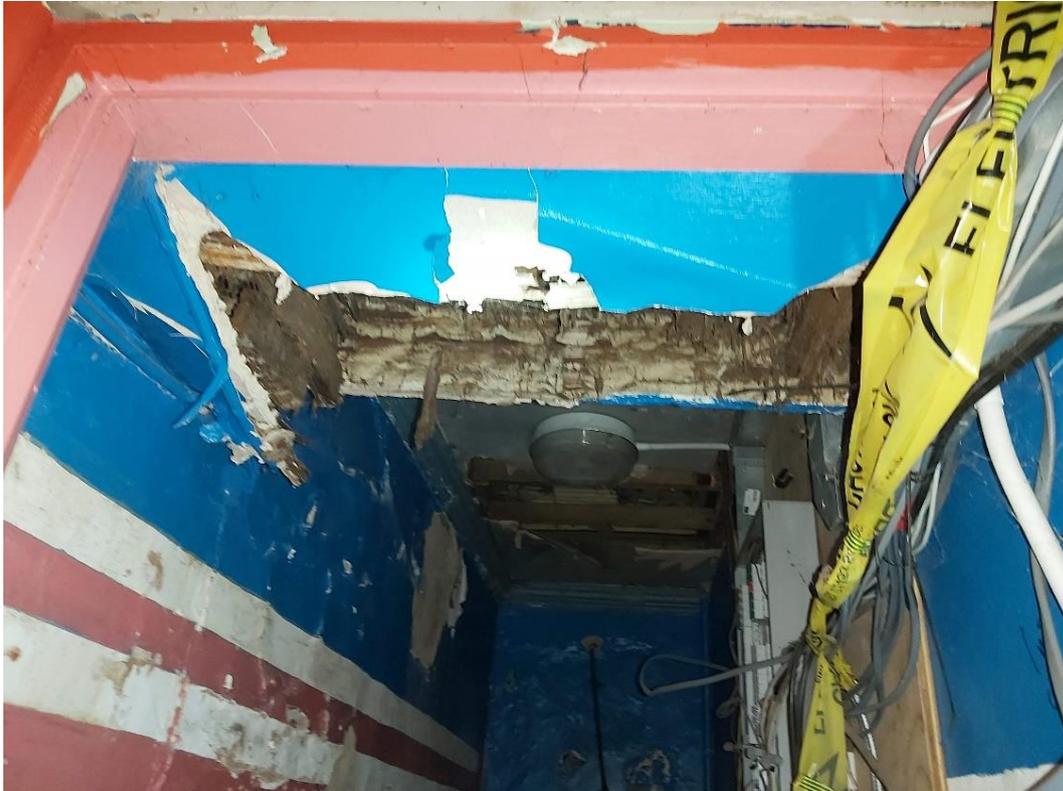
Photo 19 - Main Hall / Stairwell Electrical Room Ceiling Damage

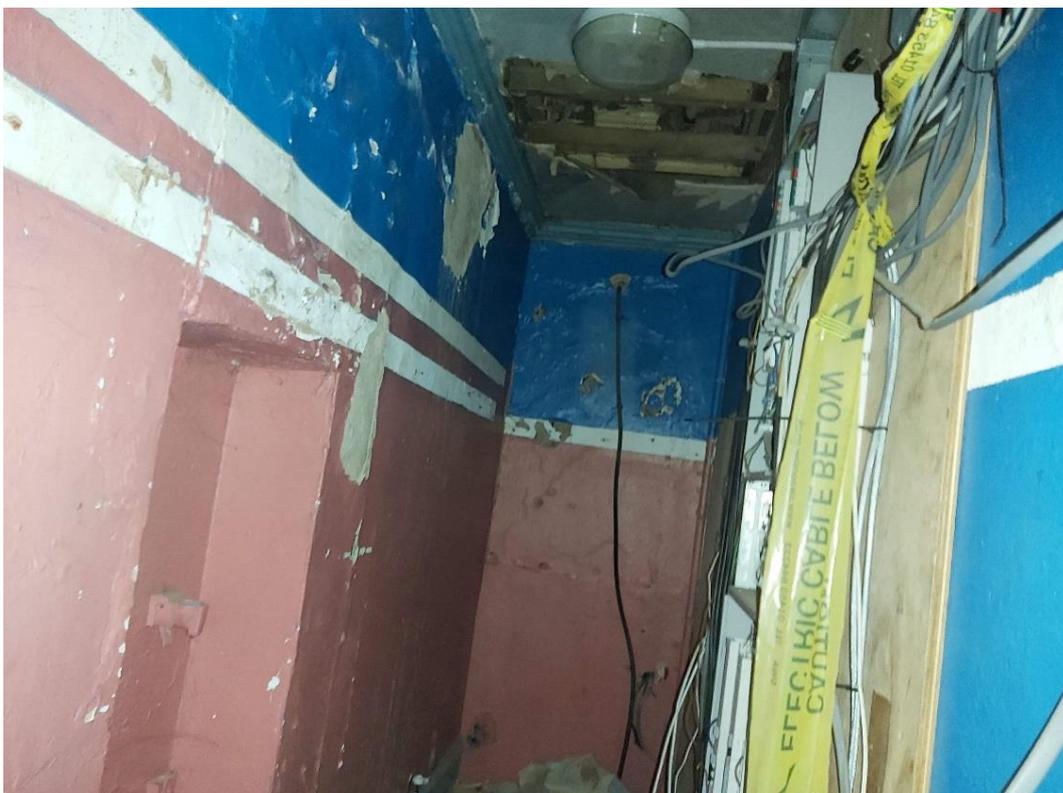
Photo 20 - Main Hall / Stairwell Electrical Room Ceiling & Plaster Damage

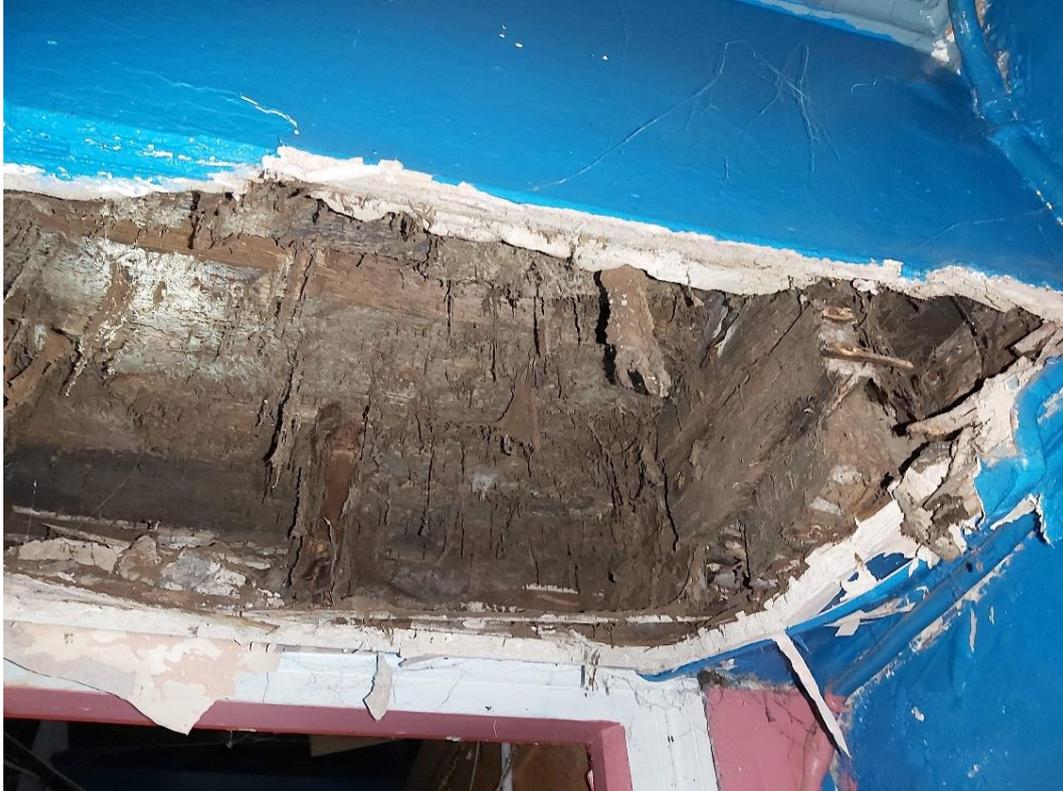
Photo 21 - Main Hall / Stairwell Electrical Room Ceiling Damage From Water Ingress

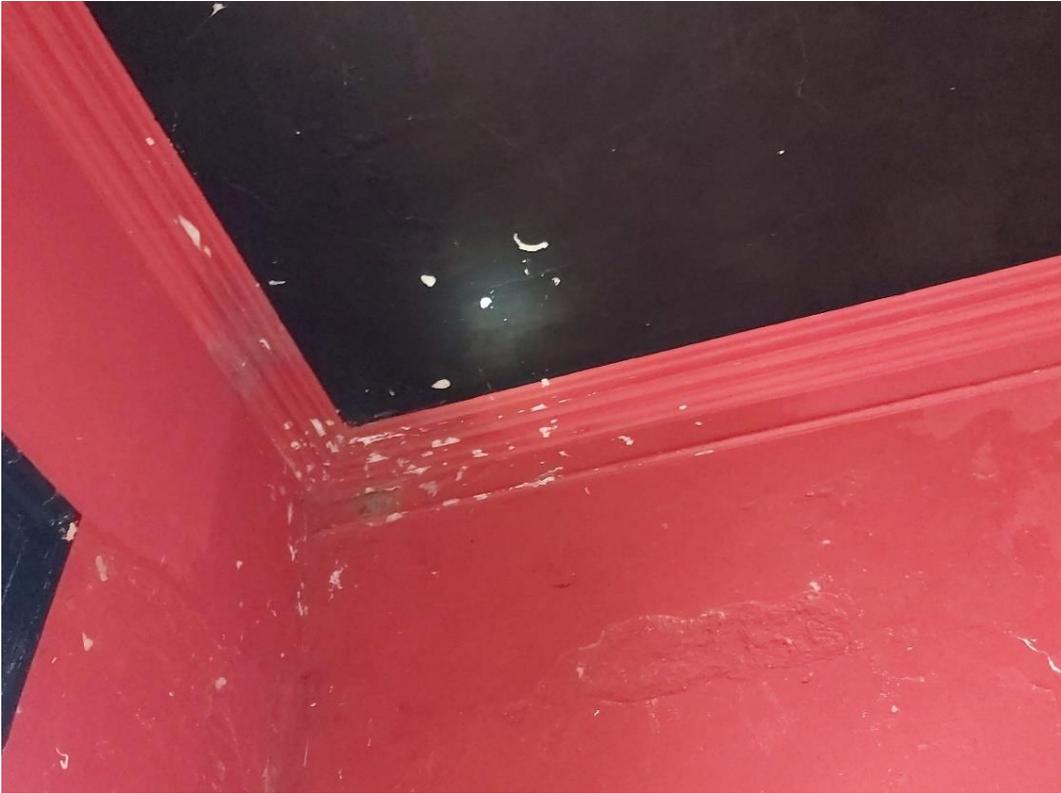
Photo 23 - First Floor Front Room Cracked Plaster & Signs of Damp / Water Ingress

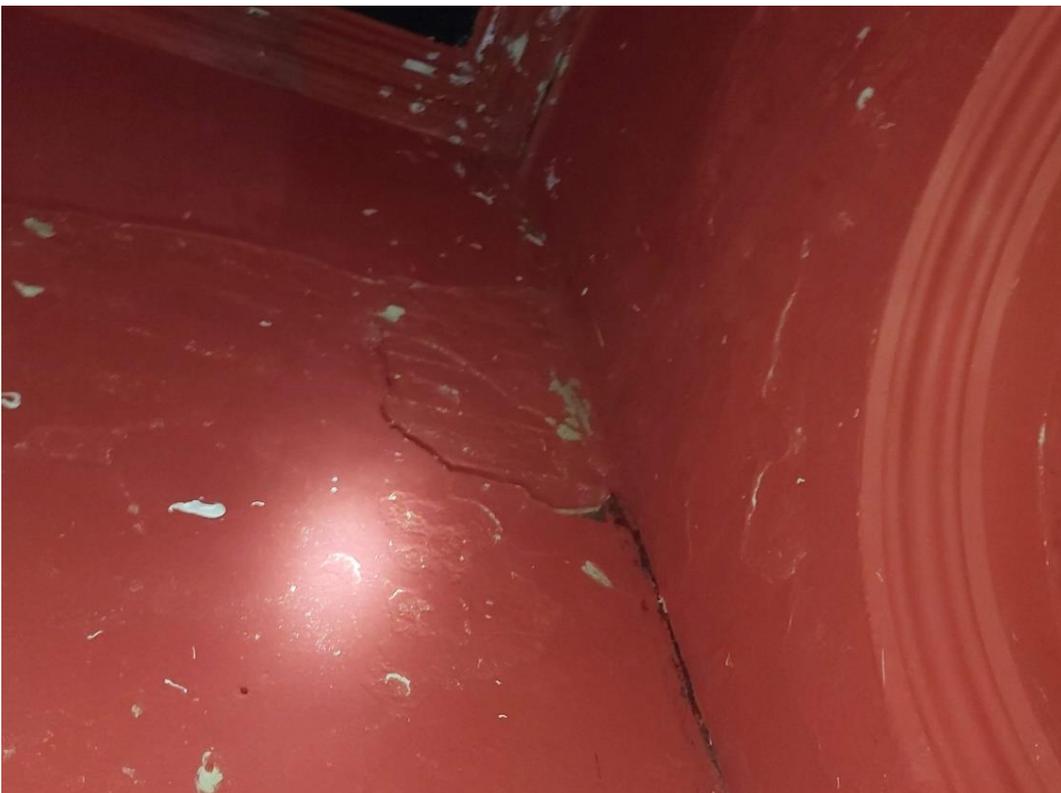
Photo 24 - First Floor Front Room Cracked Plaster & Signs of Damp / Water Ingress

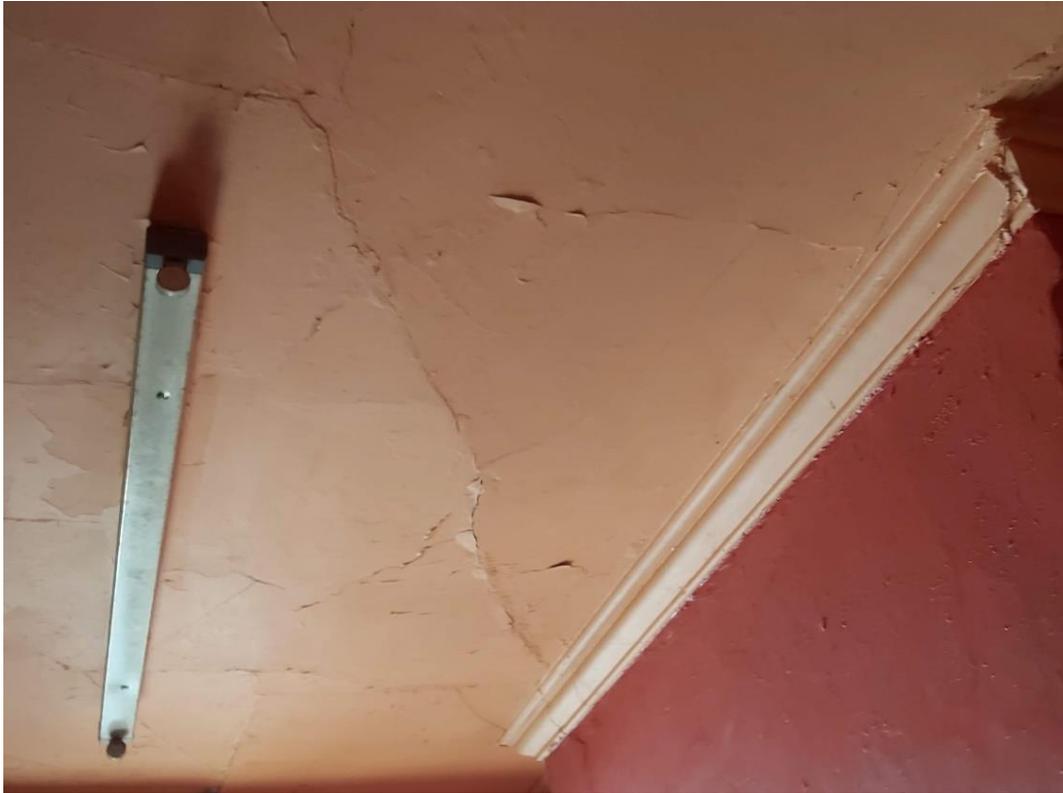
Photo 25 - First Floor Back Room Cracked Ceiling Plaster

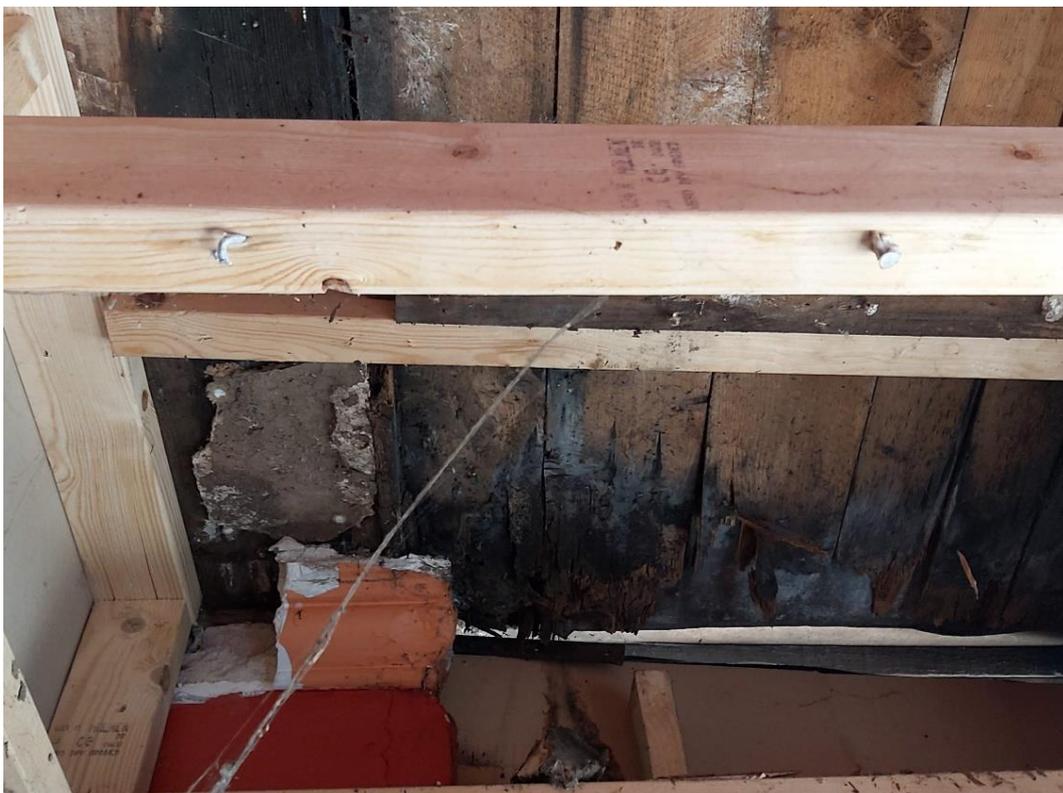
Photo 26 - First Floor Rear Room Signs of Water Damage to Woodwork

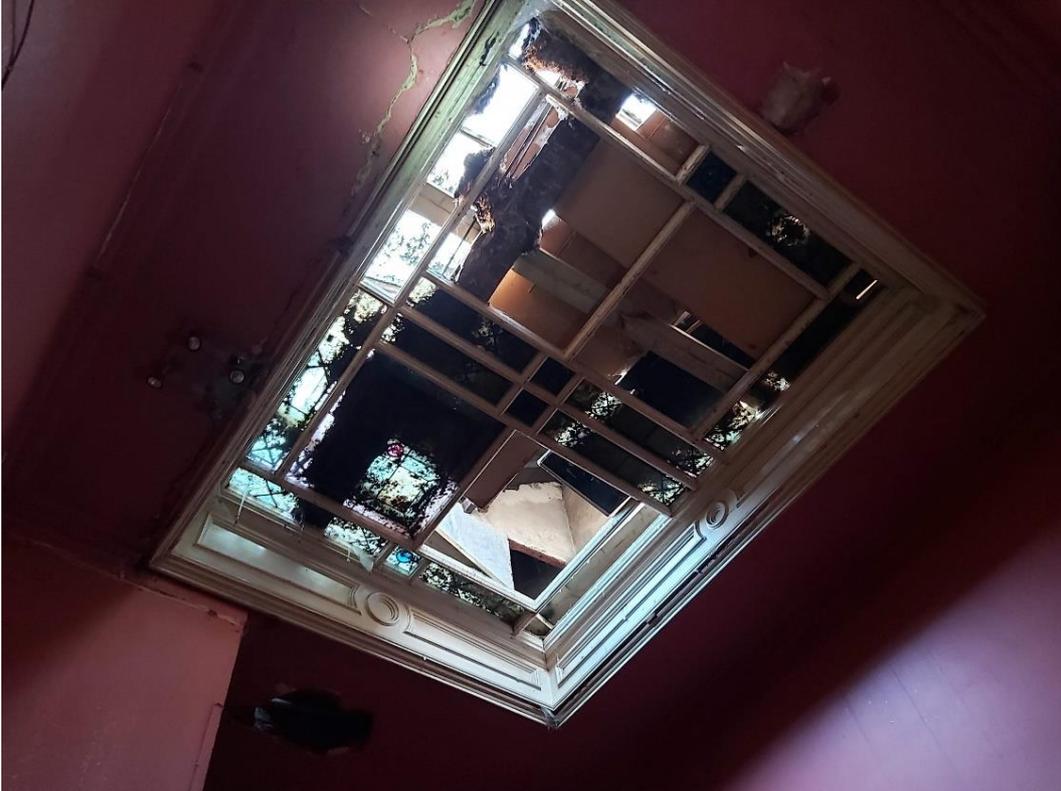
Photo 27 - First Floor Stairwell Cracking Around Roof Light

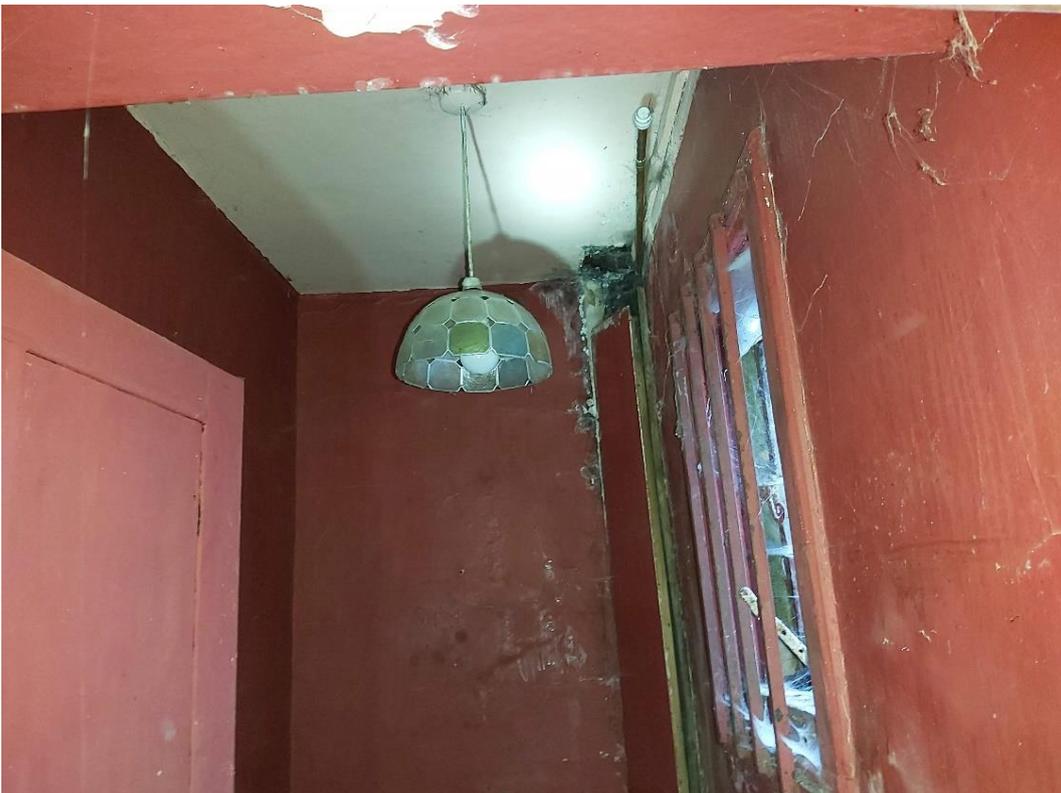
Photo 28 - First Floor Hallway Signs of Water Ingress & Mould

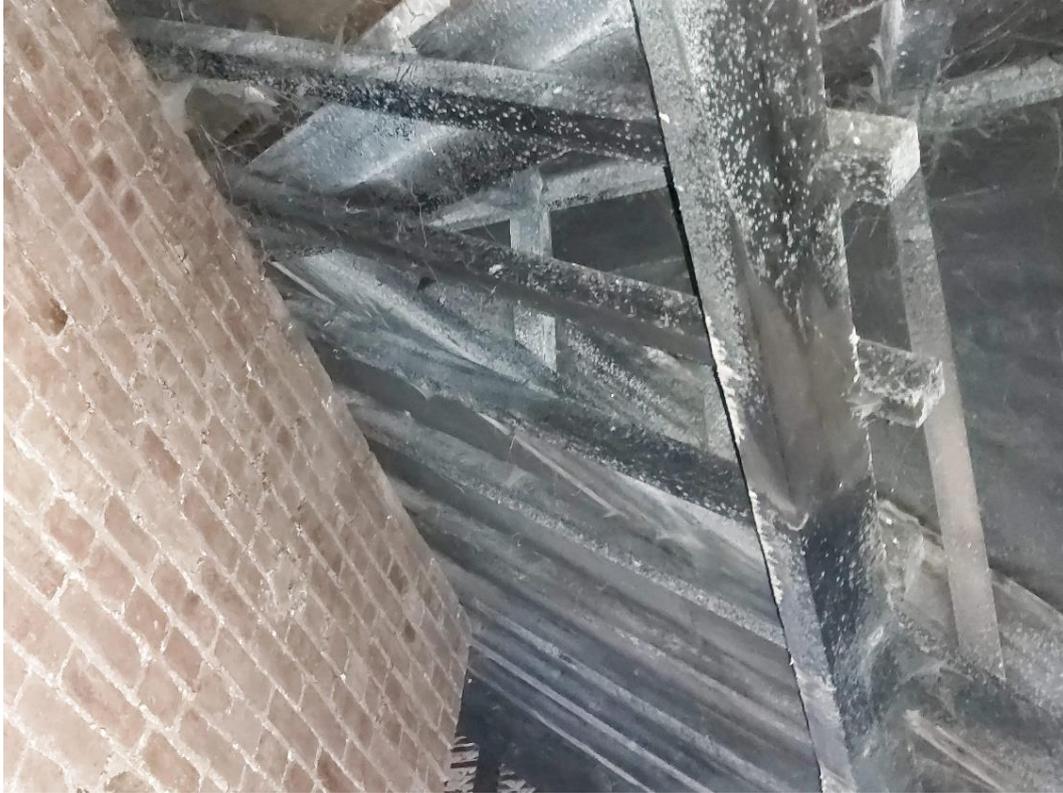
Photo 29 - First Floor Roof Void Damaged Rafters Due To Inadequate Ventilation

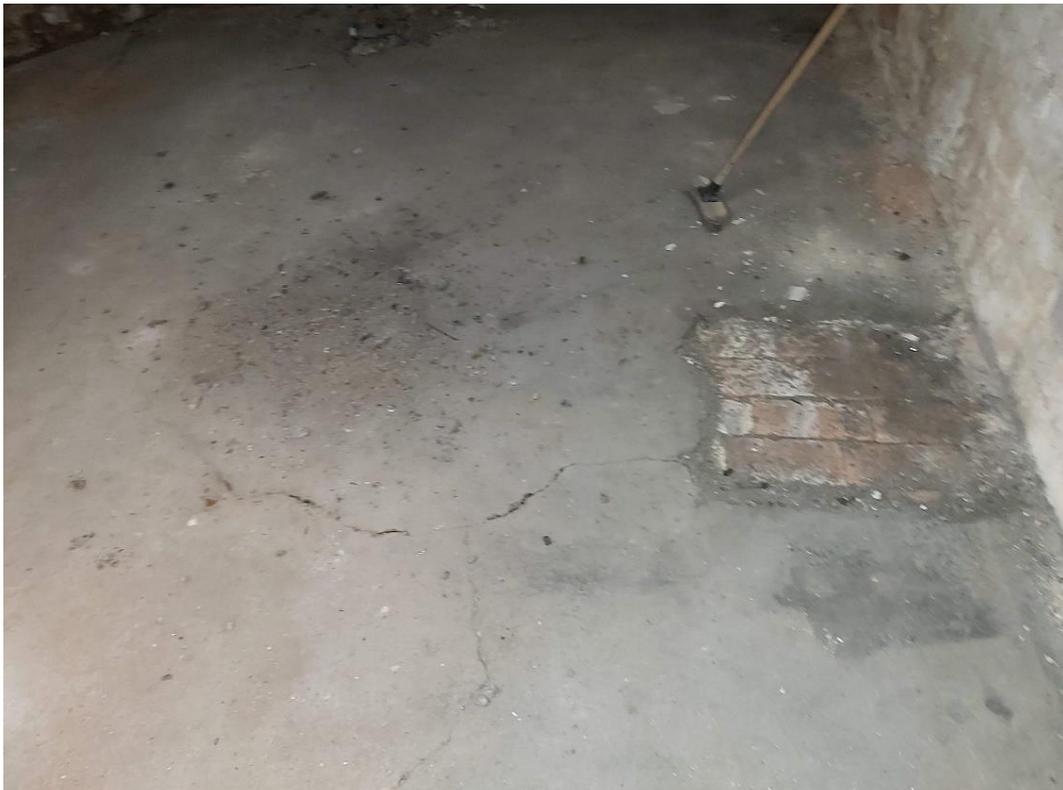
Photo 30 - Cellar Broken Screed Showing Floor Construction

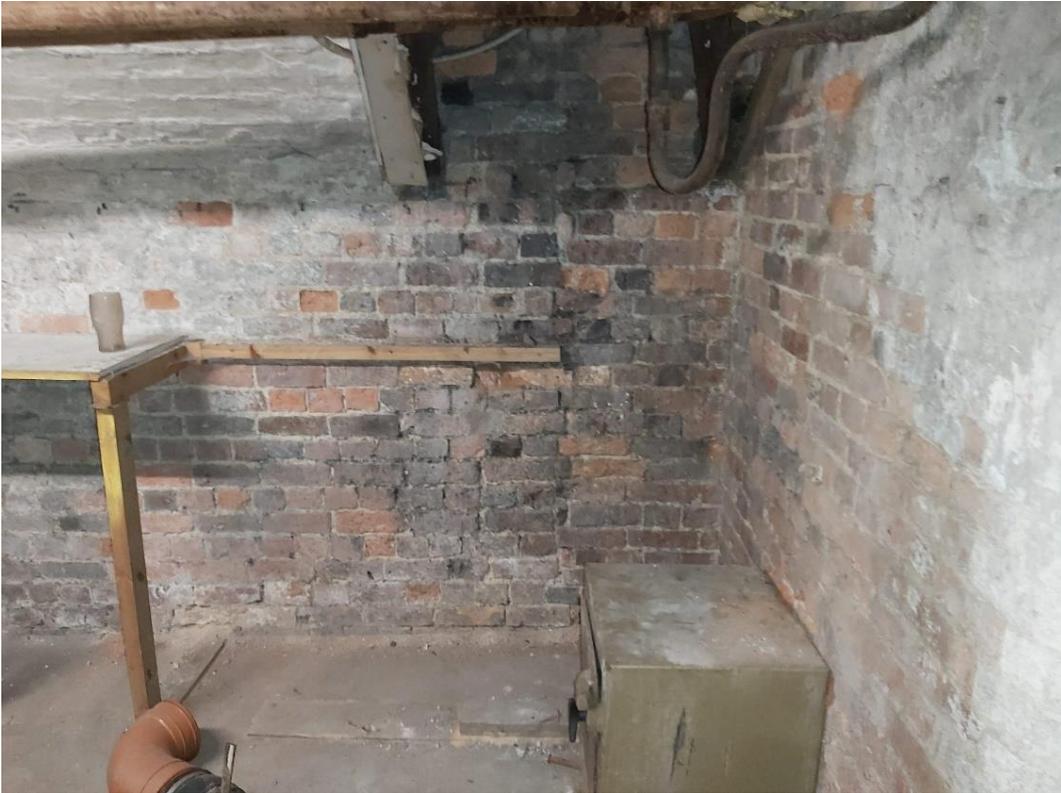
Photo 31 - Cellar Damaged Masonry & Defective Mortar Joints
