Westgate Hall: Options Appraisal

Conception Architects

Condition Survey and Schedule of Required Conservation Works Westgate Hall

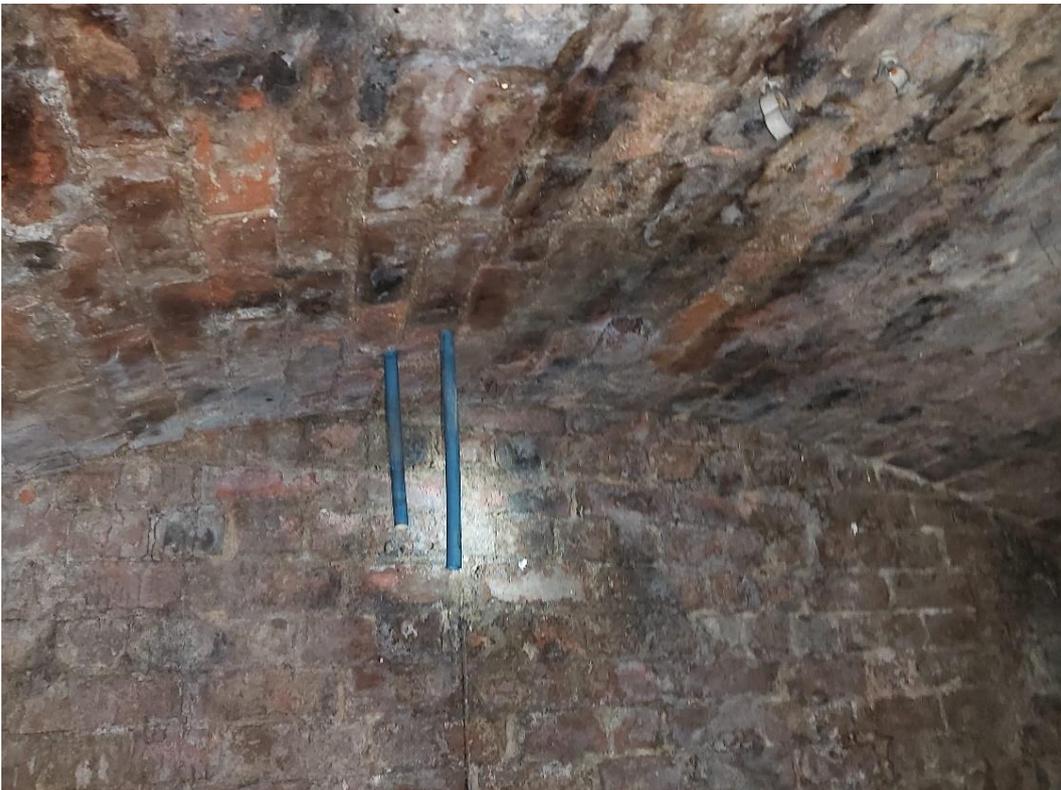
Photo 32 - Cellar Signs of Water Ingress

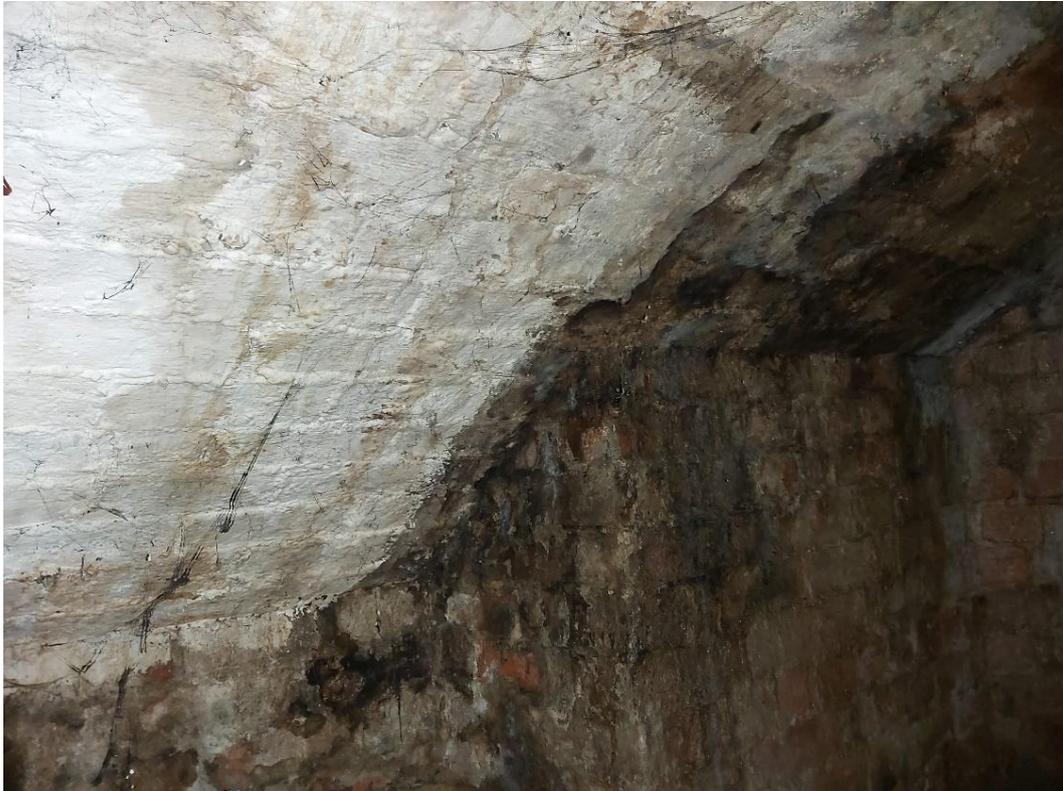
Photo 33 - Cellar Signs of Water Ingress & Damage to Masonry & Mortar Joints

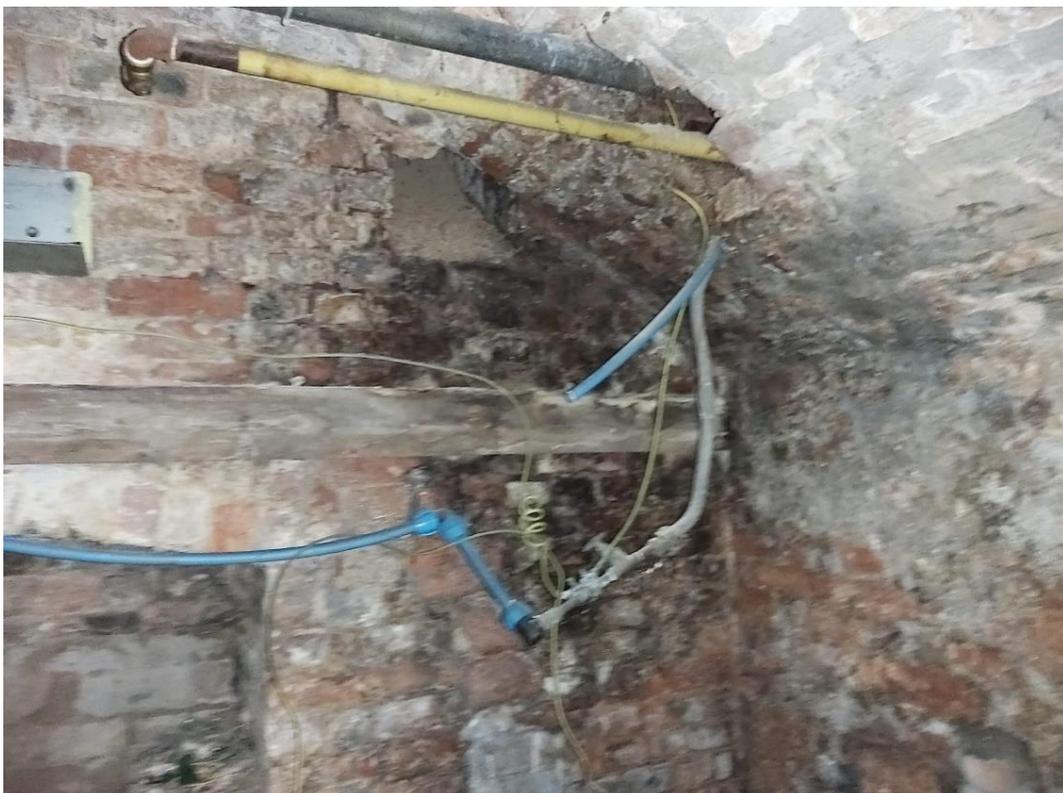
Photo 34 - Cellar Signs of Water Ingress

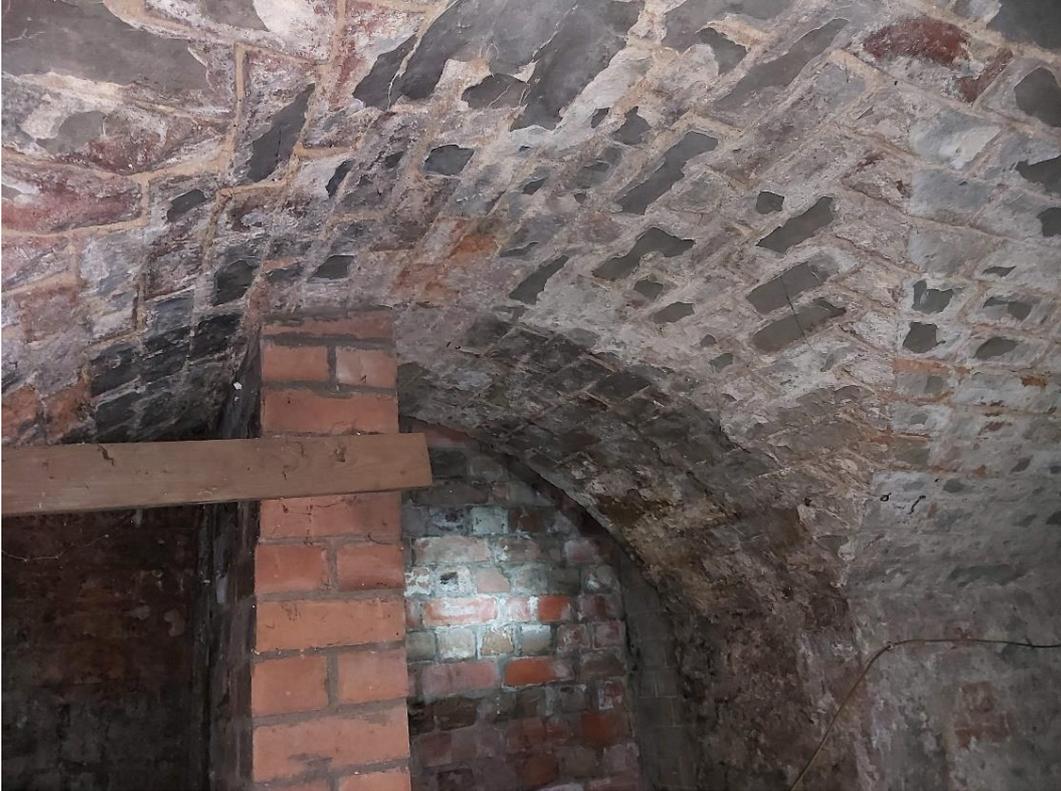
Photo 35 - Cellar Signs of Water Ingress

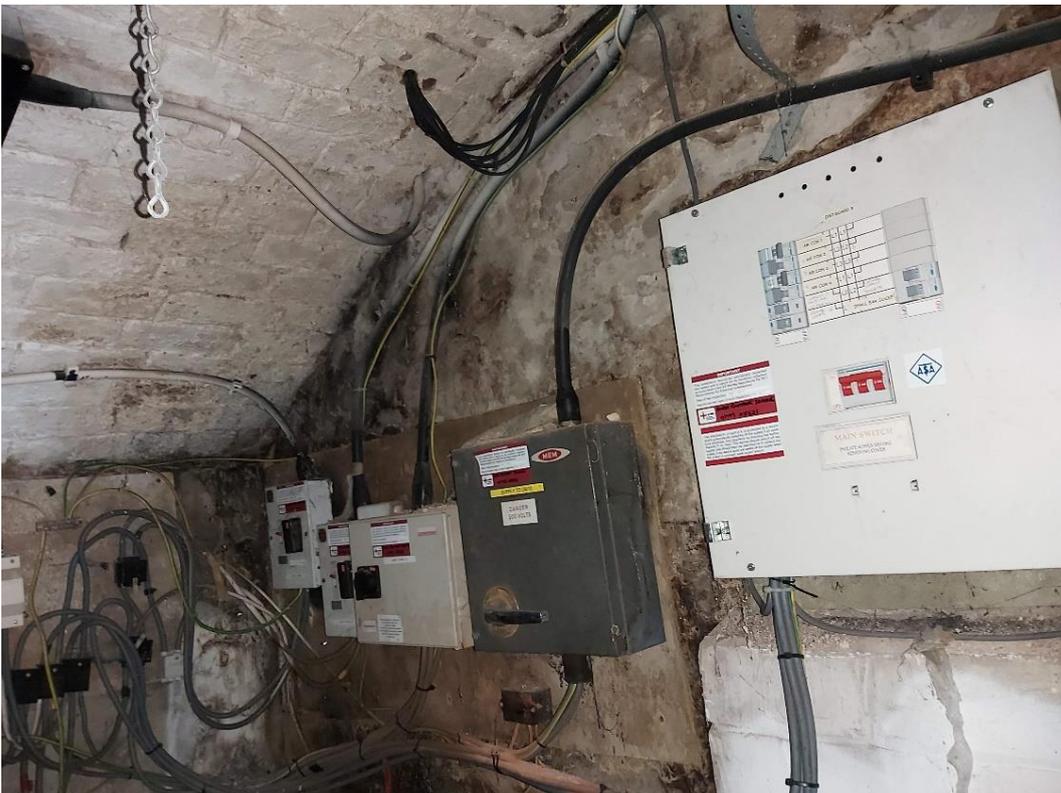
Photo 36 - Cellar Signs of Water Ingress Around Electrics

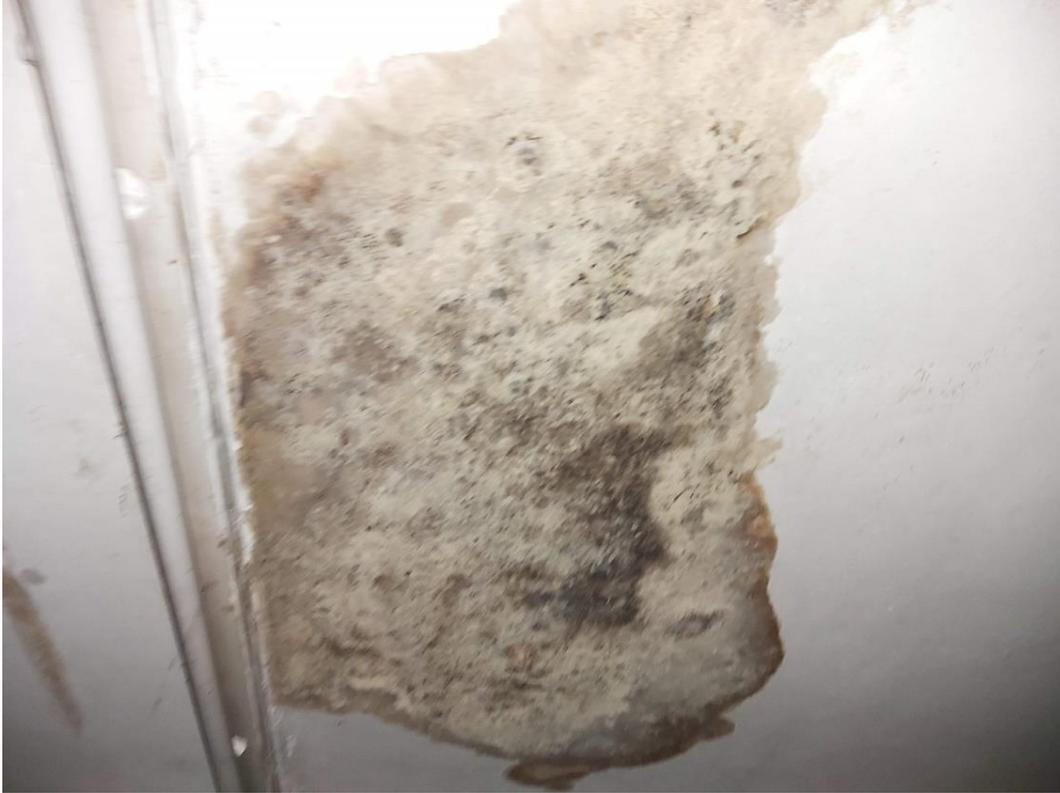
Photo 37 - Cellar Ceiling Damage from Ground Floor Flooding

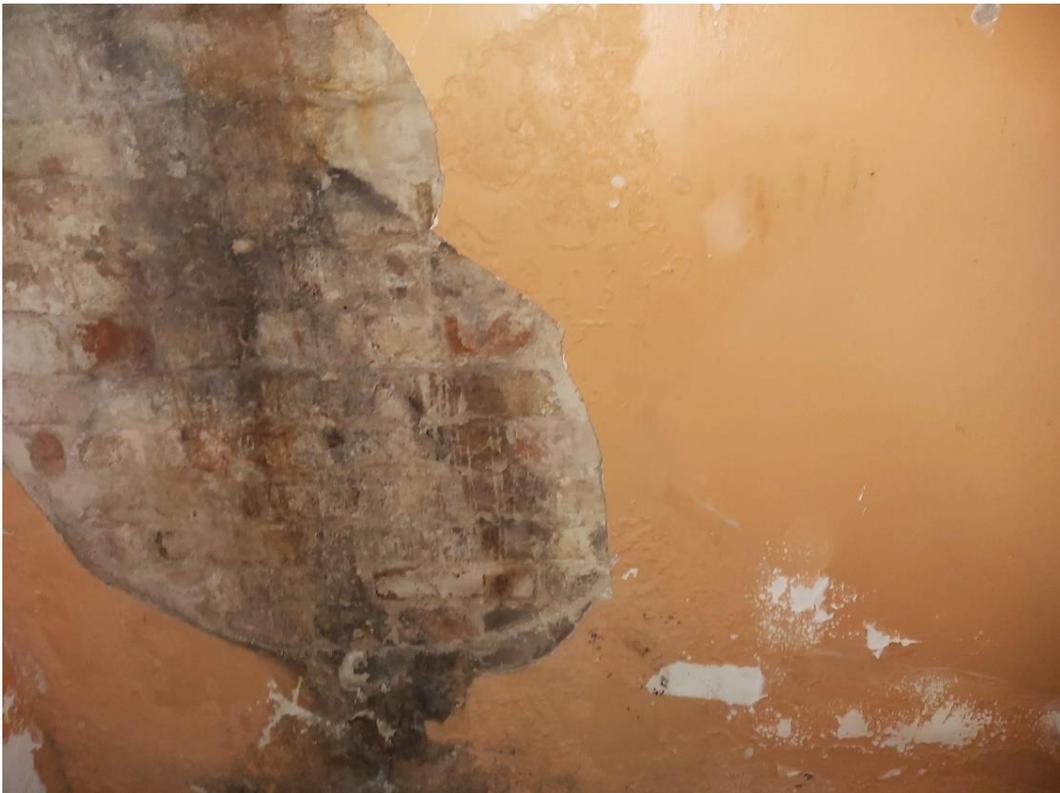
Photo 38 - Cellar Weak / Damaged Plaster Due to Water Ingress

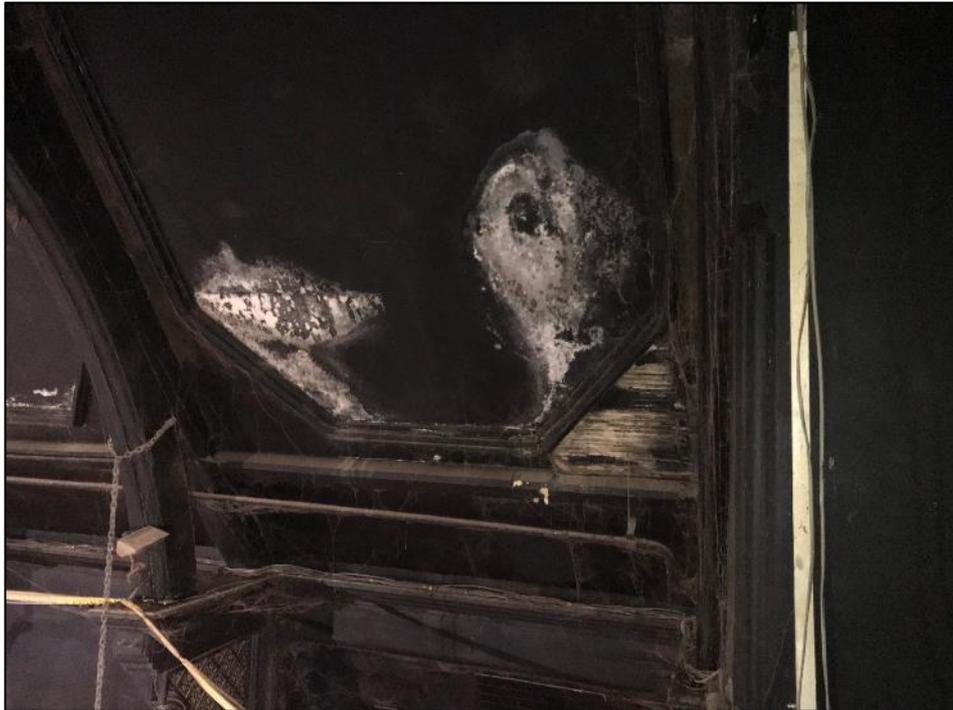
Evidence of water ingress to octagonal blocked off windows
