Deeping Leisure Centre

Pool Hall, Sports Hall and
Squash Court

**Inspection of roof coverings and
assessment.**

Report No: **5452 / 01**

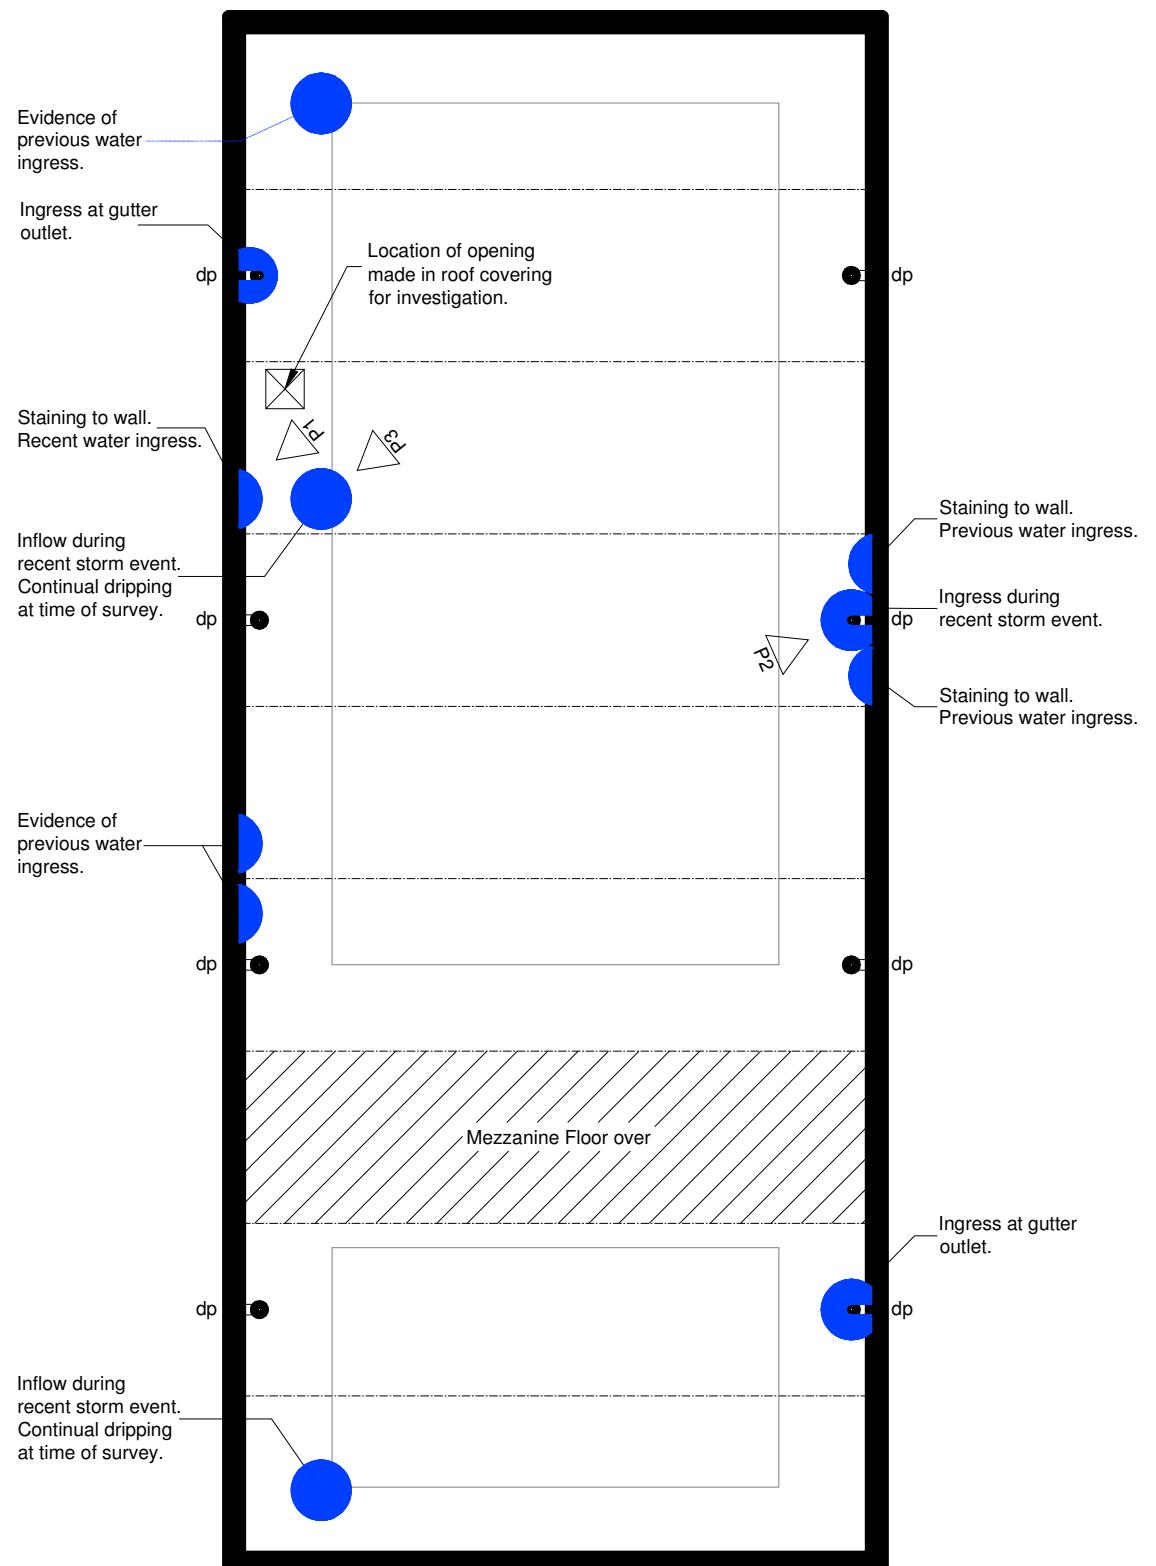
Figure 1

- 3.1.1. The locations of water ingress through the swimming pool building roof are shown on Figure 1. Record photograph locations are also referenced.
- 3.1.2. Water ingress during the recent heavy rainfall event was identified to us by the Leisure centre Duty Manager. Evidence of staining within the locations identified would confirm this.
- 3.1.3. In other areas we noted staining to the ceiling and perimeter walls suggesting previous water ingress. SKDC advised that repairs had been made to the roof covering after previous leaks.
- 3.1.4. The visual evidence would indicate that the majority of the water ingress in to the pool building occurs adjacent to the side walls (Plate 1) and around the gutter outlets (Plate 2).
- 3.1.5. In two locations water ingress (continuous dripping) continued at the time of our survey despite it not having rained for at least 4 days (Plate 3).

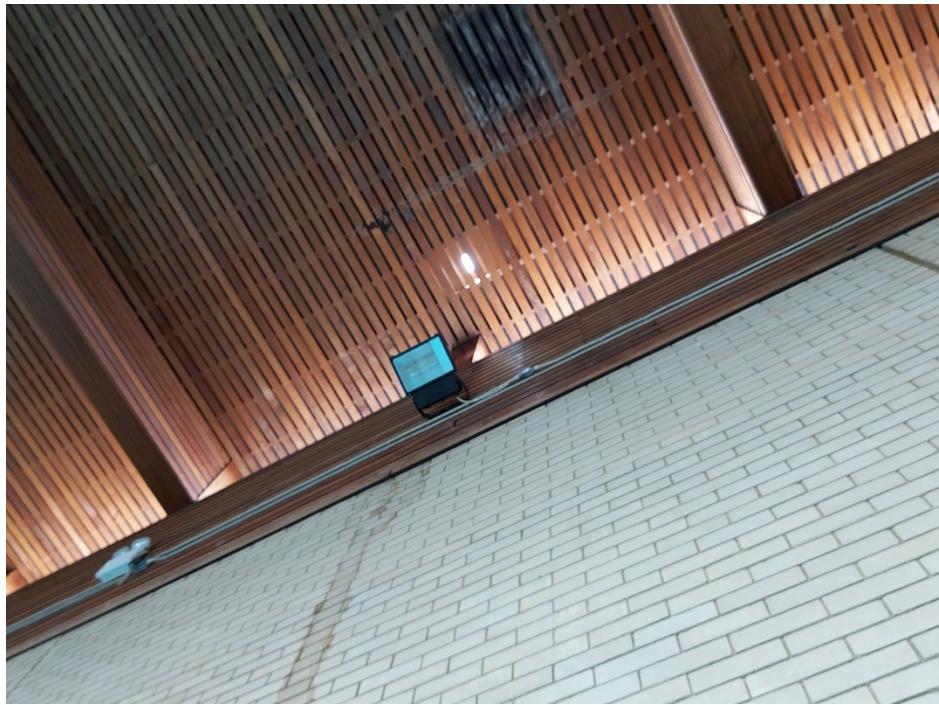
Plate 1

Evidence of water staining to perimeter wall between downpipes

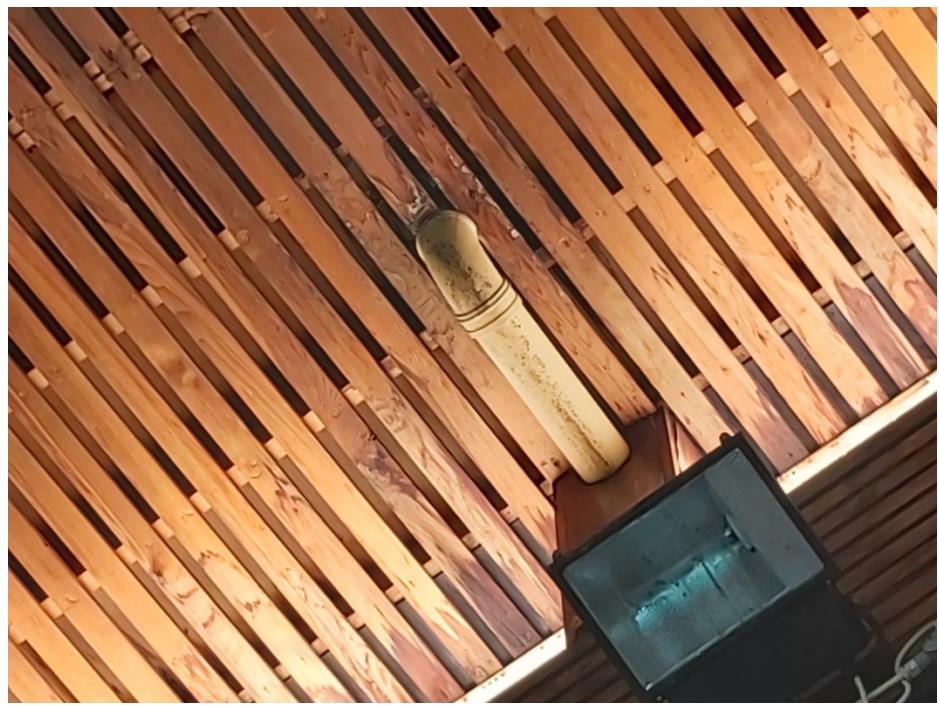
Plate 2

Evidence of water staining to ceiling at gutter outlet penetration

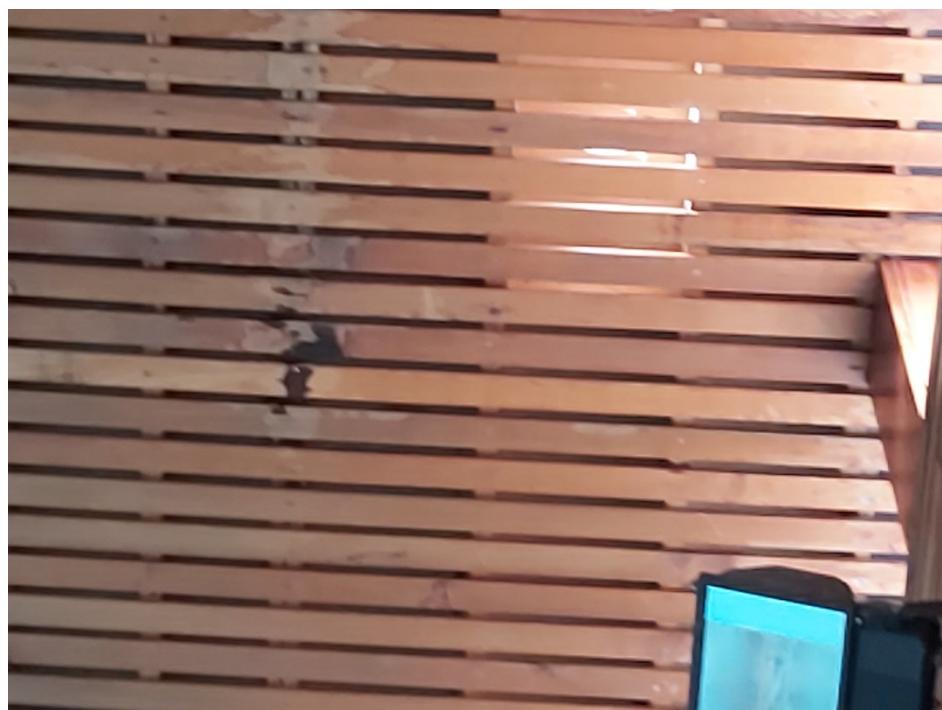
Plate 3

Water ingress at the time of survey

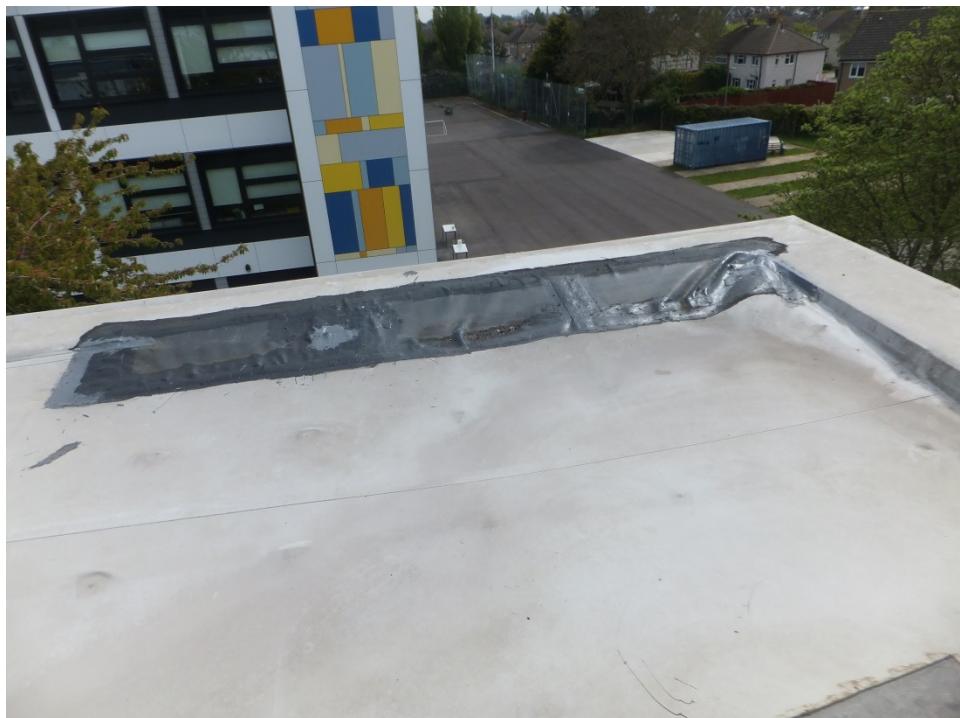
Plate 4

- 3.2.1. The current roof covering is a single ply membrane understood to be Trocal by Sika.
- 3.2.2. The covering was seen to slope upwards along the perimeter of the roof where it meets the small upstand. This has resulted in their being a void between the membrane and the roof insulation. The unsupported membrane is prone to stretch and failure. There is evidence of significant repair to the membrane in these locations (Plate 4).

Single ply membrane lifted at perimeter of roof – Evidence of repair.

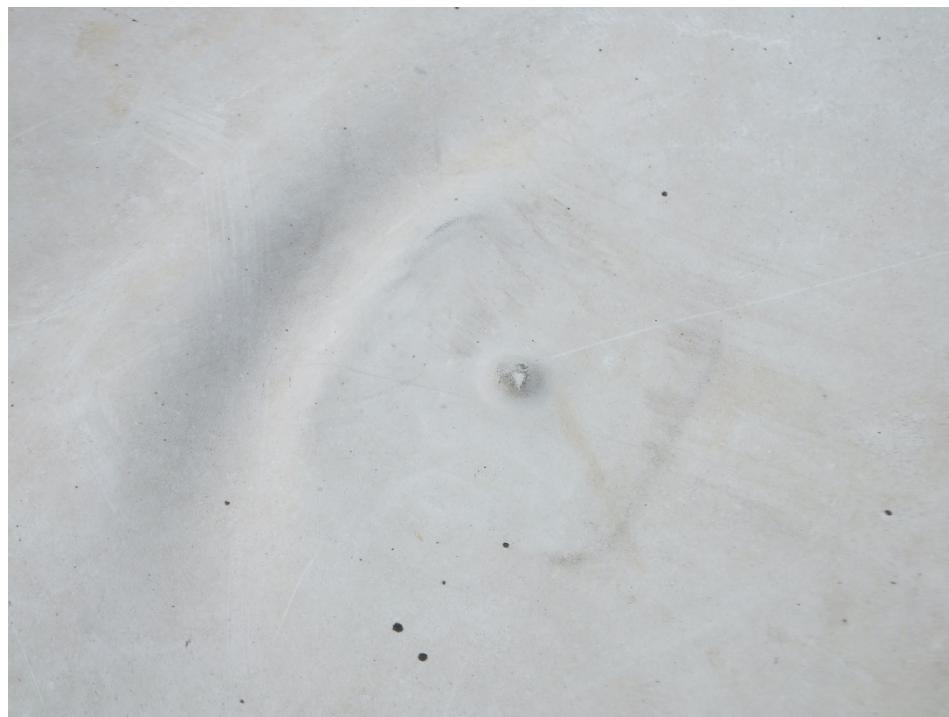
Plate 5

Stretching of single ply over withdrawn screw.

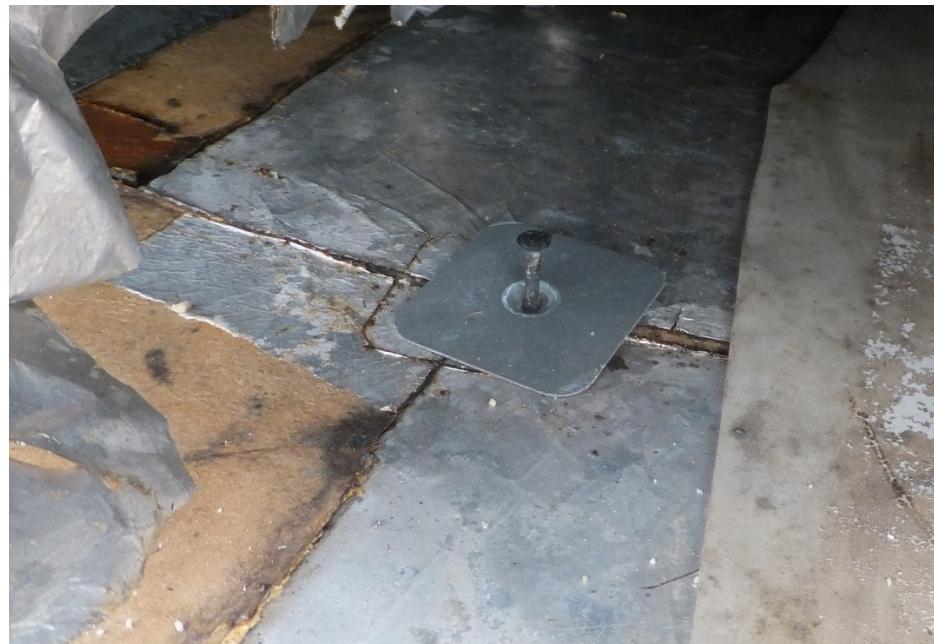
Plate 6

- 3.2.3. The roof covering is secured in position by screws glued to the underside of the membrane. In many locations the screw heads could be seen to have lifted with the membrane stretched over the top (Plate 5). In numerous locations there is evidence of a bituminous repair over the screw head where it has punctured the membrane.
- 3.2.4. From the investigation it appears that the screws have become partially withdrawn from the roof deck (most likely due to wind suction on the roof). Many of the screws will not push back down into the deck and so they create local high points where the membrane is prone to fail (Plate 6).

Exposed screw partially withdrawn.

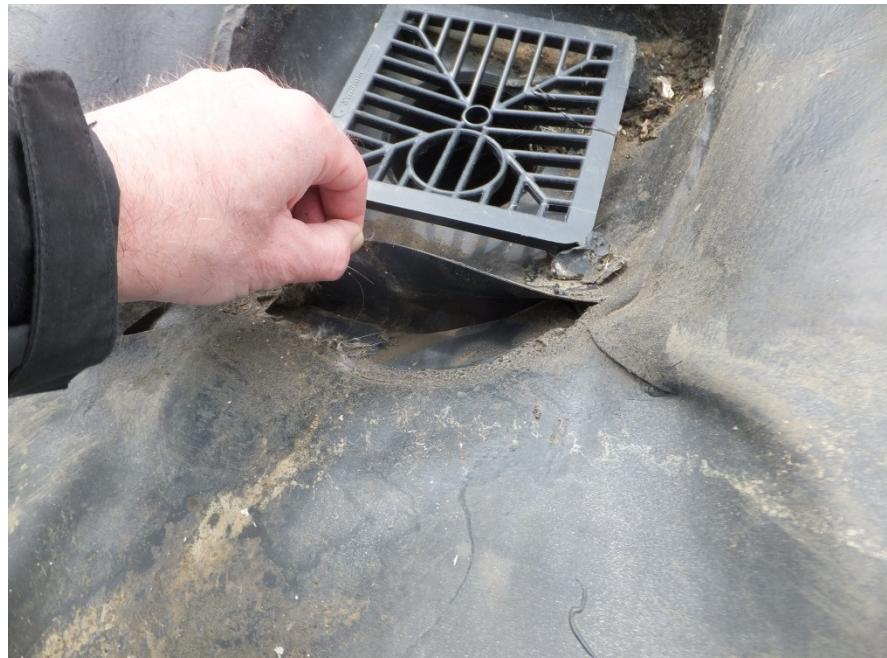
Plate 7

3.2.5. Previous repairs have been made to the gutter outlets using a rubber membrane material. The inspection found that the joints between the membrane and the gutter outlet had failed to at least three outlets (Plates 7, 8 and 9). This is allowing roof water to track back between the roof deck and the membrane or directly to the outside of the downpipe.

Failed joint between roof covering and outlet.

- 3.6.3. Immediate repairs around the gutters and where joints have failed may be able to offer a short term improvement. However we do not have confidence that all defects could be addressed and such repair may only lead to water ingress in other locations.

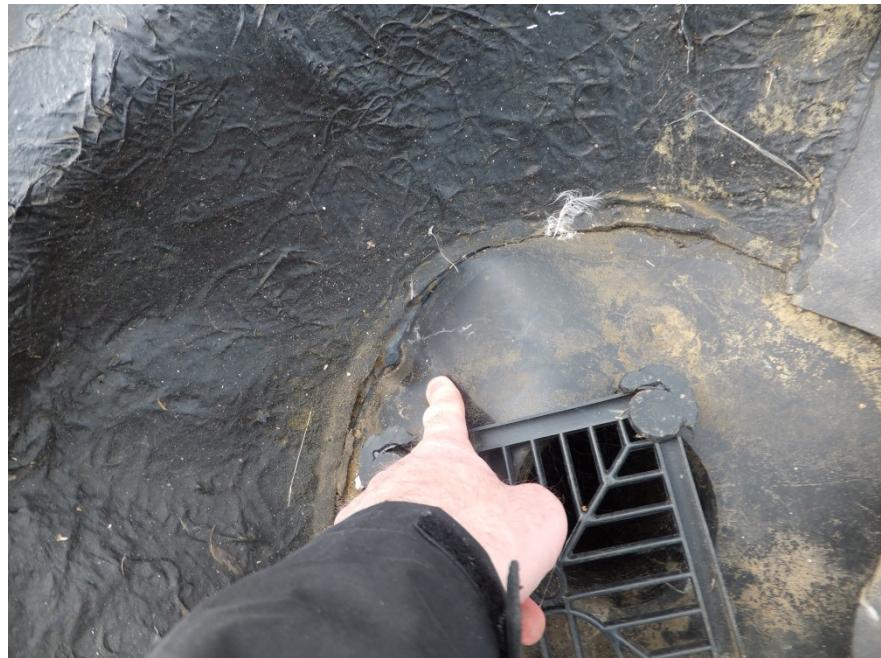
Plate 8

Failed joint between roof covering and outlet.

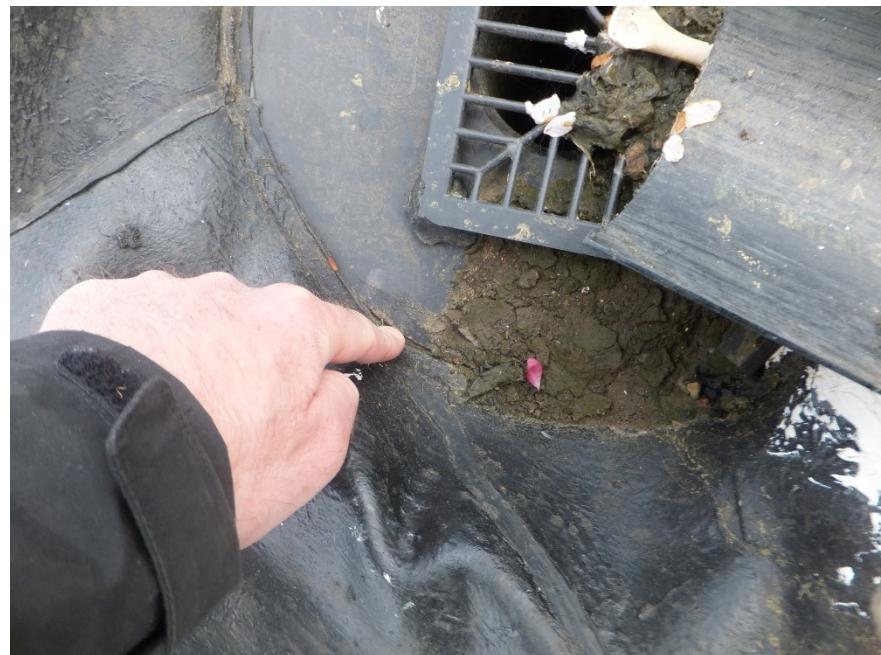
Plate 9

Failed joint between roof covering and outlet.

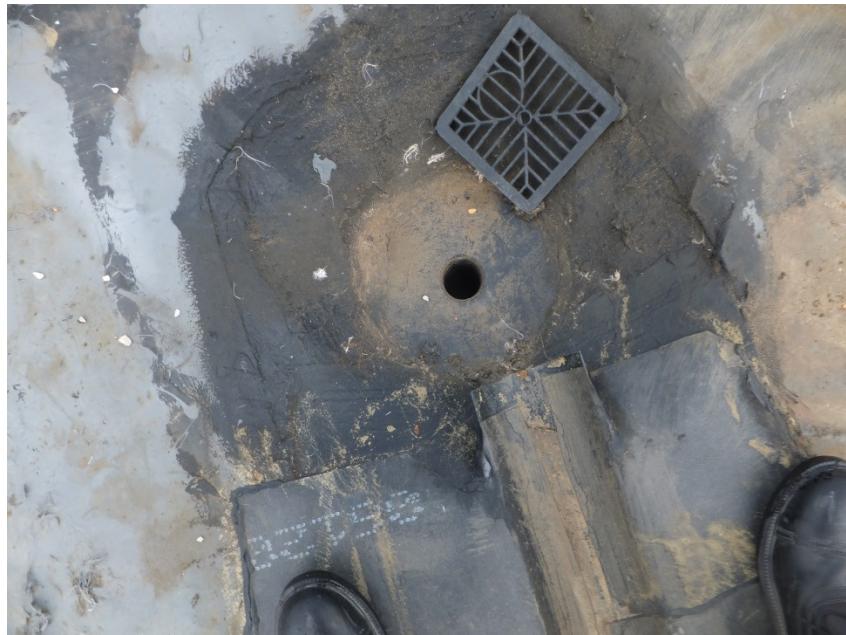
Plate 10

3.2.6. One gully outlet seen appeared to be undersized (Plate 10).

Undersized gutter outlet

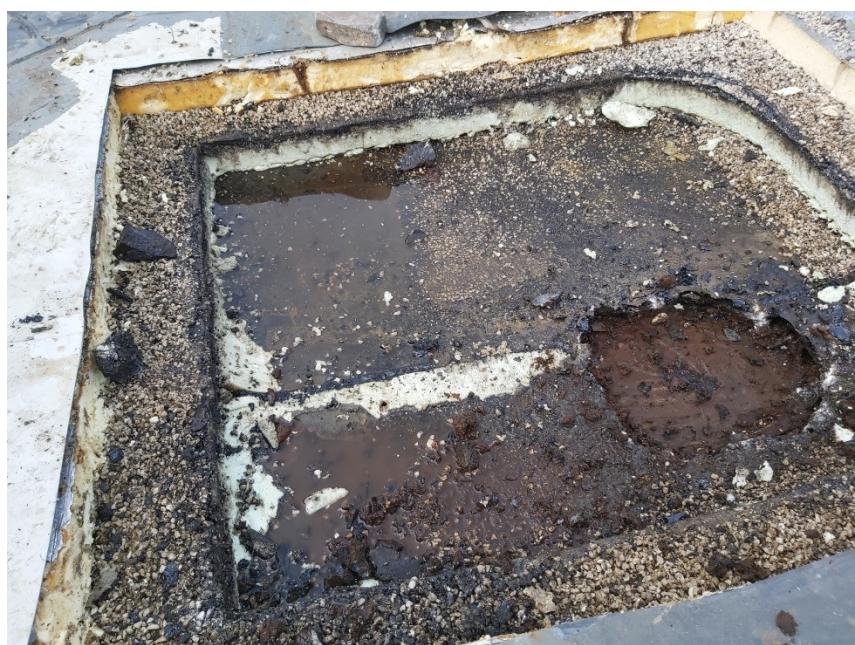
Plate 11
Roof build-up exposed

- 3.3.6. In the location exposed, a significant amount of standing water was seen between the polystyrene insulation and the original bitumen roof finish. (Plate 11).
- 3.3.7. This finding would confirm that roof water is breaching both of the overlays.
- 3.3.8. Water ingress has extended through the lower bituminous layer onto the supporting ply board. The moisture has caused delamination to the top ply of the board, but had not extended beyond this at the inspection point. (Plate 12).

- 3.5.3. The significant amount of standing water discovered beneath the lower insulation layer would confirm that the first overlay is also failing to prevent water ingress.

- 3.6.4. We would recommend that the roof overlays are removed due to the existing water ingress and overloading of the timber joists.
- 3.6.5. Covering over is NOT a viable option based on our findings.

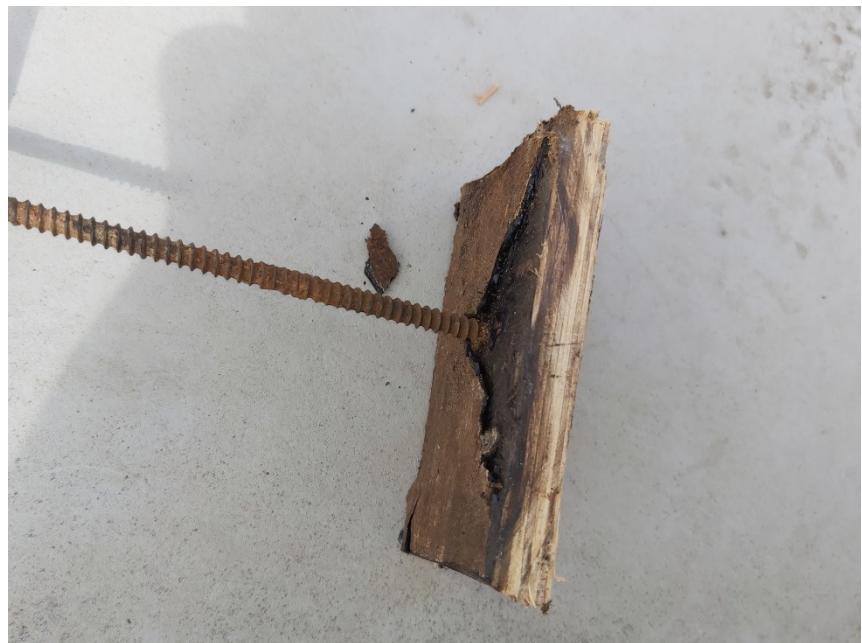
Plate 12

Evidence of damage to top laminate of ply board roof deck.

- 3.5.6. The ply board at the location inspected was seen to be in fair condition. Damage had occurred to the outer lamination but this is not seen to be significantly affecting its structural performance.

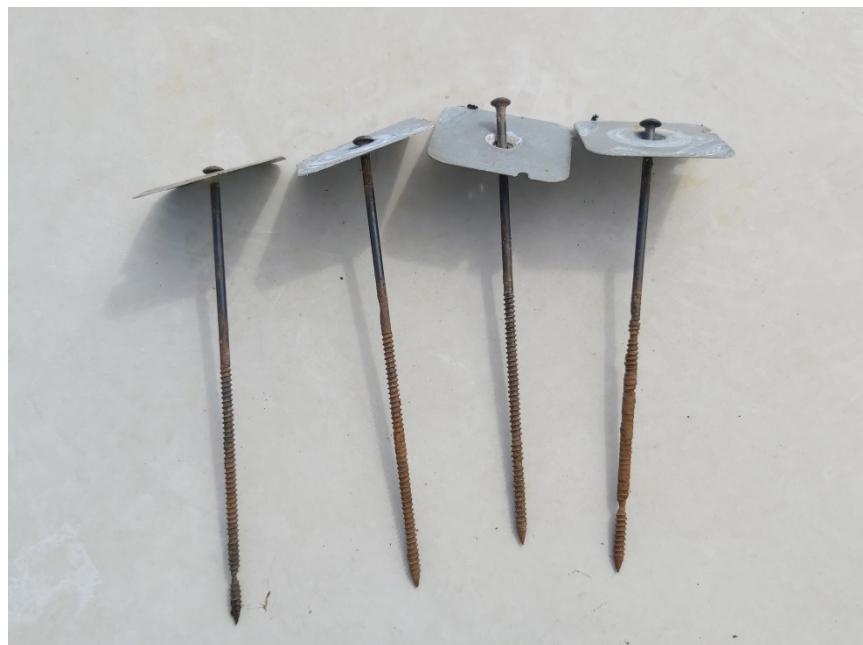
- 3.3.9. Significant corrosion was visible to the removed screw fixings (Plate 13).

Plate 13
Corrosion to screw fixings including thread failure

- 3.6.7. The screw fixings used to secure the single ply membrane to the ply wood roof sheet are inadequate to resist the wind suction forces. Any replacement roof covering fixings would need to address this issue.

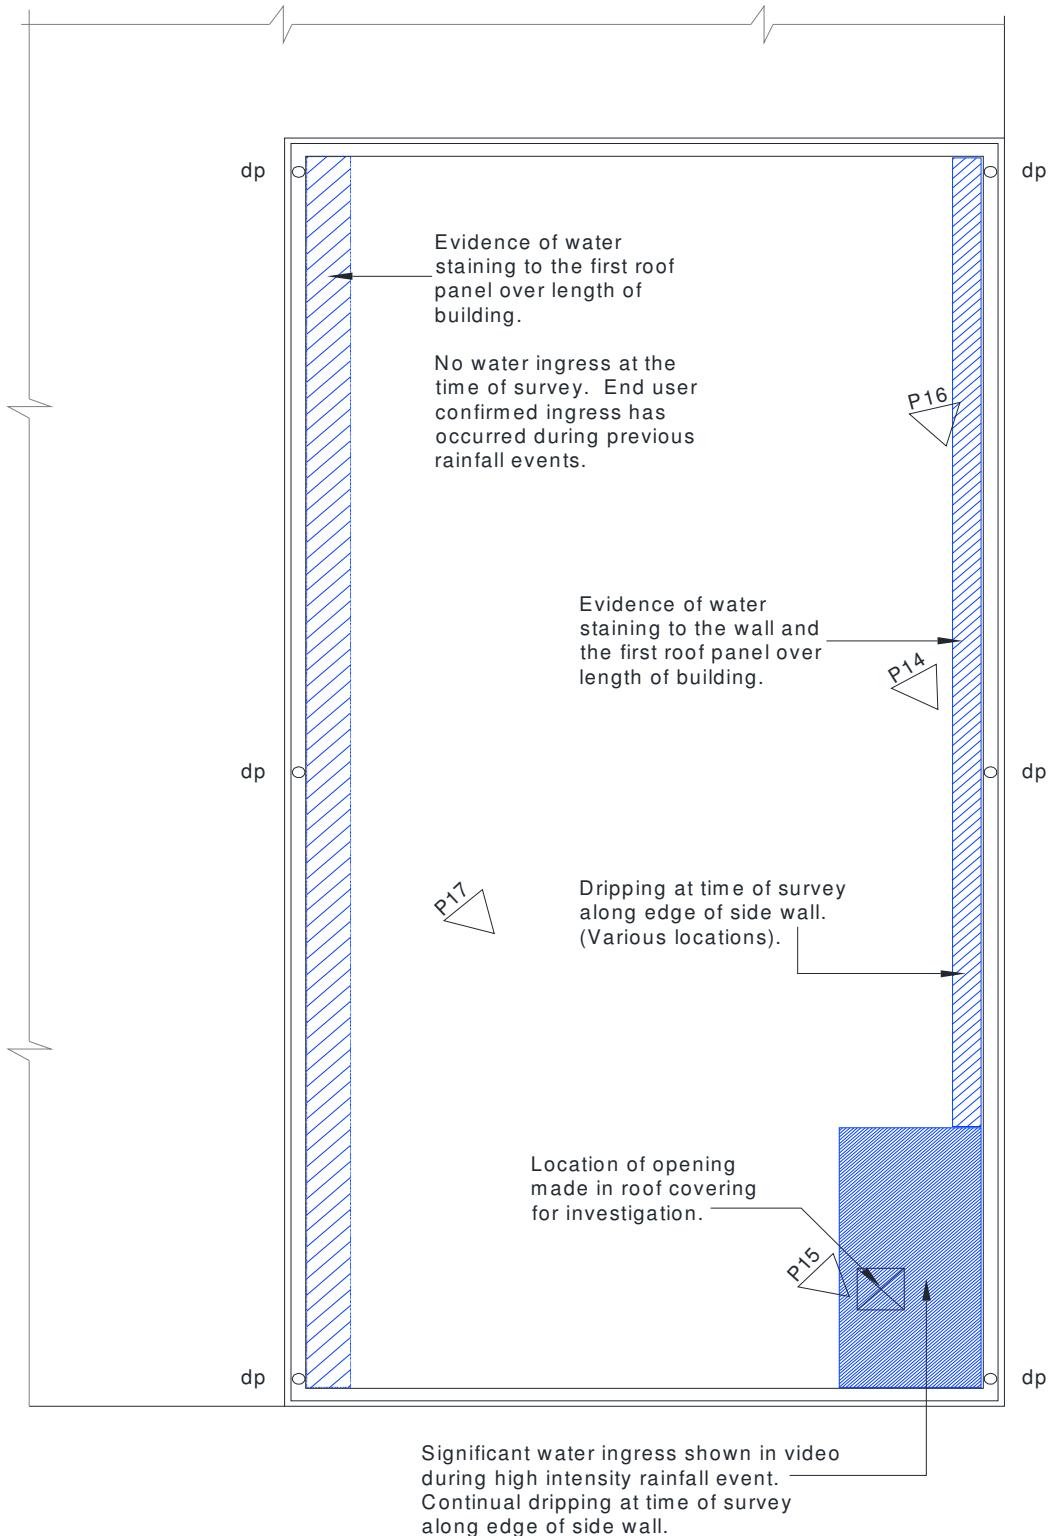
Figure 3

- 4.1.1. The locations of water ingress through the sports hall building roof are shown on Figure 3. Record photograph locations are also referenced.
- 4.1.2. Water ingress during the recent heavy rainfall event was identified to us by the Leisure Centre Duty Manager who also showed a video. The majority of the ingress occurred adjacent to the long wall on the open side of the building (Plate14), with the greatest ingress near to the right hand corner (Plate 15).

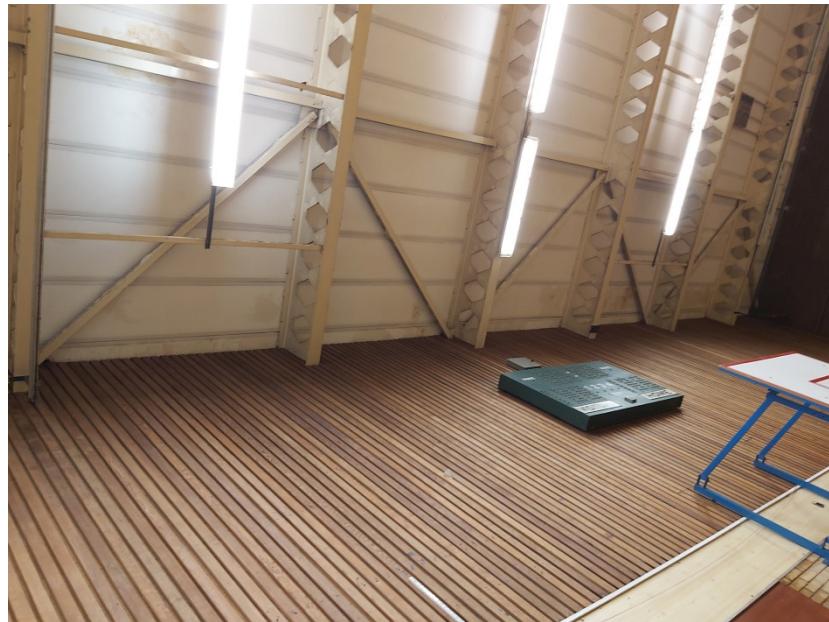
Plate 14

Evidence of water staining to the long wall (open side)

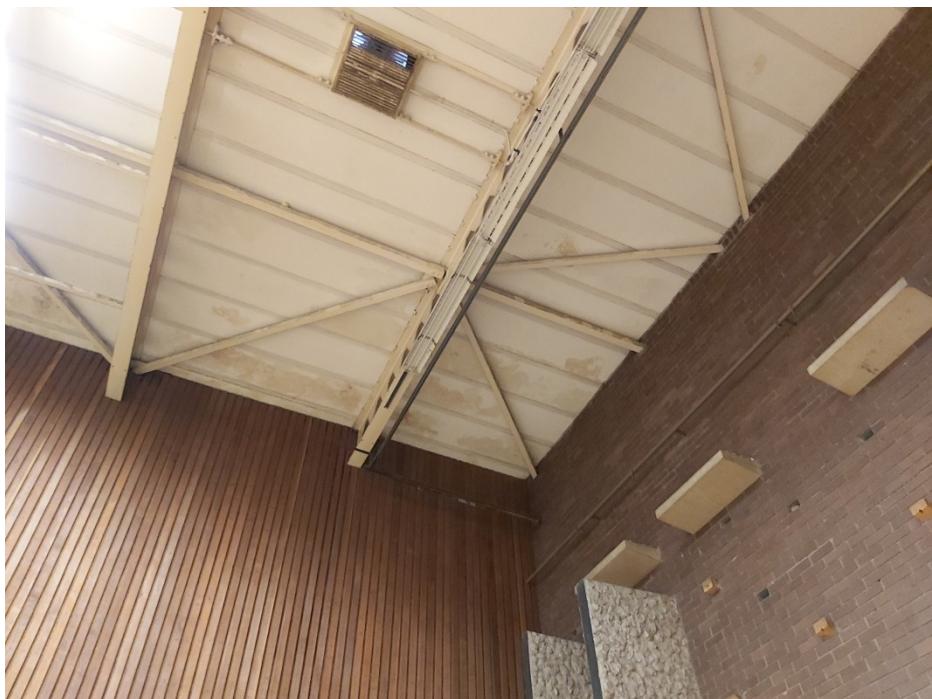
Plate 15

Evidence of water staining to the cornetr of the roof extending into the hall

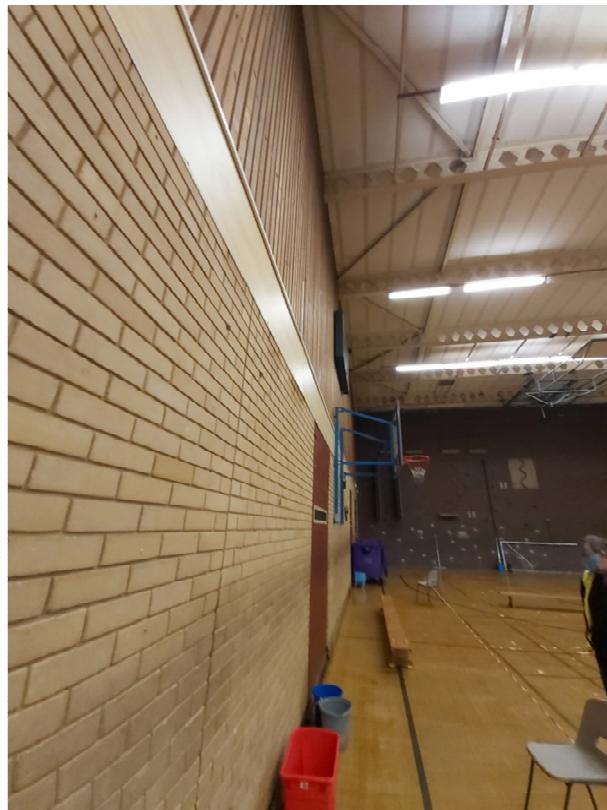
Plate 16

- 4.1.3. In a number of location along the side wall water ingress (dripping) continued at the time of our survey despite it not having rained for at least 4 days requiring the area to be cordoned off and buckets left in place (Plates 16 and 17).

Area cordened off due to continuing water ingress

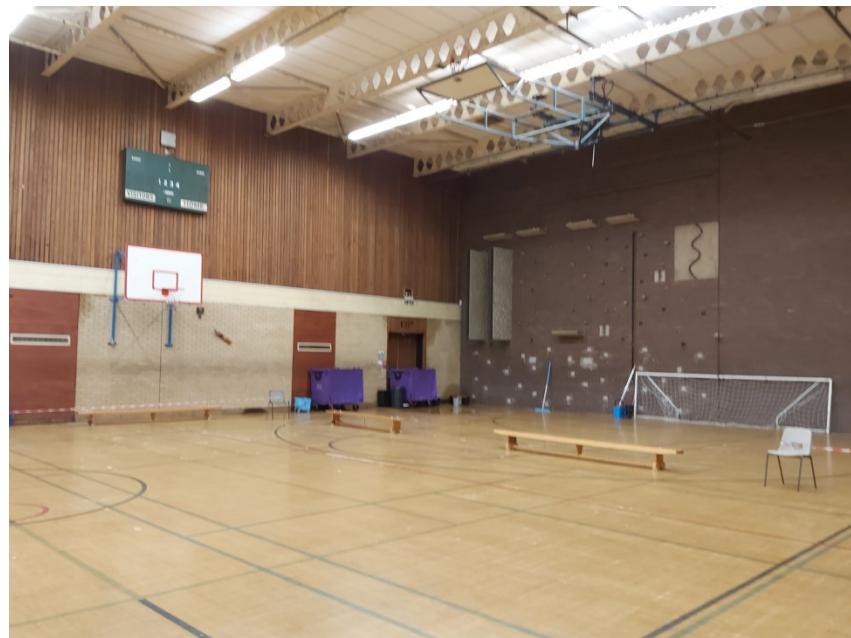
Plate 17

Area cordened off due to continuing water ingress

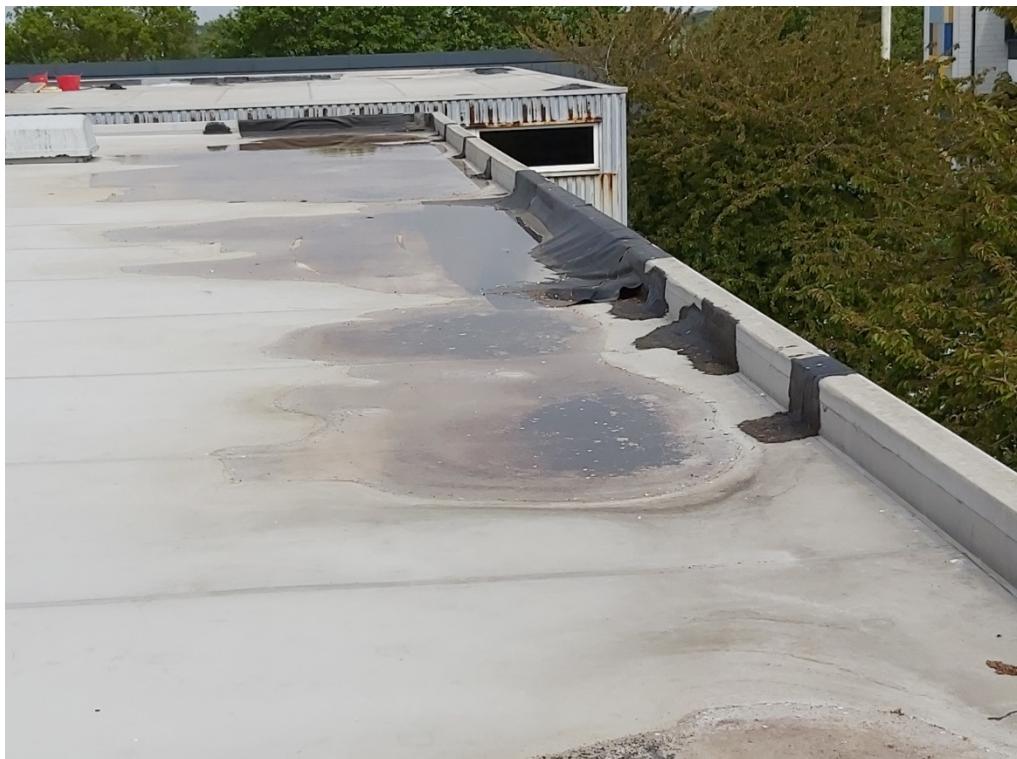
Plate 18

- 4.2.1. The current roof covering is a single ply membrane understood to be Trocal by Sika.
- 4.2.2. There were substantial areas of standing water and further areas of staining from previous standing water on the roof where it dips lower than the level of the gully outlet. (Plates 18 and 19).

Standing water and staining due to standing water on single ply membrane.

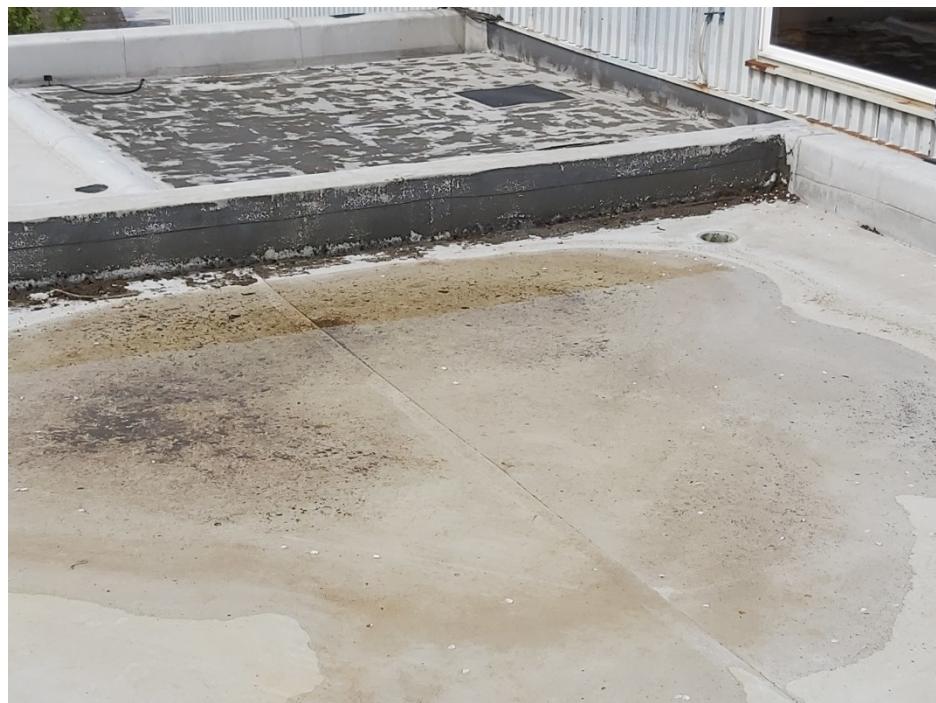
Plate 19

Dip in roof finish below outlet level.

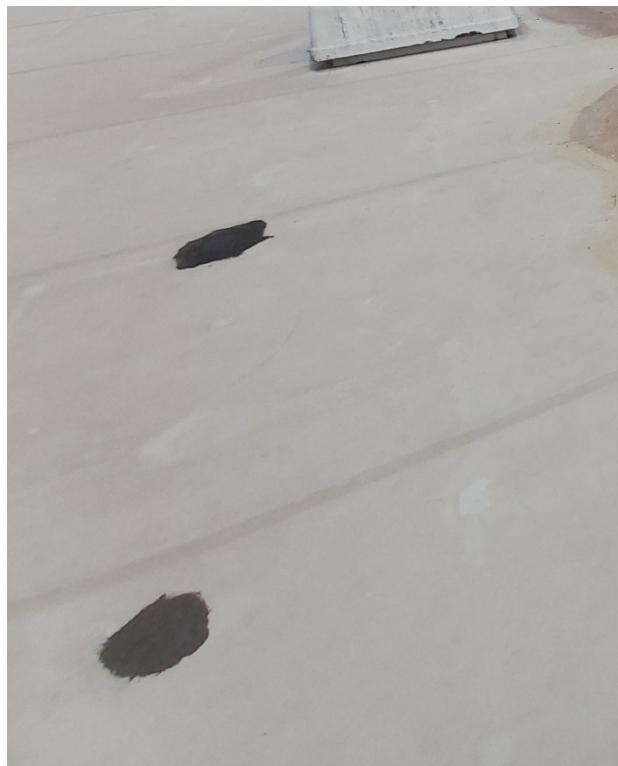
Plate 20

- 4.2.3. The roof covering is secured in position by screws glued to the underside of the membrane. In many locations the screw heads could be seen to have lifted with the membrane, causing it to puncture the membrane. A bituminous repair had been applied over the screw heads. (Plate 20).
- 4.2.4. From the investigation it appears that the screws have become partially withdrawn from the roof deck (most likely due to wind suction on the roof). Many of the screws will not push back down into the deck and so they create local high points where the membrane is prone to fail.

Stretching of single ply over withdrawn screw and bitumnet repair.

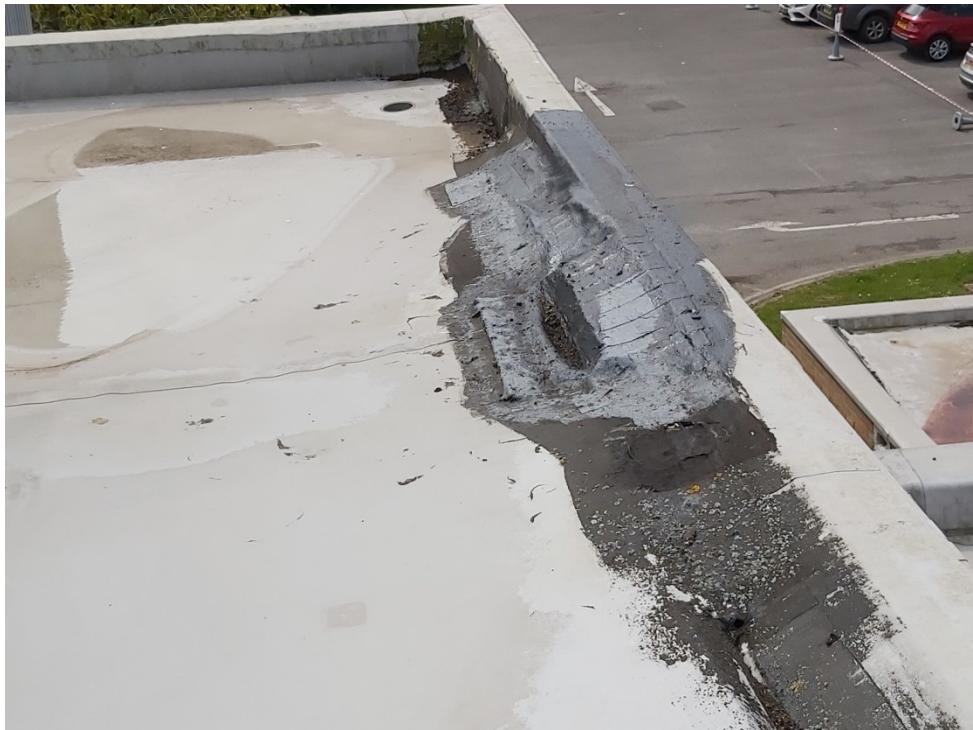
Plate 20

- 4.2.5. Sections of the roof covering along the long side, was seen to slope upwards along the perimeter of the roof where it meets the small upstand. This has resulted in their being a void between the membrane and the roof insulation. The unsupported membrane is prone to stretch and failure. There is evidence of significant repair to the membrane in these locations (Plate 21 and 22).

Single ply membrane lifted at perimeter of roof – Evidence of repair.

- 4.5.1. The water ingress would appear to occur mostly at the roof perimeter and at the gutter outlets. Significant attempts to repair the membrane along the edges of the roof have been made, but there was evidence of failed joints (Plates 20 and 21).

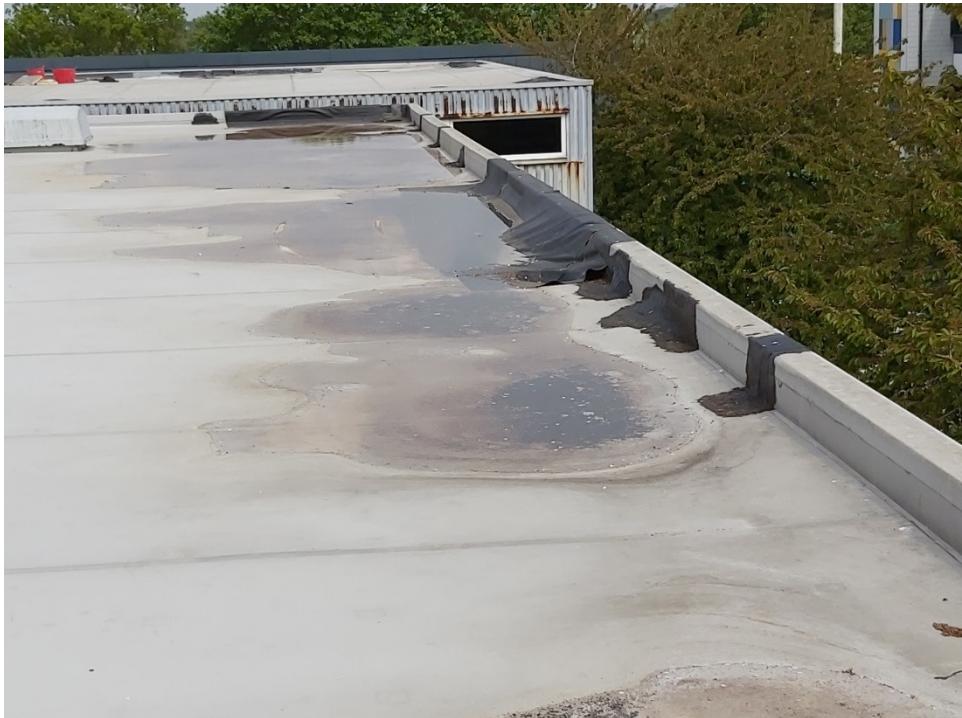
Plate 21

Single ply membrane lifted at perimeter of roof – Evidence of repair.

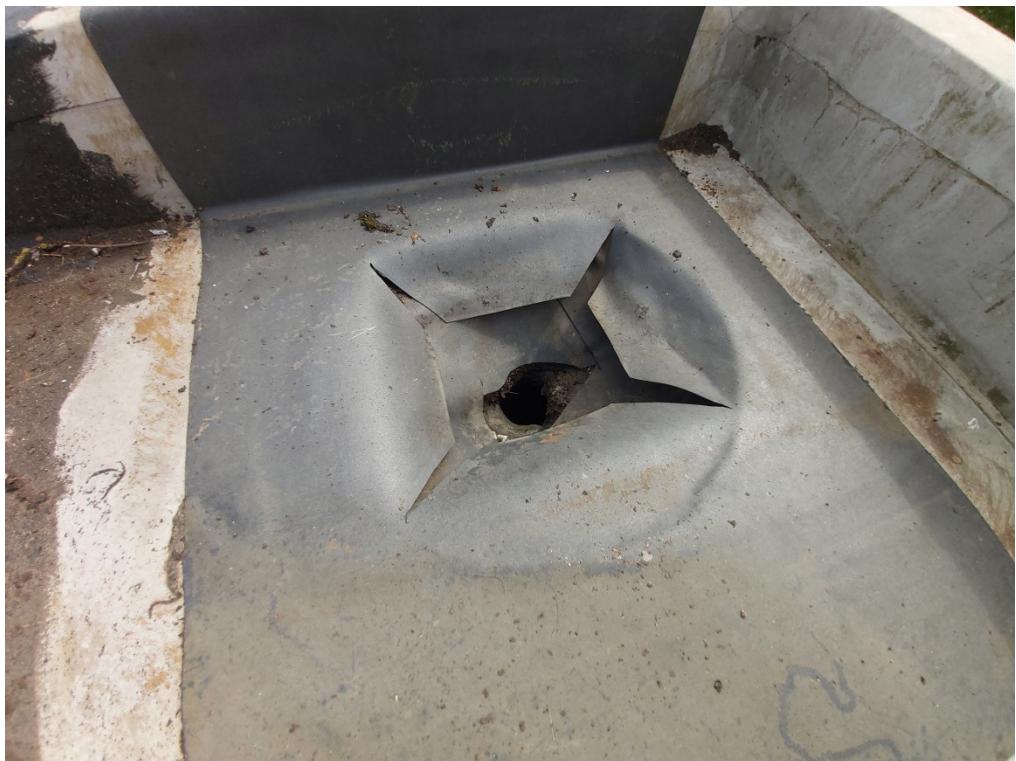
Plate 22

Rubber membrane has become detached from the gutter outlet.

- 4.5.2. The gutter outlet joints with the roof membrane have been patched, but again these had failed (Plates 22 and 23). The most significant failures being to the gutters above the areas suffering for the greatest water ingress during the recent rainfall event.

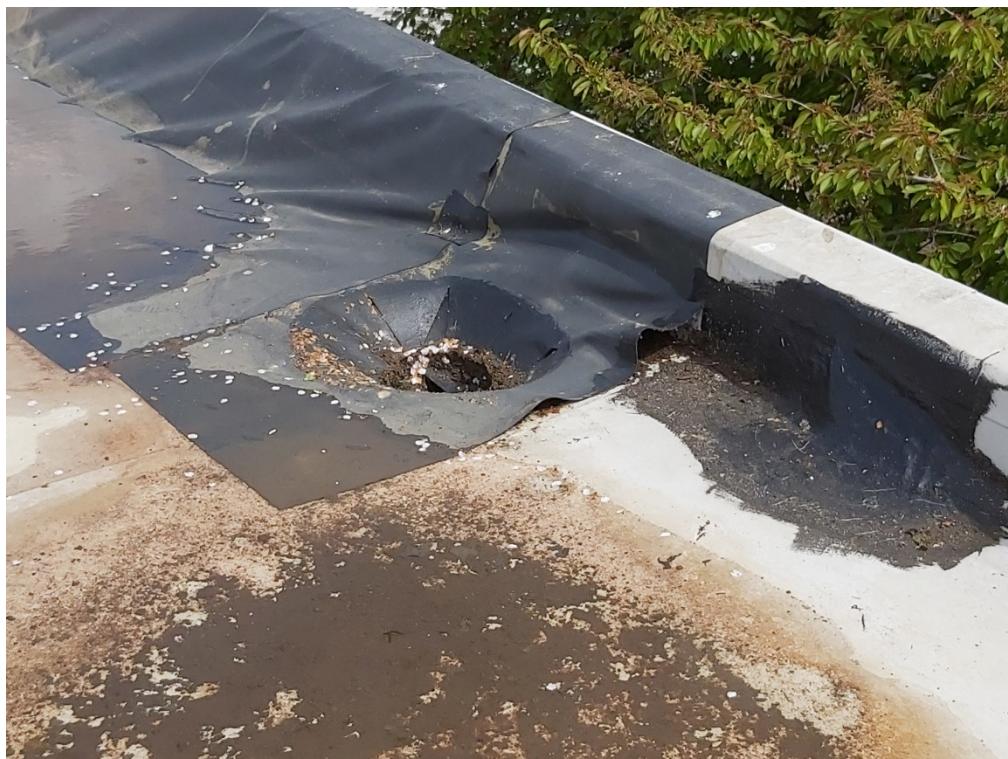
Plate 23

Rubber membrane has become detached from the gutter outlet and the original roof membrane.

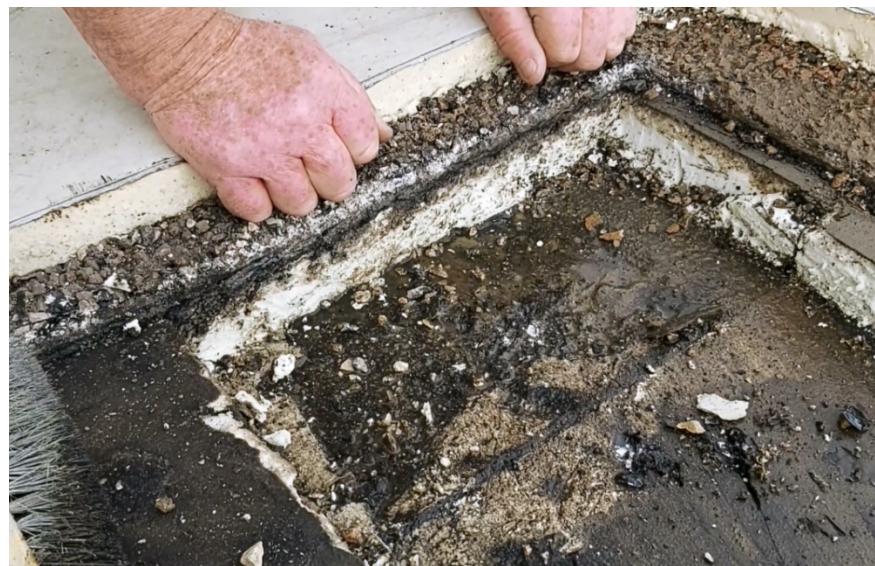
Plate 25

4.3.7. In the location exposed, trapped standing water was seen between the lower polystyrene insulation and the original bitumen roof finish. (Plate 25 and video).

Trapped water below insulation

- 4.6.8. Removing the existing insulation layers is critical to allow all of the trapped water within the roof to be drained and the roof dried out before covering.

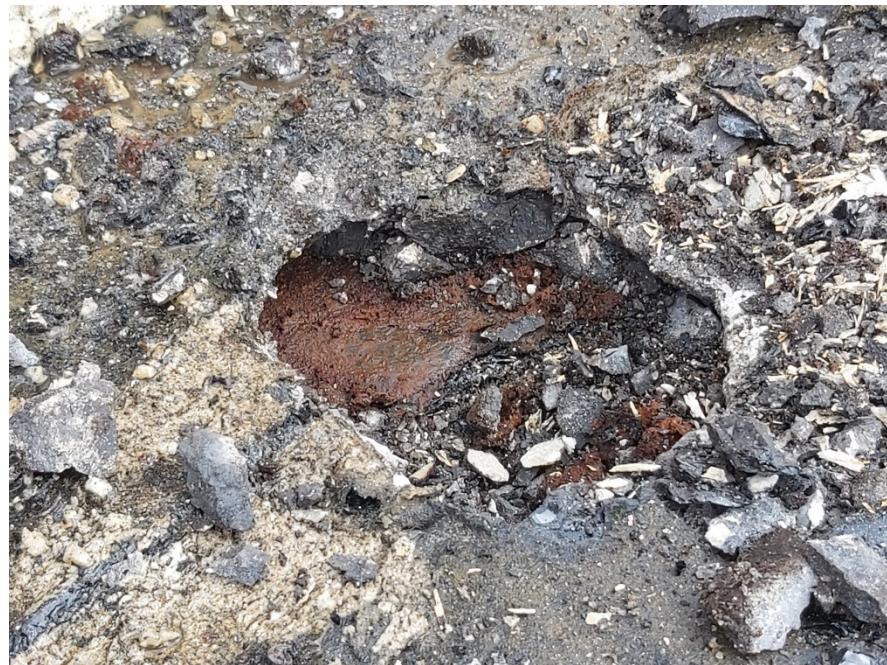
Plate 26

4.3.8. Cutting through the bitumen layer exposed a brown fibrous material (believed to be hardboard). This was found to be saturated and had disintegrated (Plate 26).

Top of Stramit Board
