Section 19

Flood and Water Management
Act 2010

Ref S19-865

Date and version number –
11/11/2024

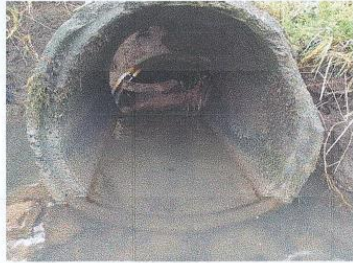
Fig. 1.

600mm Ø concrete pipe has become disjointed and partially blocked.

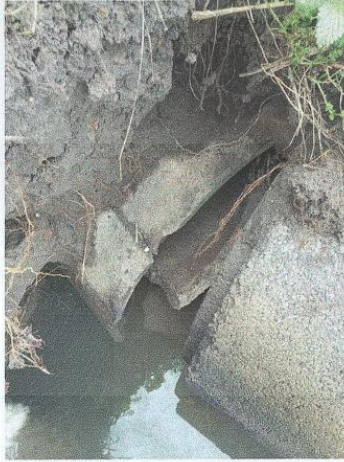
Fig. 2.

Further cracking/damage to concrete pipe.

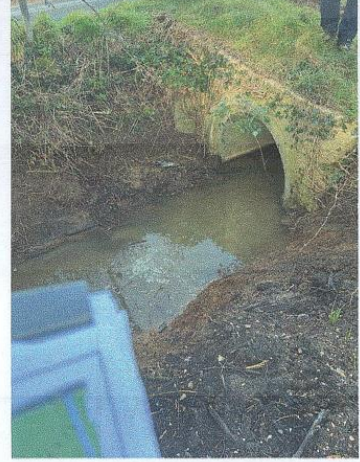
Fig. 3.

1150mm Ø pipe over farmer's entrance is an appropriate diameter but approximately 1/4 full of silt, reducing capacity.

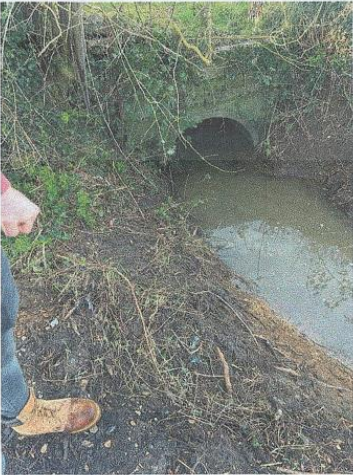
Fig. 4.

1150mm Ø pipe under main road from SKDC owned dyke is a suitable diameter but approximately 1/3 - 1/2 full of silt and debris.

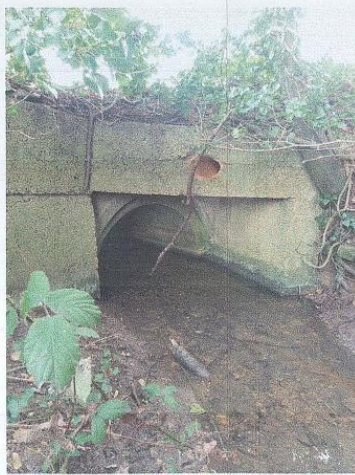
Fig. 5.

1150mm Ø pipe viewed from Pointon House side of main road. Full of debris hense reducing flow and capacity considerably.

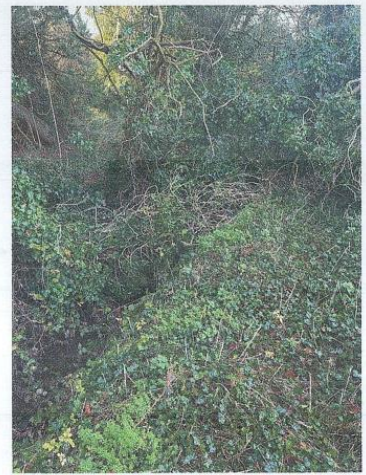
Fig. 6.

Dyke full of overgrown, self planted trees ivy and shrubs behind Pointon House - SKDC owned dyke.

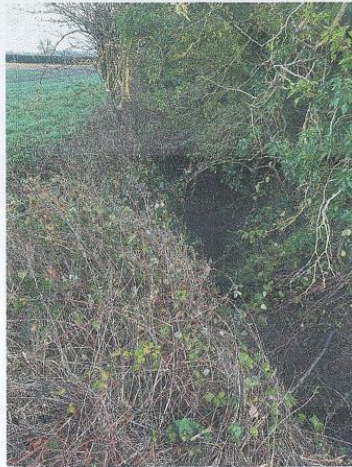
Fig. 7.

SKDC dyke has not been maintained in years. Needs grubbing out.

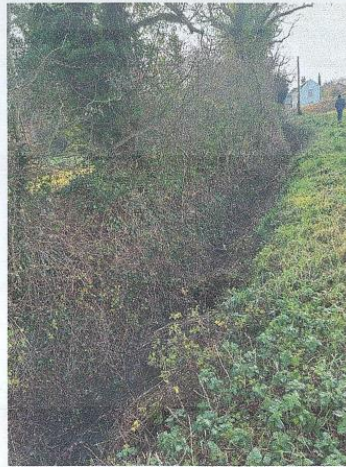
Fig. 8.

Dyke full of brambles and other undergrowth.

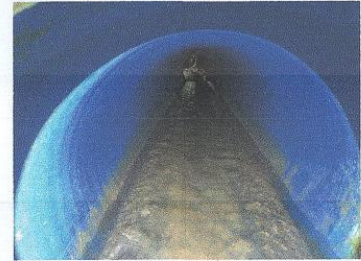
Fig. 9.

450mm Ø pipe beneath west road at brick headwall. This is working fine in principle as it was designed to lower the volume of water able to go under the road towards the houses on West Road.

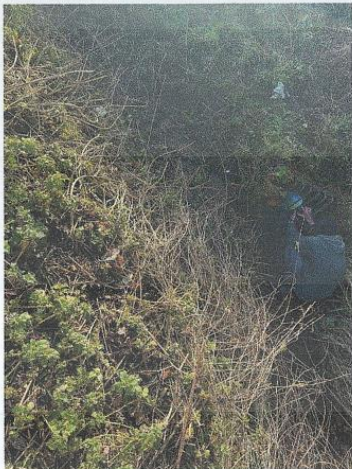
Fig. 10.

The area to the left of the head wall and 450mm Ø pipe is full of sediment putting increased pressure on the small pipe.

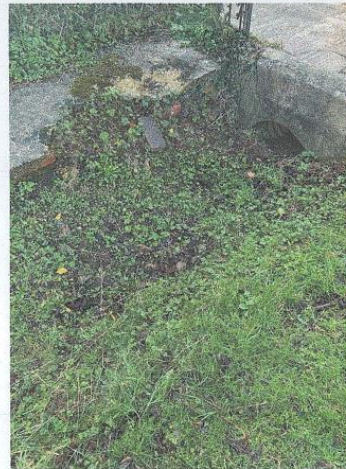
Fig. 11.

Shallow ditch above a buried 450mm Ø piped run beneath. Ditch could do with a light grubbing out and jetting out debris in above ground pipes where vehicle bridges are.

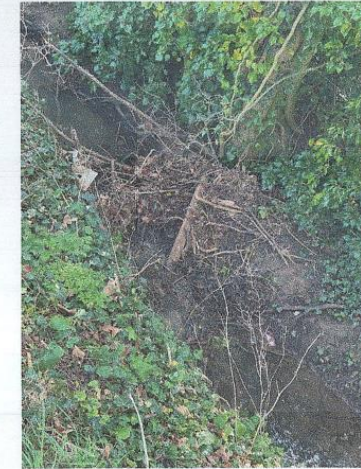
Fig. 12.

Just one example of many blockages along the dyke which runs behind the houses and school to the north of West Road.

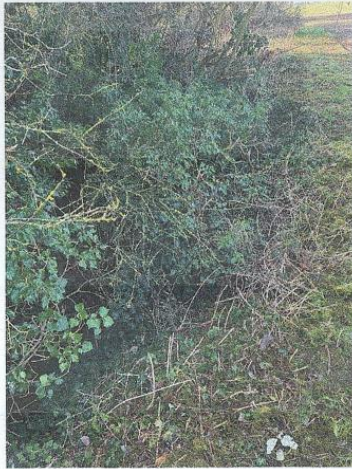
Fig. 13.

Parts of the dykes are not even visible as there is that much undergrowth.

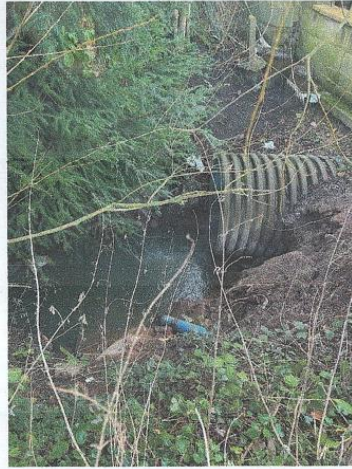
Fig. 14.

900mm Ø pipe where householder at number 42 West Road has piped the ditch. It is unknown as to if permission was sought for this. However this drastically reduces capacity compared to the open ditch.

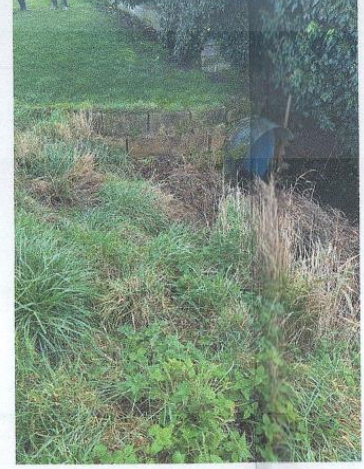
Fig. 15.

Pipe viewed from the other end of number 42 West Road.

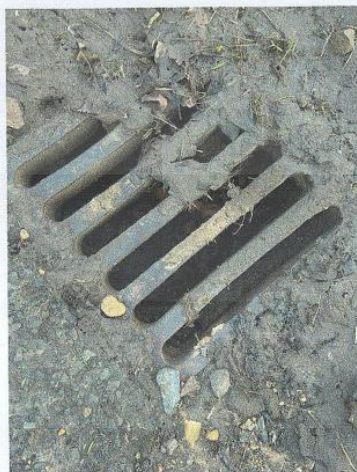
Fig. 16.

Example of one of the many road gulleys throughout the village which clearly haven't been opened and cleaned due to the fact their perimeter is partially covered by road plantings.

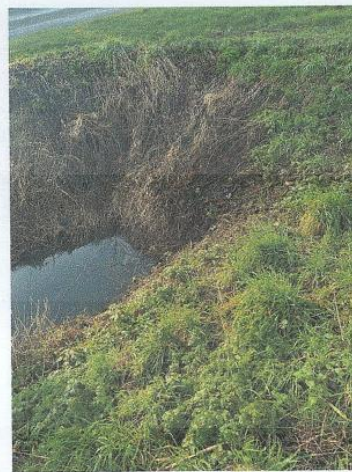
Fig. 17.

Undergrowth means that the 450mm Ø pipe cannot even be seen at a farmers entrance.

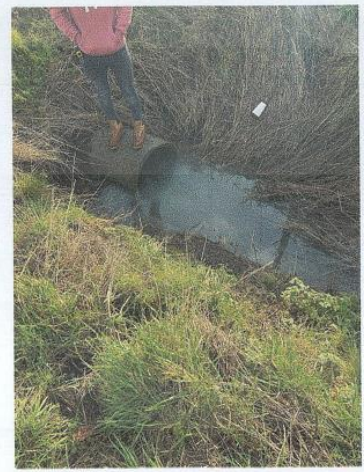
Fig. 18.

450mm Ø concrete pipe at farmers entrance is totally blocked and the pipe diameter is nowhere near large enough given the capacity of the open dyke either side.

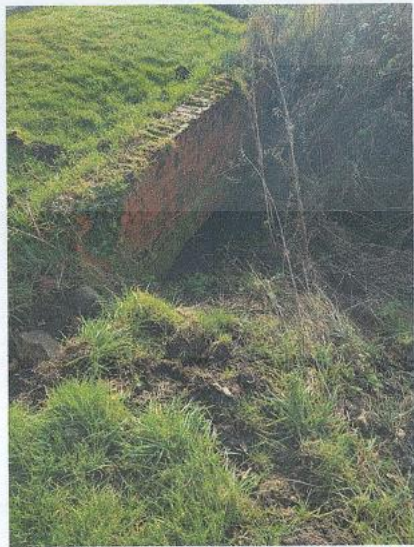
Fig. 19.

Old brick bridge almost full of sediment and undergrowth caused by years of no maintenance.

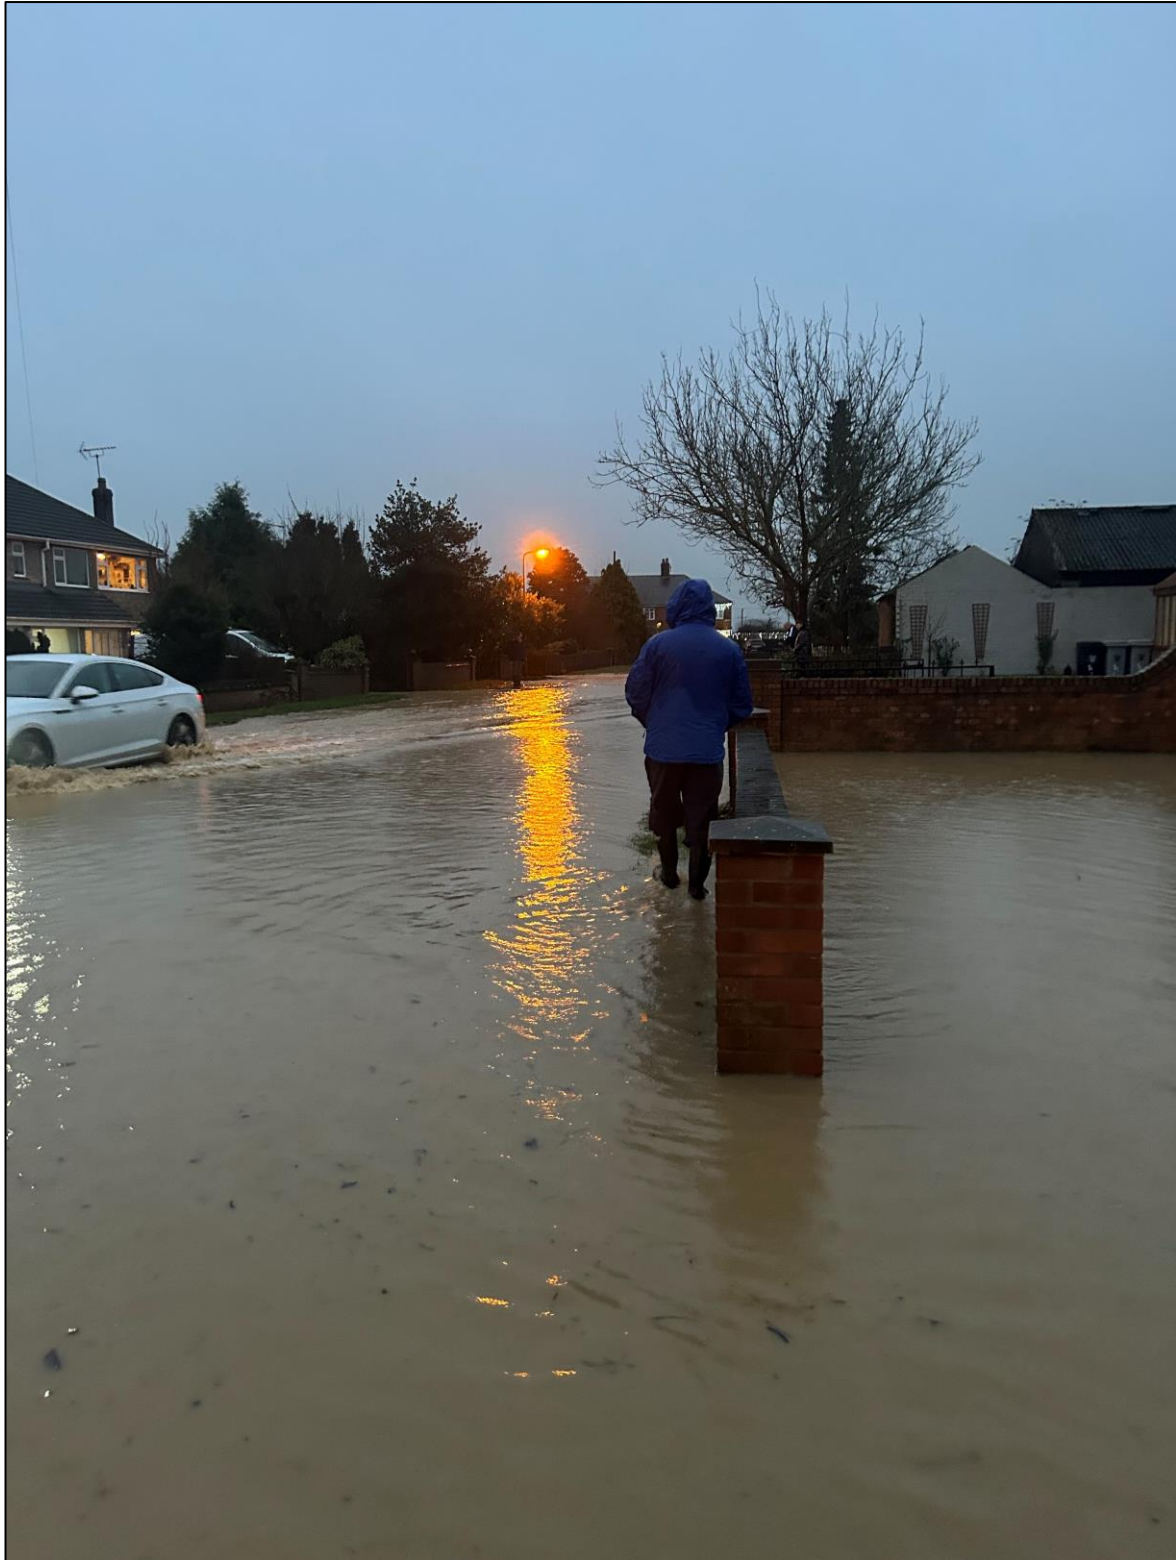
(Photo 2 – External flooding during Storm Henk in Pointon)

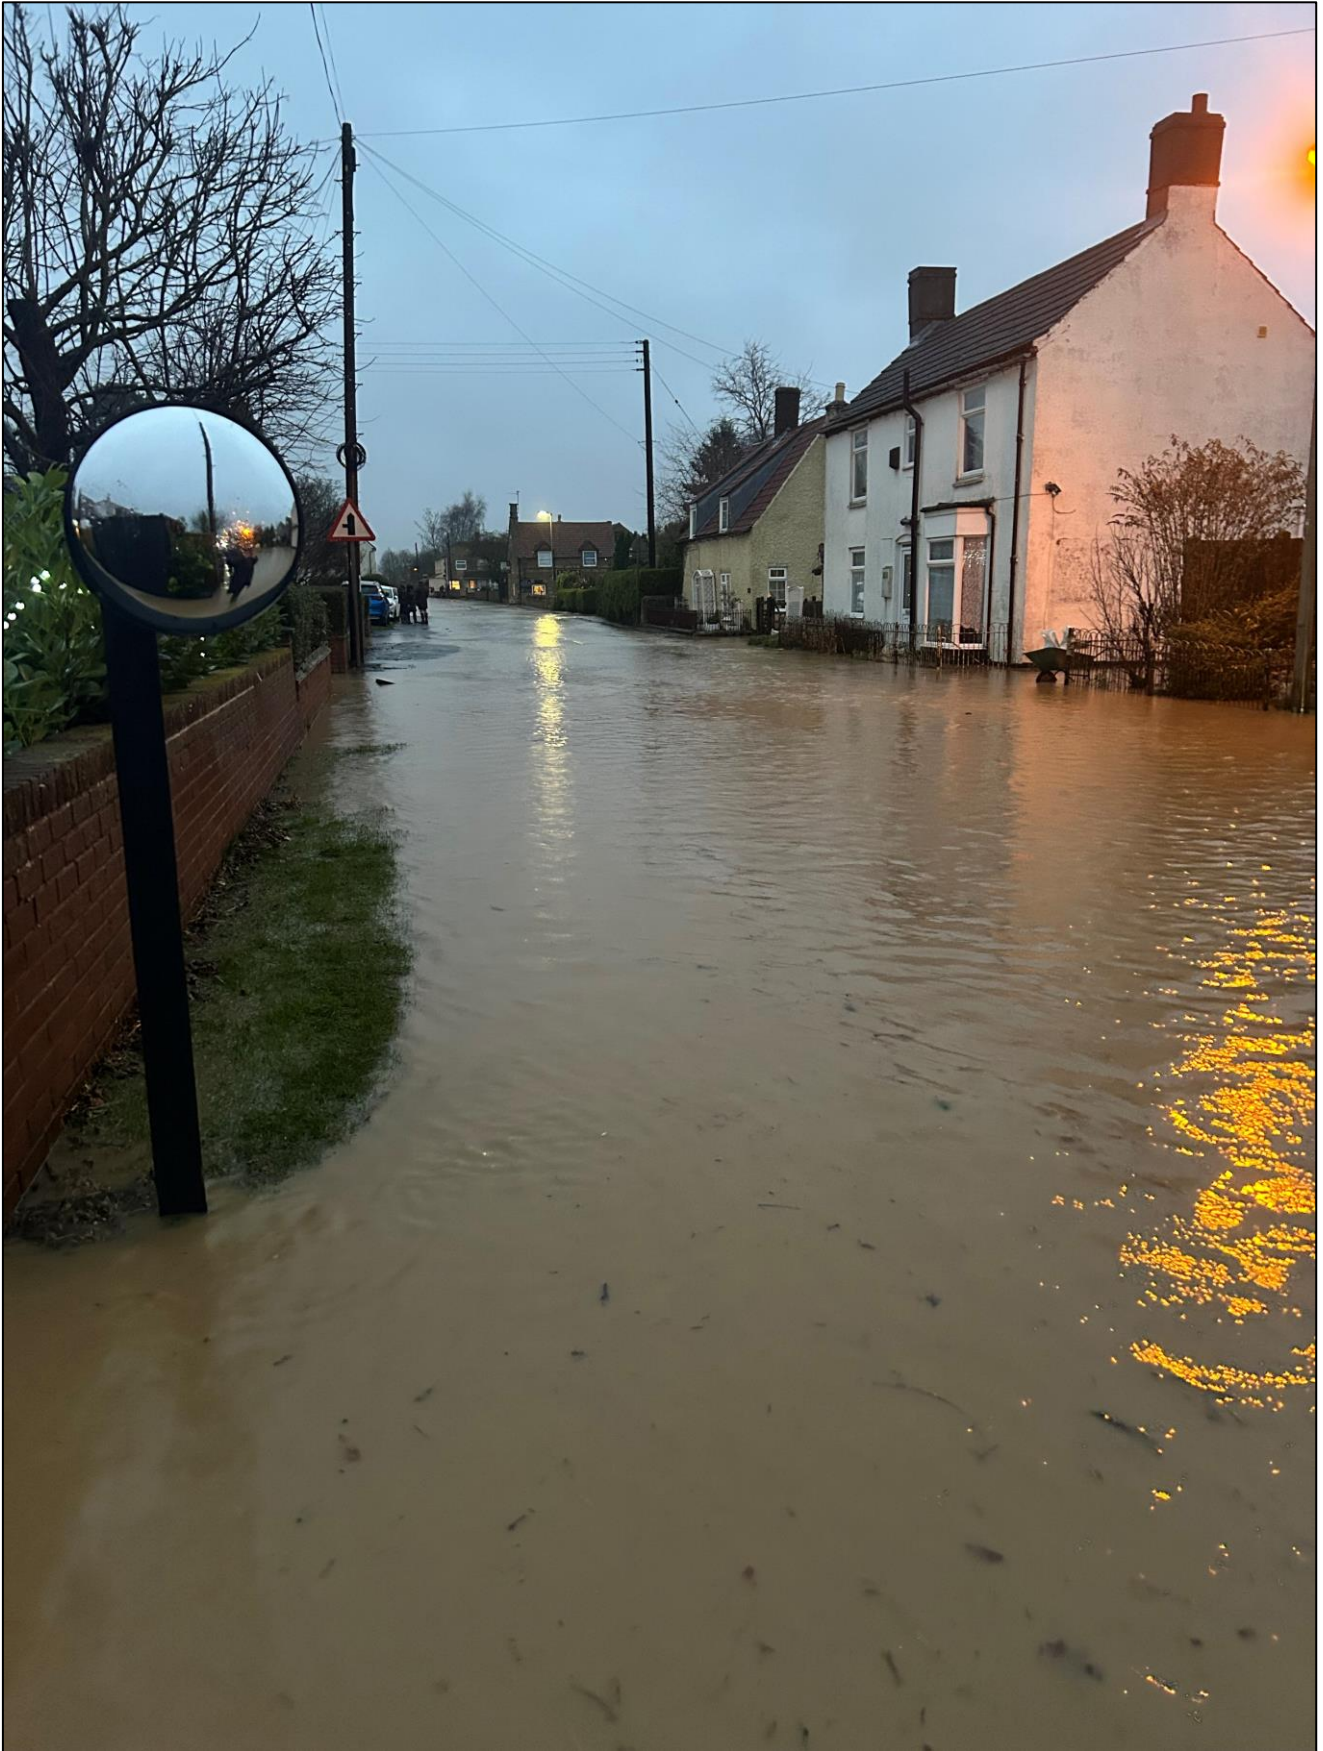
(Photo 3 – External flooding during Storm Henk in Pointon)
