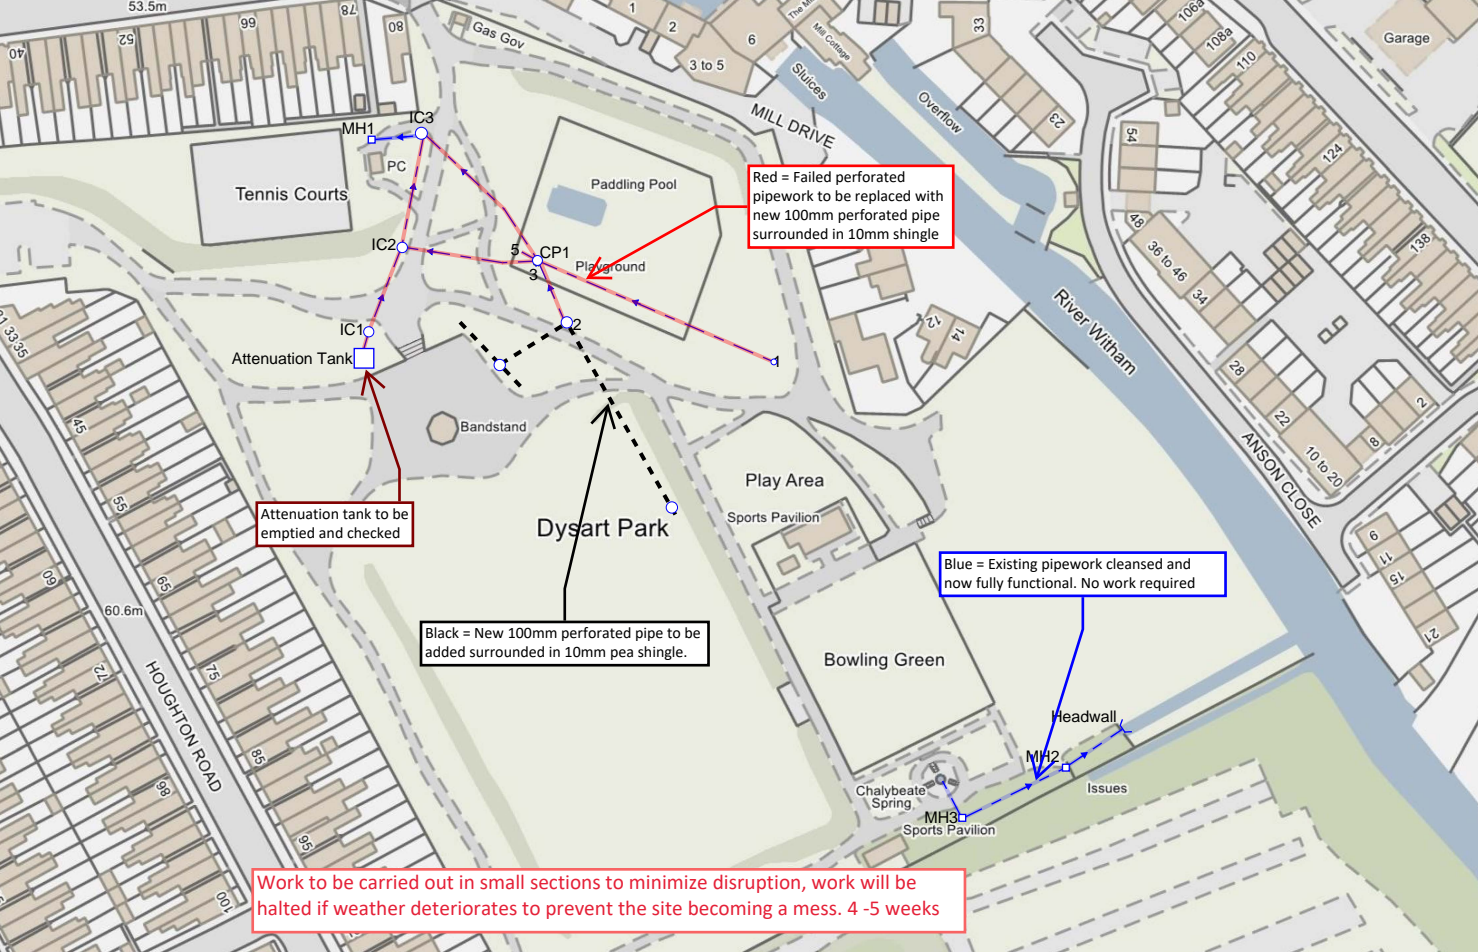
Red = Failed perforated pipework to be replaced with new 100mm perforated pipe surrounded in 10mm shingle

Black = New 100mm perforated pipe to be added surrounded in 10mm pea shingle.

Blue = Existing pipework cleansed and now fully functional. No work required

Attenuation tank to be emptied and checked

Work to be carried out in small sections to minimize disruption, work will be halted if weather deteriorates to prevent the site becoming a mess. 4-5 weeks
