Deeping Leisure Centre

Pool Hall, Sports Hall and
Squash Court

**Inspection of roof coverings and
assessment.**

Report No: **5452 / 01**

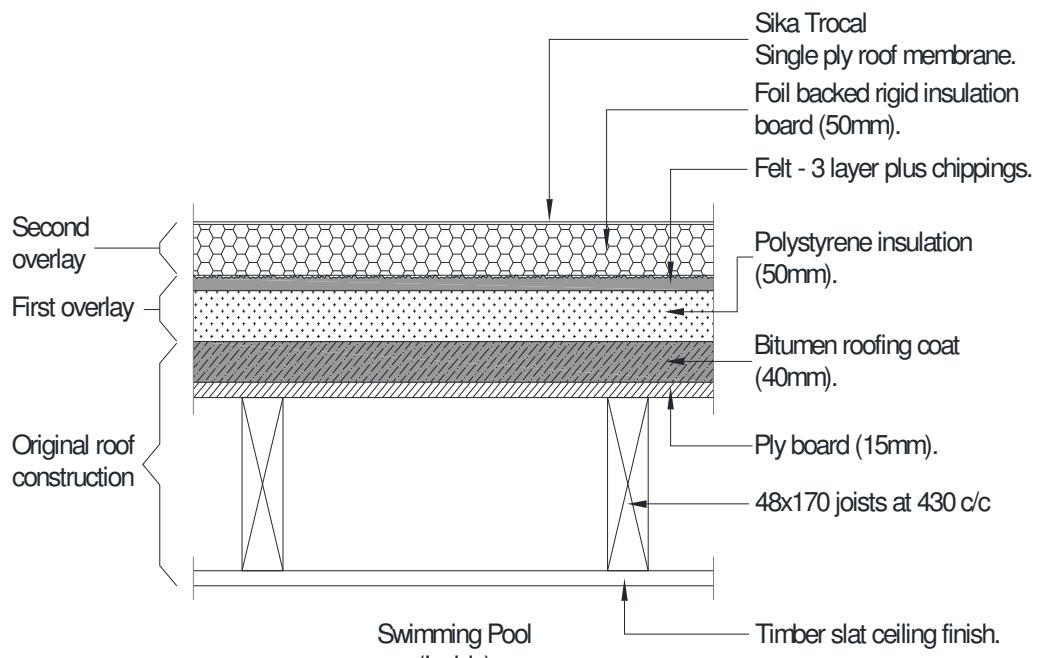
- 3.3.1. With the assistance of the SKDC appointed contractor a section of the roof covering (location shown on figure 1) was removed.
- 3.3.2. A cross section of the current roof construction is given in Figure 2 and photograph Plate 11.
- 3.3.3. The original roof comprised of a bituminous top coat laid over a ply board, supported by timber joists spanning between the primary roof beams. The pool ceiling is under drawn with slatted timbers. The original roof did not appear to have been insulated.
- 3.3.4. The first roof overlay comprises of polystyrene insulation covered with 3 layer roofing felt and chippings.
- 3.3.5. The second roof overlay comprises a foil backed insulation board with single ply roof membrane over. The membrane being fixed with screws into the deck.

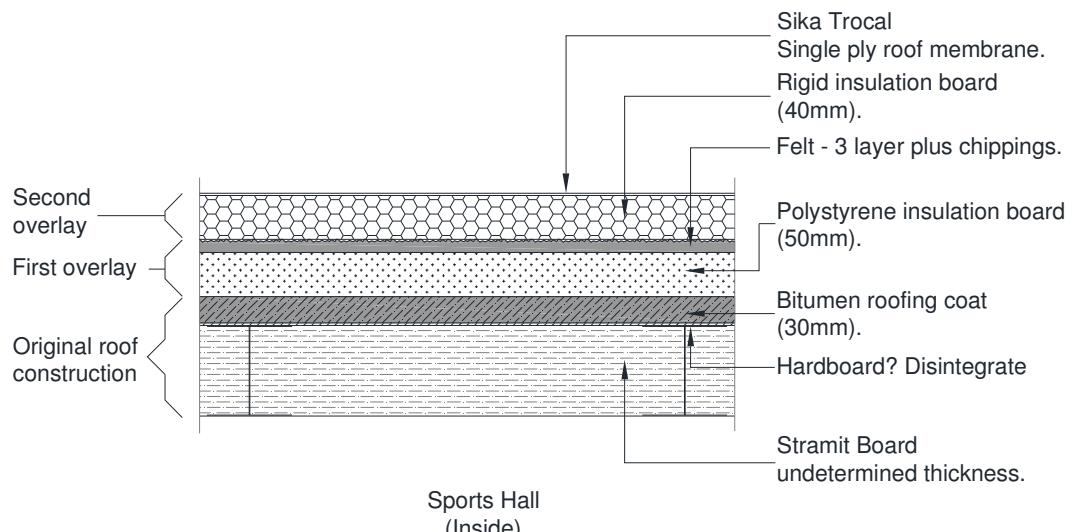
- 4.3. *Intrusive inspection of roof build-up.*
- 4.3.1. With the assistance of the SKDC appointed contractor a section of the roof covering (location shown on figure 3) was removed.
- 4.3.2. A cross section of the current roof construction is given in Figure 4 and photograph Plate 24.
- 4.3.3. The original roof comprised of a bituminous top coat laid over what appears to be a thin layer of hardboard (disintegrated by opening up works and moisture) onto 'Stramit' board.
- 4.3.4. The first roof overlay comprises of polystyrene insulation board covered with 3 layers roofing felt and chippings.
- 4.3.5. The second roof overlay comprises rigid insulation board with single ply roof membrane over. The membrane being fixed with screws into the 'Stramit' board below.

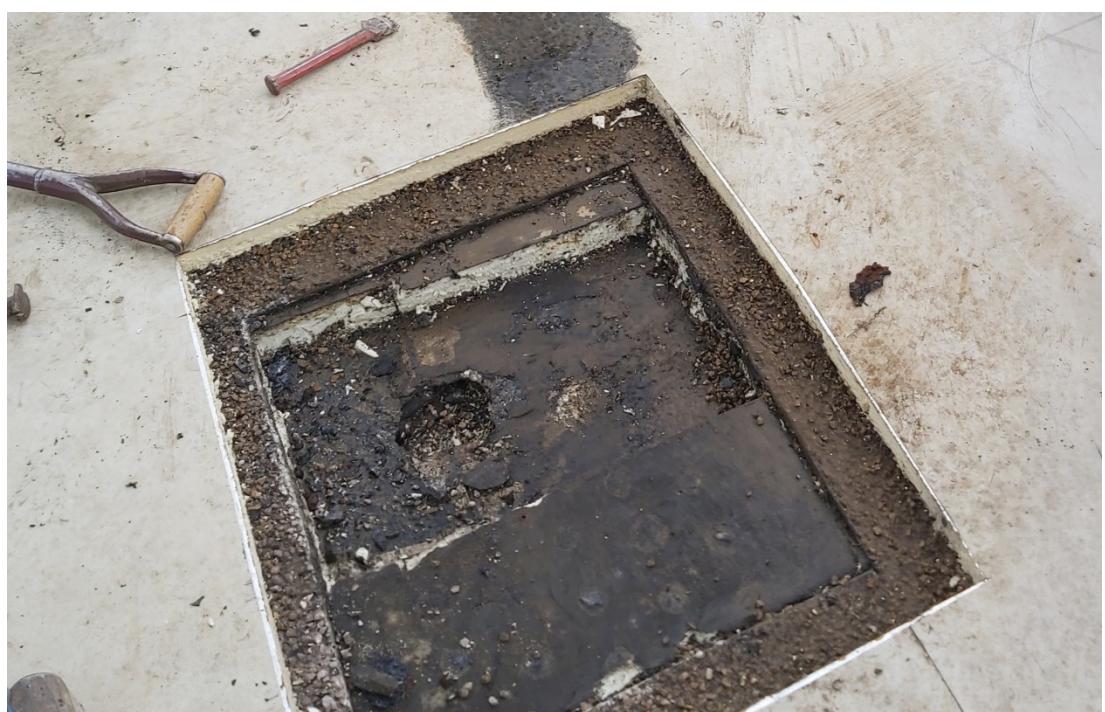
Plate 24
Roof build-up exposed

4.3.7. In the location exposed, trapped standing water was seen between the lower polystyrene insulation and the original bitumen roof finish. (Plate 25 and video).

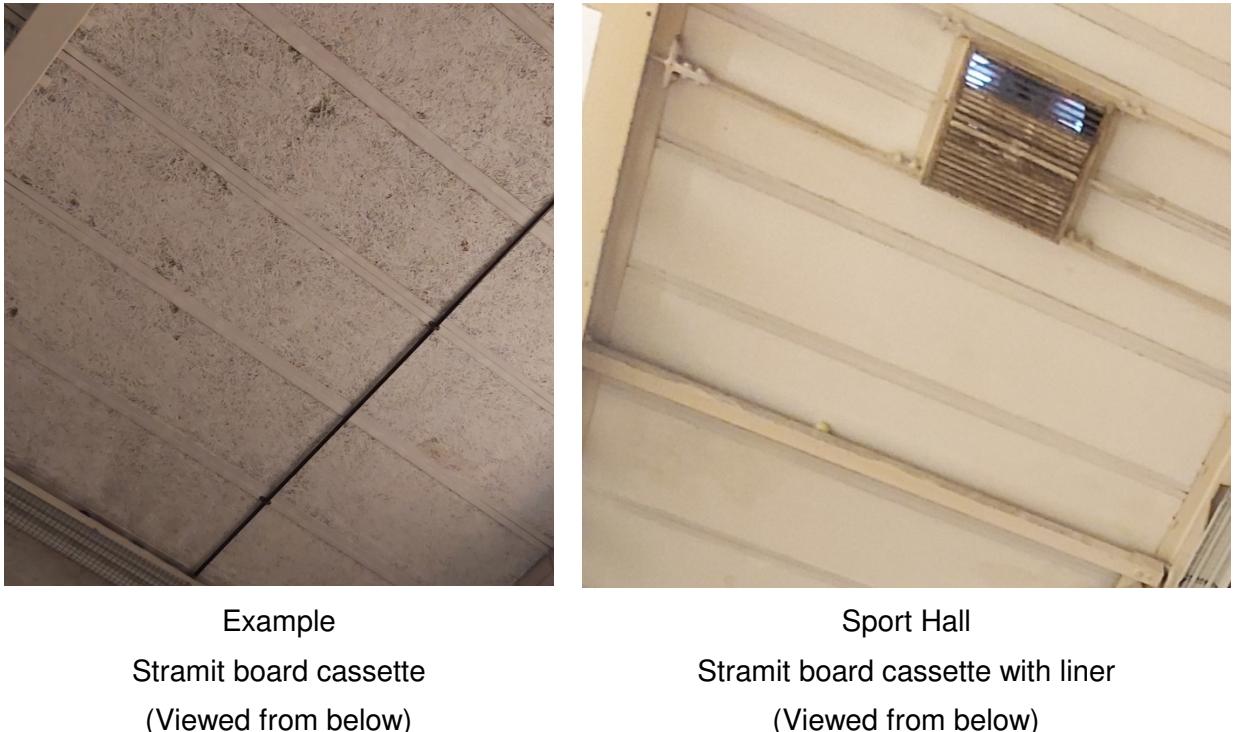
Figure 5

4.3.6. The 'Stramit' board is a matrix of compressed fibres which are impregnated with cement to form boards. It was mainly used in the 1960's and 70's. In this instance the boards are set within a pair of steel channels forming a cassette which spans between roof beams. An example of the Stramit board cassette and a comparison of the sport hall cassette where the underside has a finished sheet is shown in Figure 5.
