Section 19

Flood and Water Management
Act 2010

Ref S19-865

Date and version number –
11/11/2024

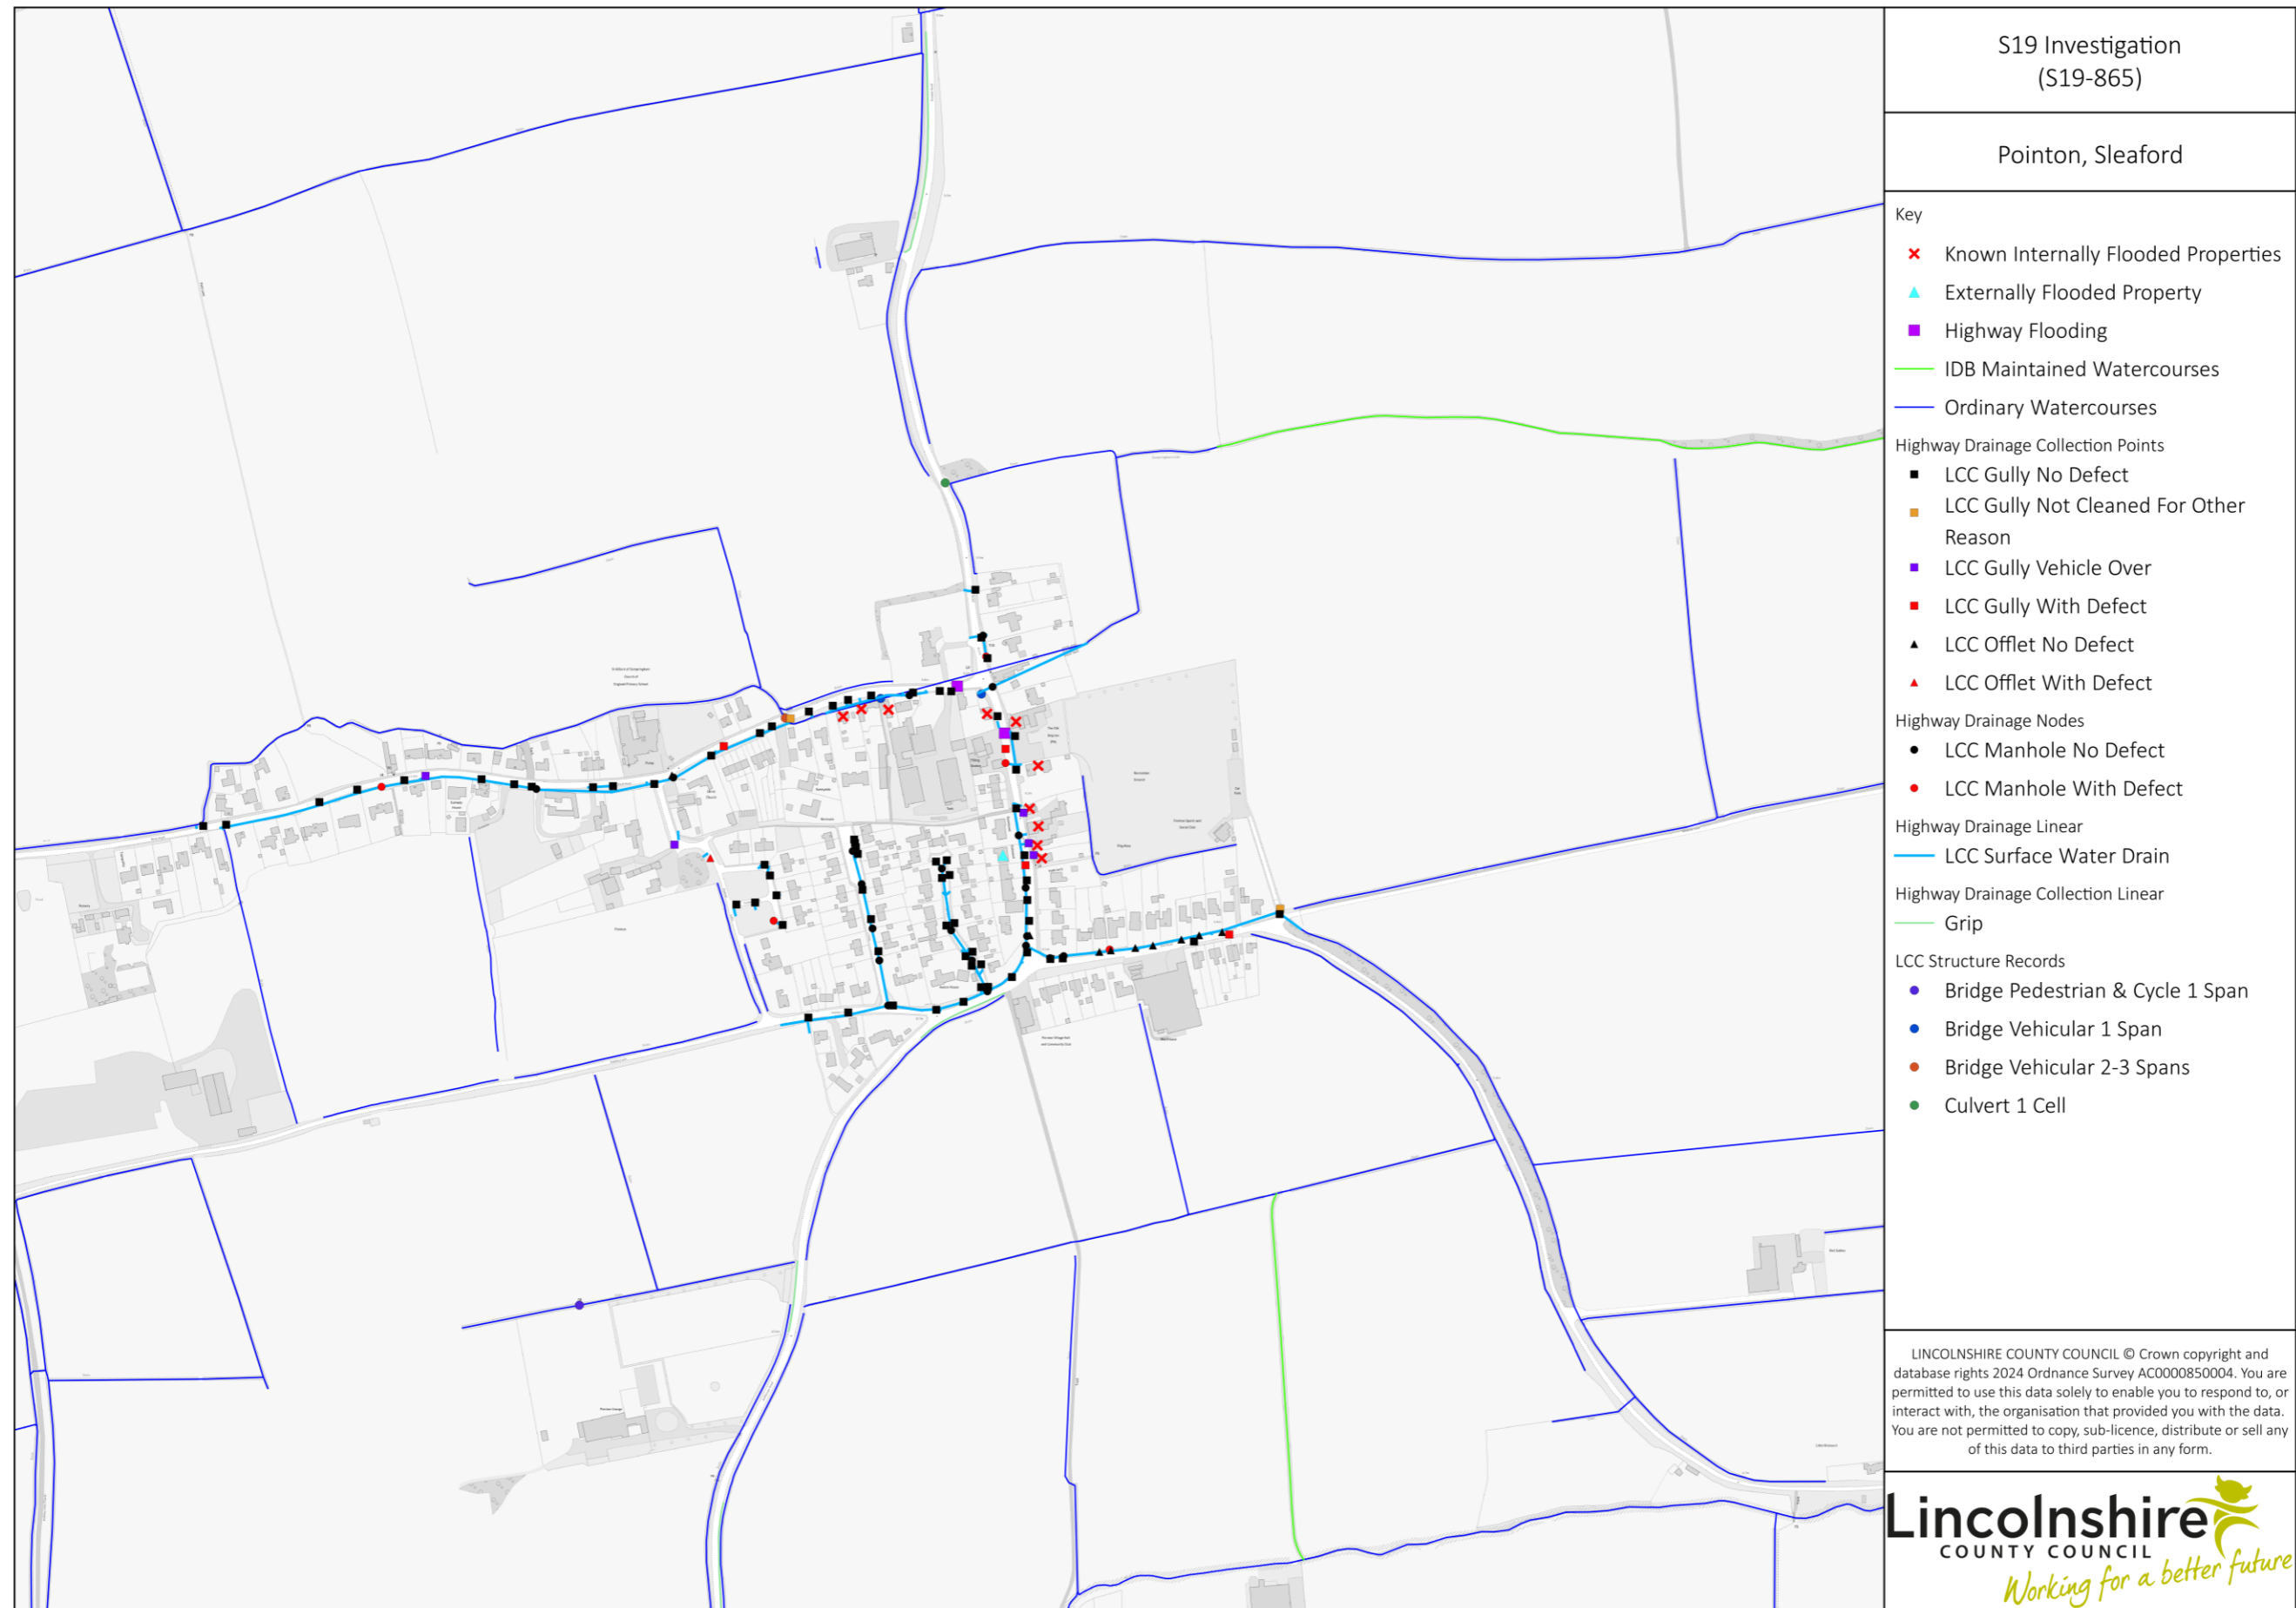
(Figure 3 – Drainage arrangement of surrounding land)

The drainage arrangement of the surrounding land is outlined in Figure 3.

Residents affected by flooding in Pointon have conducted a site walkover of their own which has identified various issues within the surrounding area which may have contributed to the flooding experienced in January 2024.
