Westgate Hall: Options Appraisal

Conception Architects

Condition Survey and Schedule of Required Conservation Works Westgate Hall

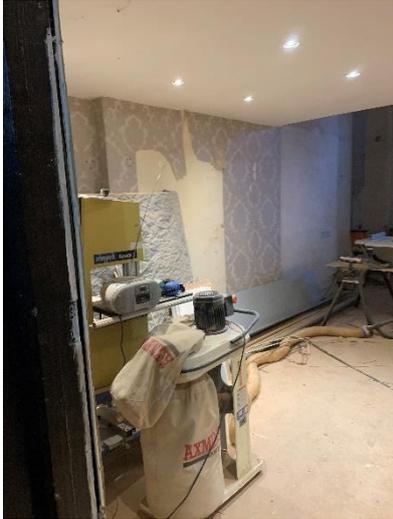
RG01

Walls beneath mezzanine floor covered with plasterboard and wallpaper.

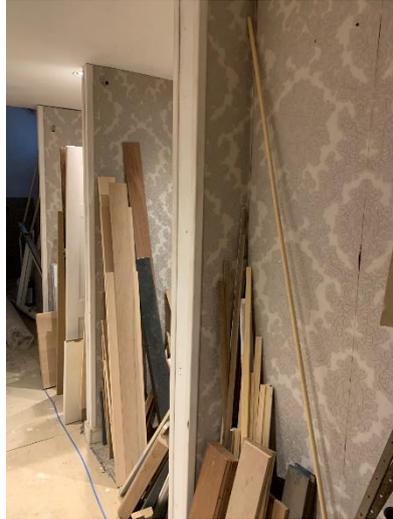
Partition walls, plasterboard, and wallpaper on right hand side of room beneath mezzanine floor.

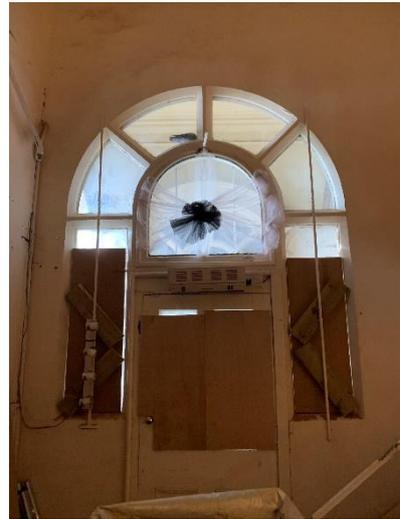
External door and surrounding stone detailing and glazing.

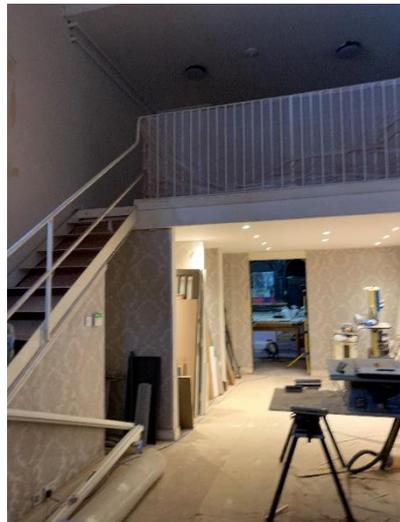
Modern mezzanine floor with stairs.

The various modern fixtures and decorations, including the mezzanine floor and modern floor covering, should be removed. The room/unit does not appear to be damaged.

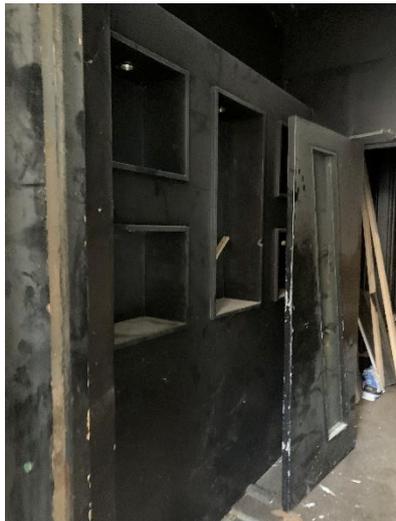
RG02 & RG03

False display wall on left hand side in RG02.

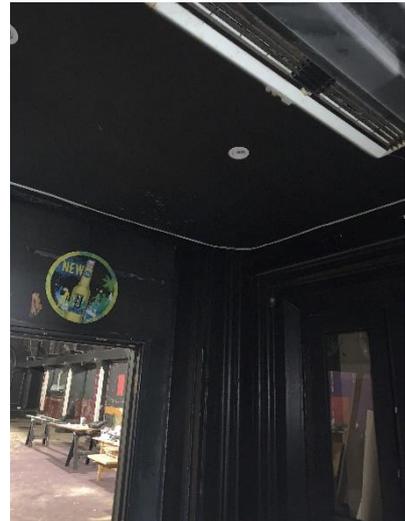
False ceiling in RG03 with blocked door through to RG01.

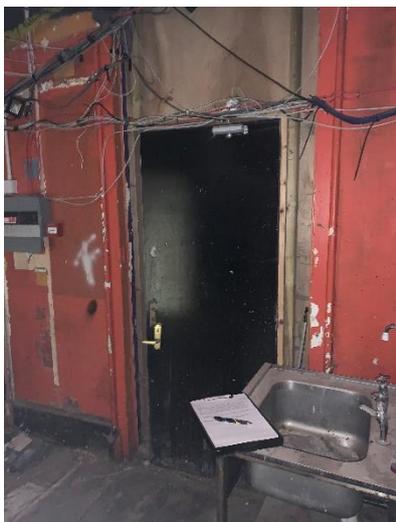
RG05 & RG06

Door through to RG07 with modern timber frame.

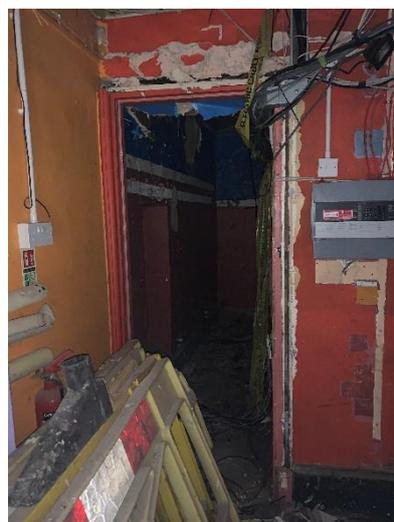
Door through to RG06 with rubble covering floor.

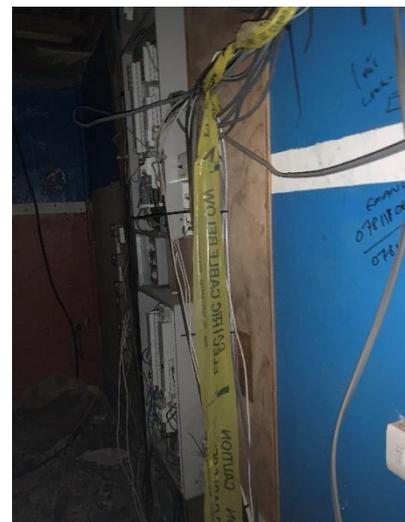
Wiring centre on right-hand side wall of RG06.

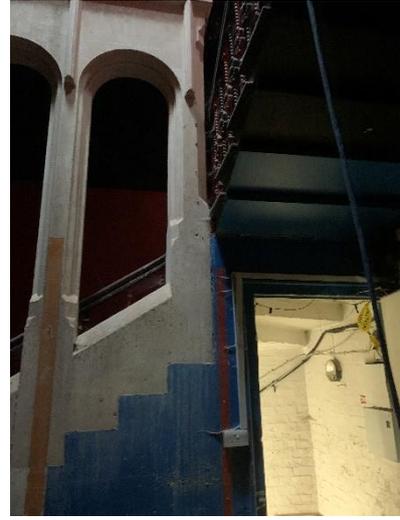
Door to basement and corner of stairs leading to 1st floor.

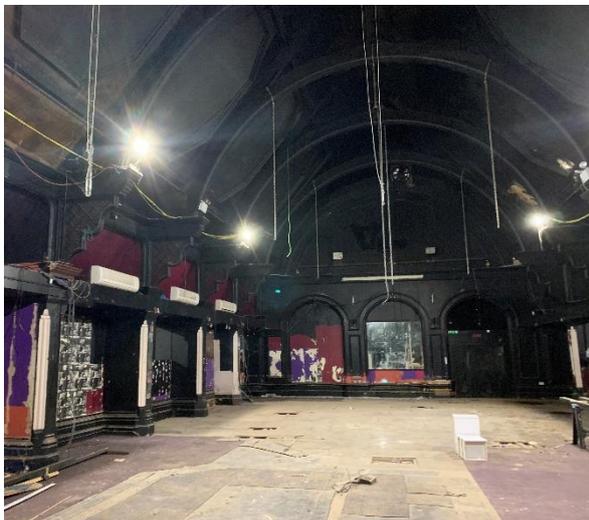
View of length of RG07 facing east. Mirrors around perimeter of room with blocked roof windows above.

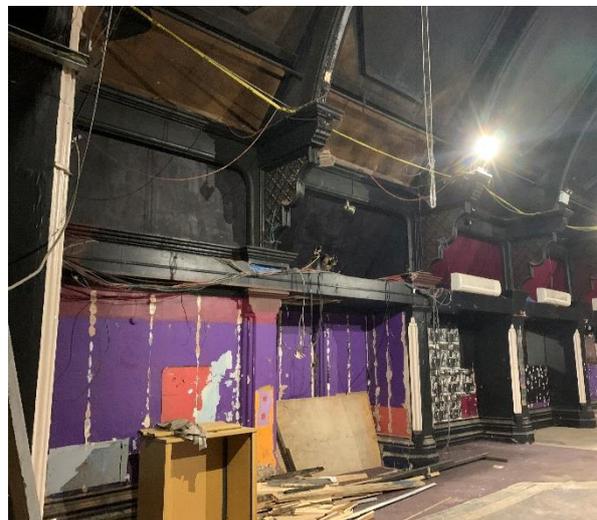
North side of room with timber framing containing wiring and HVAC systems fixed above.

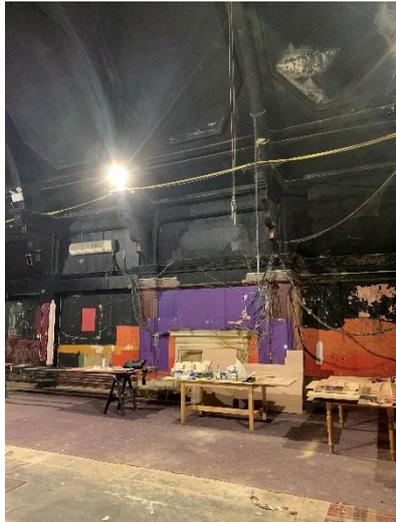
Right-hand side of room with wiring running between corbels and modern lights.

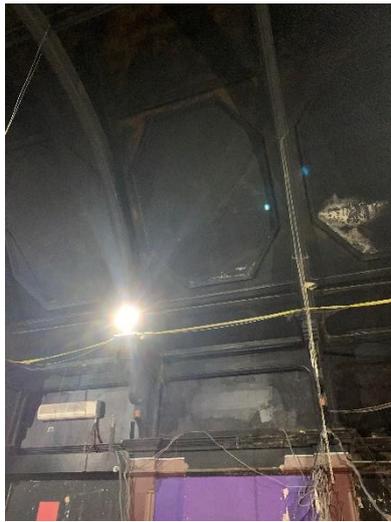
Hexagonal roof window boarded over.

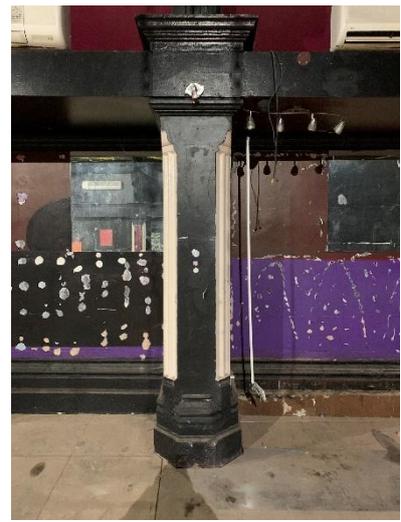
Original columns supporting corbels for arched roof timbers.

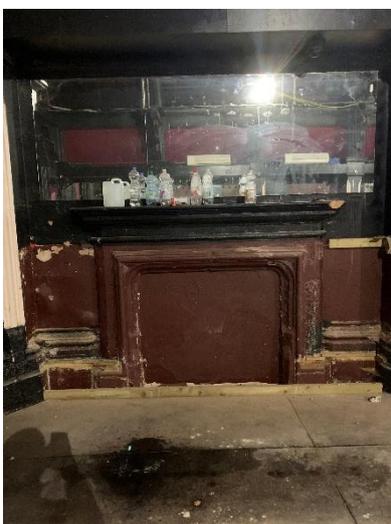
Original fireplace exhibiting signs of damage and modern decoration.

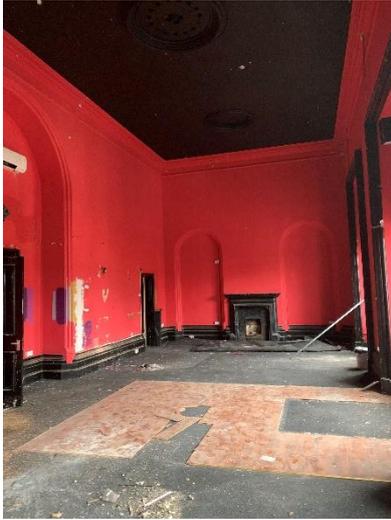
RF01

View from north to south along RF01. Door to RF02 at far end.

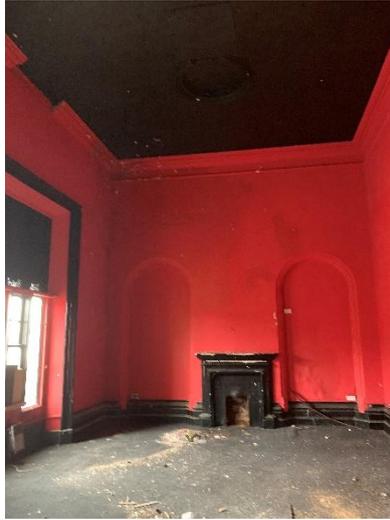
Fireplace at north end of RF01.

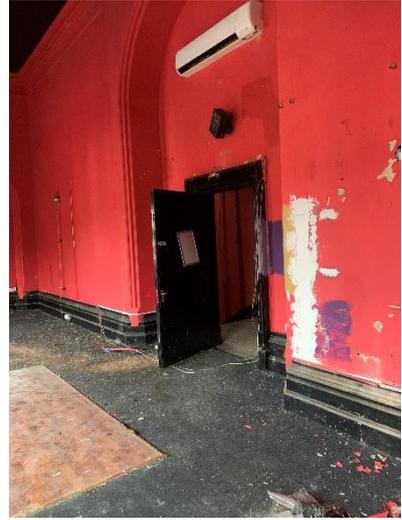
Door into RF01 from RF03 with fan heater above.

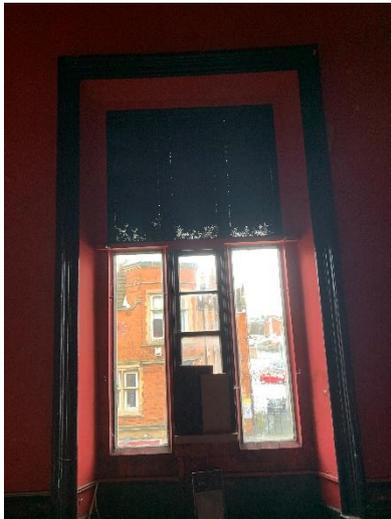
Right-hand window with boarded lower-middle section.

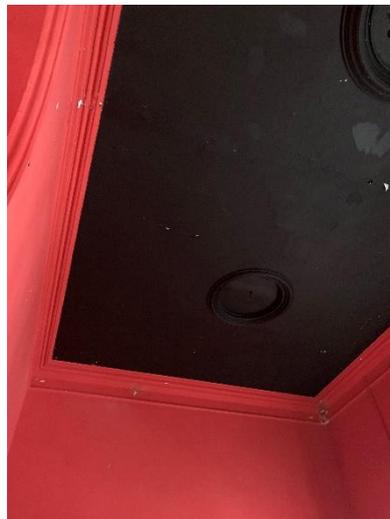
Black painted ceiling with historic detailing.

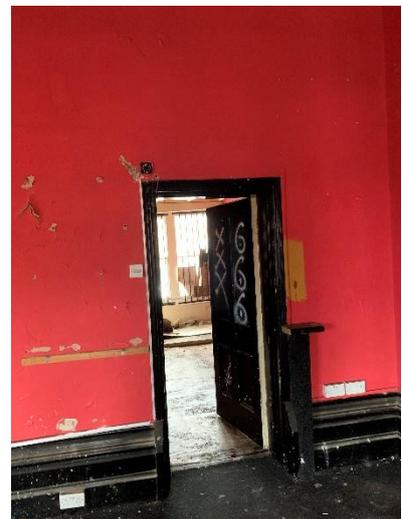
Door into RF02 from RF02.

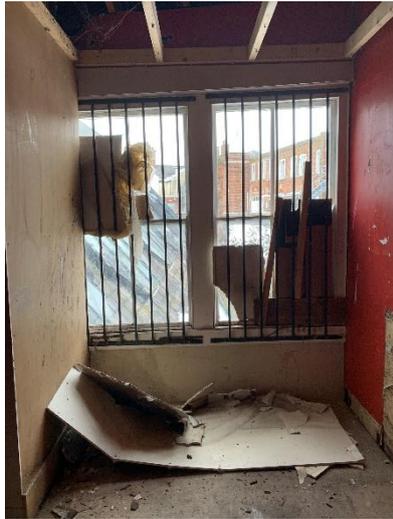
RF02

Window in RF02, angled suggesting structural issues. Modern timber framing around.

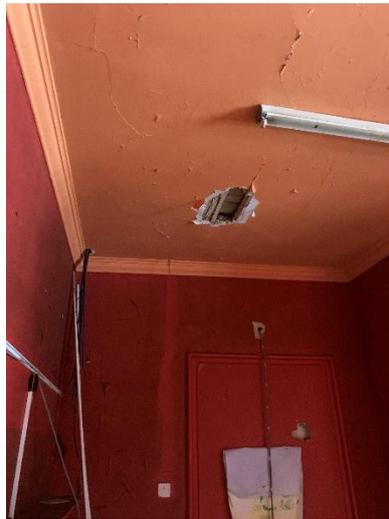
Hole in ceiling with modern light fixture.

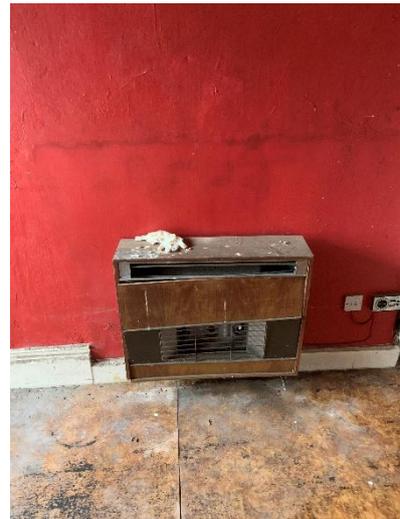
70's/80's heating unit.

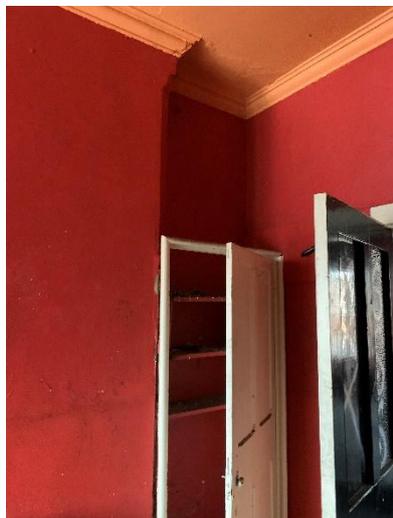
Damaged cupboard in corner of room.

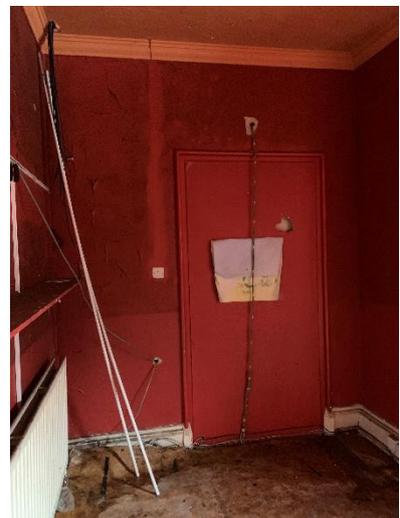
Doorway into RF03 boarded over with historic door frame still in place.

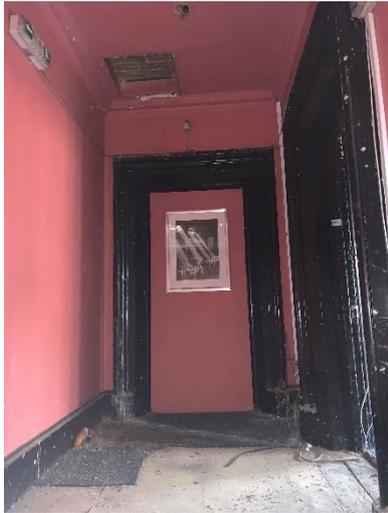
RF03 & Stairwell

Doorway into RF02 blocked with historic door frame still in place. Loft hatch above.

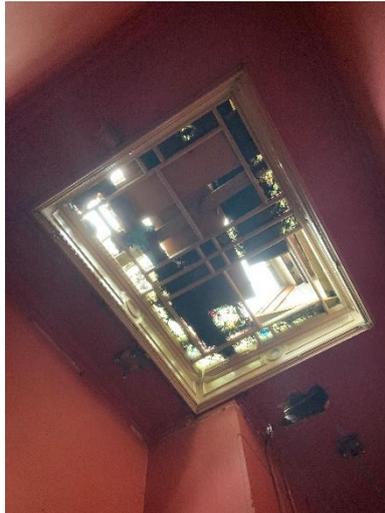
Intricate historic ceiling light with damaged/missing glazed sections.

The ornate ceiling window will also need to be repaired and the missing glazing reinstated as required.

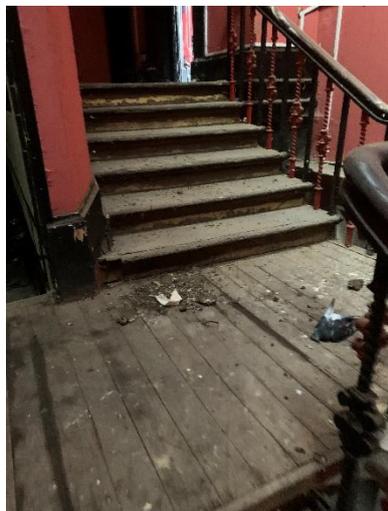
Landing before RF03 with pigeon remains.

The historic stairwell is in relatively good condition, though will need to be cleaned of all faeces before undergoing repairs where noted, and finally it will need to be redecorated.

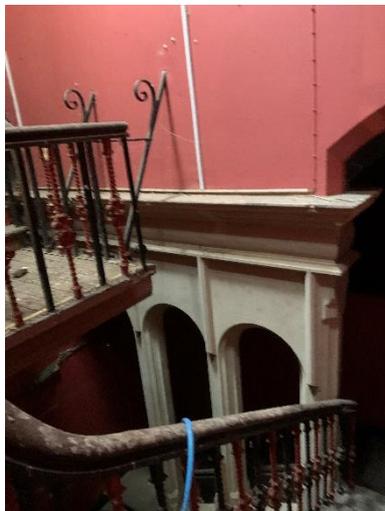
Stone cornice running around stairwell.

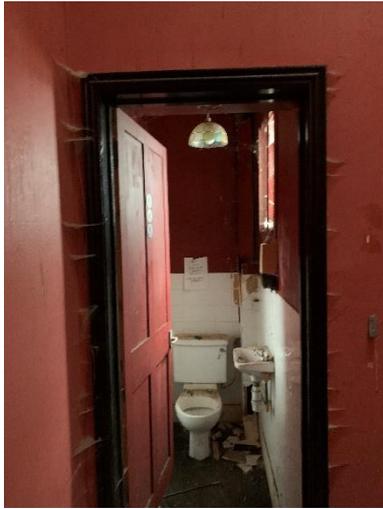
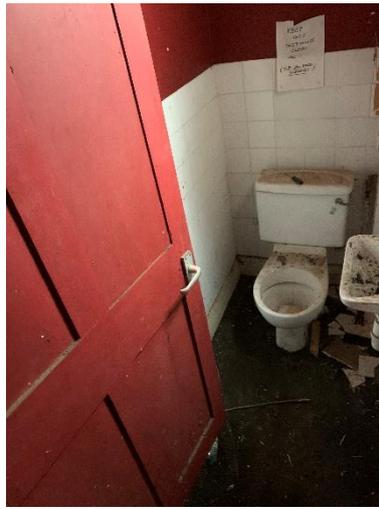
RG04

WC in RF04.

The existing WC fixtures and decorations should be removed so the room can be repaired and reinstated as a WC with new fixtures.

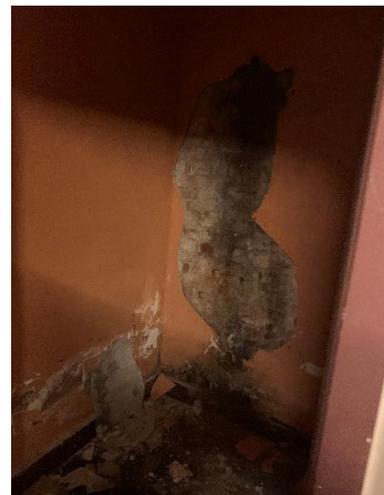
Damaged plaster finish.

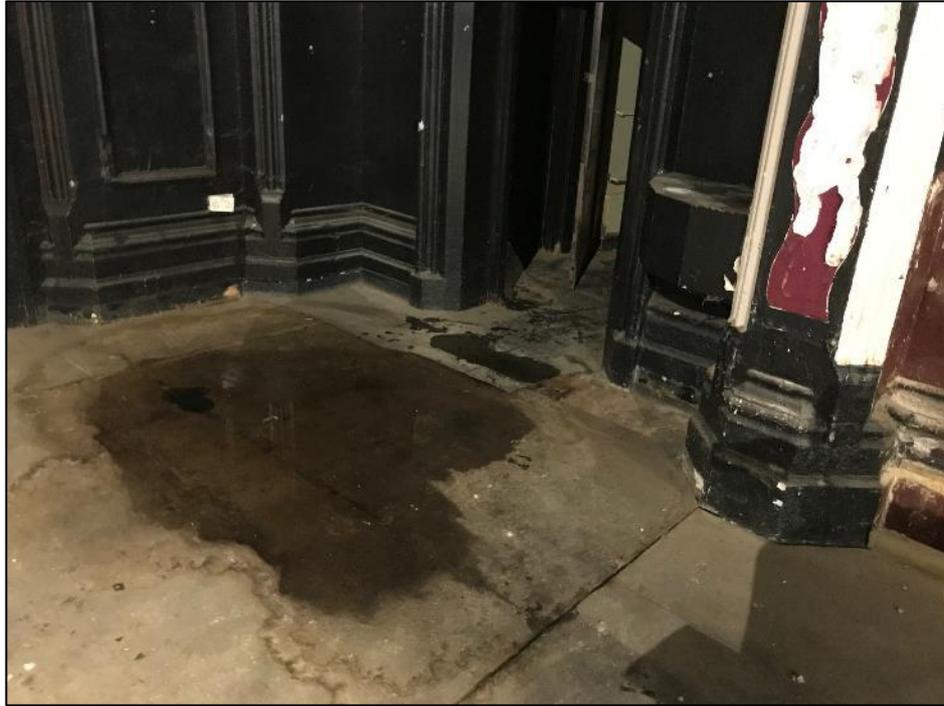
Evidence of water ingress
